Illy Auerbach & Liza Hegedus  
Professor Normandin  
Building Conditions Assessment  
4 March 2024

## Lescaze House and Studio- The first modern residence in New York City<sup>1</sup>

### Investigation and Assessment

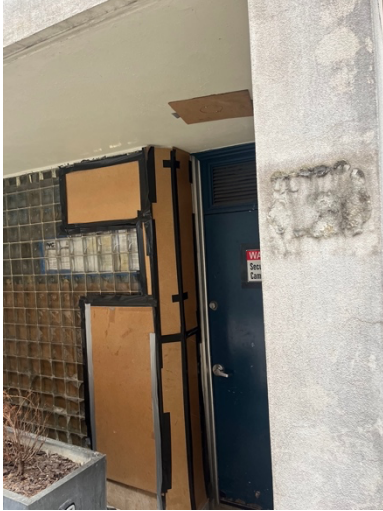
Figure 18 Alterations

- On the English basement level, there is a partial covering of glass blocks from outside with cardboard glued by duct tape (figure 18).

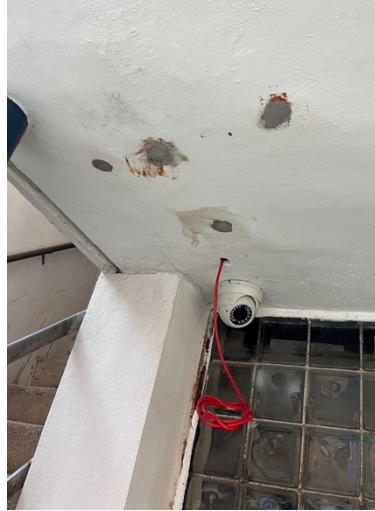
Figure 17 Fixtures\_a

- Some gray cement patches on the walls and ceiling of the English basement level.
- Exposed security camera on the English basement (figure 17).
- Exposed electrical wiring coming out of the ceiling next to the security camera and by the main door (figure 17).
- Peeled building number signage at the east end of the building (figure 16).
- Missing hardware: door knob from the gate, lighting fixtures from above the office door, and above the main house door (figure 15).

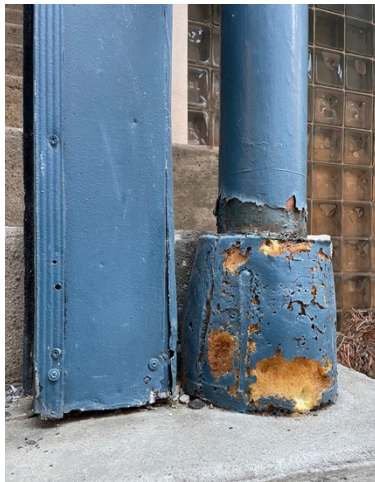
Figure 14 Foam

- On the base of the steel column on the east side of the main stairs leading to the house, there is a protective shoe foam in a state of heavy deterioration, much of the foam is missing, and its texture is crumbly (figure 14).

Regarding the shoe foam on the base of the column, we could not find any documentation of this element before the proposal to the LPS from 2021. We assume that this element is there to protect the base of the post from corroding. Therefore, if

careful treatment and ongoing maintenance are given to the steel column, the foam may be unnecessary.

- **Removal of Foam:** Upon further examination of archival materials and consideration of advancements in construction materials, it has been determined that the foam used at the base of the steel column serves no structural or functional purpose and is not original to the building. Therefore, we recommend its removal to maintain the authenticity of the structure.

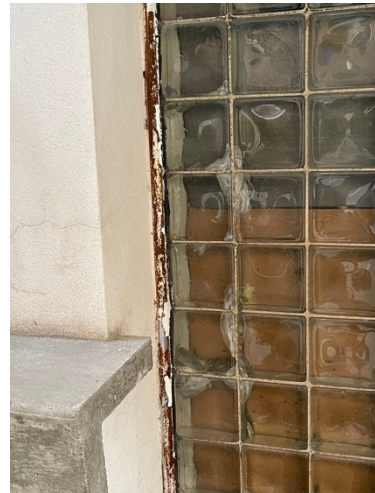
Figure 13 Steel\_a

- Heavy peeling of paint and heavy corrosion were observed on the following steel elements: columns, gate, window trim, and on the steel frame of the glass block on the English basement level. This problem is highly probable on the frames of

the glass blocks on the upper levels as well, but due to accessibility, we could not observe those (figure 10) (figure 11) (figure 12) (figure 13).

Many of the problems we were able to recognize are correlated, meaning the formation or development of one worsens the situation of others. This phenomenon is most notable in the glass block wall of the English basement level. There, we have an interaction of three elements: the glass blocks, the mortar joints, and the steel frame. Like in many steel elements in this building, paint came off the steel causing it to rust. The rust jacking puts pressure on the glass and mortar as it limits its space and decreases its ability for movement that occurs naturally with weathering. Adding to this stress is the mortar that seems to be hard and was applied in very thin joints. These factors negatively affect each other as well as the glass blocks, the crown jewel of the house, causing many of them to crack and break. This relationship can be seen in (figure 13) (figure 20) (figure 23).

The state of rust is severe in all exposed steel elements. This condition likely occurs due to a lack of maintenance, which would include priming the steel and repainting it.

Additionally, in some spots like the ends of columns or the joints of the gate, it seems like the primer and paint were not applied to the problematic parts that are harder to reach, leading to severe corrosion. Due to this condition, we could easily pick a small sample of the peeling paint and conduct a further study on it (figure 14). On February 22, 2024, we examined the sample in the Historic Preservation Lab and were able to find its match in the Munsell Book of Color and in the Benjamin Moore catalog.

- **Steel Treatment:** The steel elements require attention to address corrosion and deteriorated paint. We propose a comprehensive treatment plan that includes stripping the paint, removing corrosion, cleaning the steel surfaces, and repainting them to protect against future corrosion. Additionally, it may be necessary to break the concrete around the column to treat its base before reapplication.
- **Maintenance Protocol:** we strongly recommend creating a protocol that includes seasonal and annual maintenance tasks that will support the ongoing maintenance of the building. To maintain the integrity of this unique structure ongoing care must be given to it.

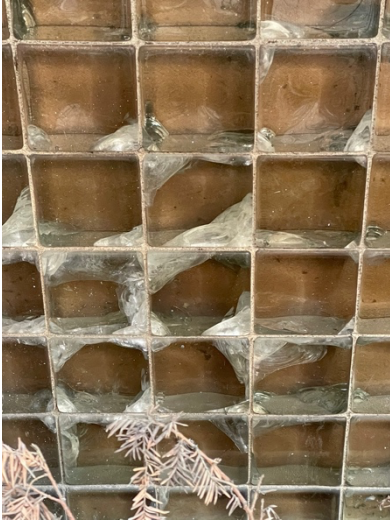
Figure 23 Mortar

- The mortar joints between the glass blocks are very thin. On the English basement level, where we could access it, much of the mortar is damaged, and some of it is missing (figure 23).

- All exposed glass blocks are in place, but many of them are chipped or broken (figure 20) (figure 23).

- **Structural Integrity Assessment:** In light of the observed cracking, we strongly advise engaging a professional to conduct a thorough assessment of the building's structural integrity. This assessment should not skip the glass bricks as some of them are structural and examining their structural capacity is vital. The assessment will help ensure the safety of the building and its occupants.
- **Glass Bricks and Mortar Assessment and Replacement:** Following the overall condition of the glass bricks and mortar, we recommend a meticulous brick-by-brick assessment to identify any areas of damage. Any damaged bricks should be

promptly replaced to maintain the structural integrity and aesthetic appeal of the facade. In replacing the glass, size, color, and level of opacity must be taken into account. For the mortar, after the analysis, there may be a need to consider the usage of a softer mortar that would be more allowing to material weather.

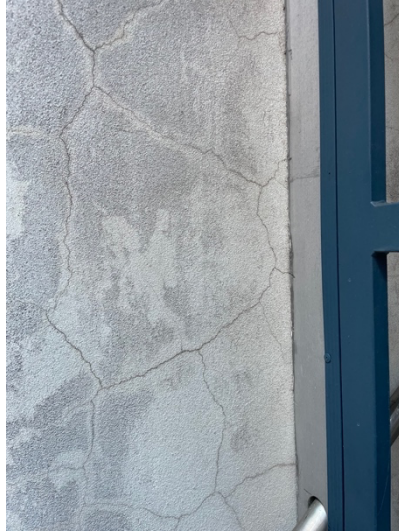
Figure 22 Stucco\_a

- There are many stains on the building (figure 22).
- There are many cracks in the stucco, mainly around the steel elements. The most severe cracking was observed in the canopy above the main entrance, by the gate, around the trims of the glass elements, and between the third and fourth floors on the west end of the building (figure 21).

Rust jacking has also significantly influenced the stucco, where we can see that the areas by the steel elements such as the columns, the gate, or the window frames are suffering from more cracks and stains, probably due to the corrosion and expansion that leads to increased pressure on the stucco (figure 21) (figure 22).

- **Stain Removal:** Cleaning and removing the stains on the stucco and concrete surfaces will significantly enhance the appearance of the facade. It is essential to utilize appropriate cleaning methods to preserve the original aesthetic materiality and appearance of the building.

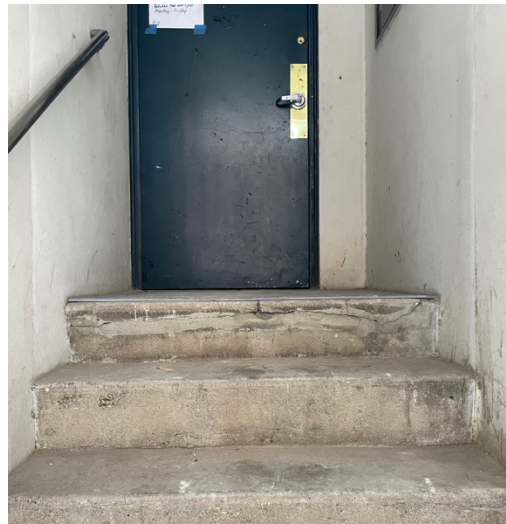
Figure 19 Concrete

- A crack in the concrete floor by the entrance to the English basement and a crack on the top stair to the main entrance (figure 19).

- **Concrete Replacement:** There is a broken concrete stair as well as a large crack on the concrete by the studio door. Those should be addressed with new material while keeping the original shape and texture.

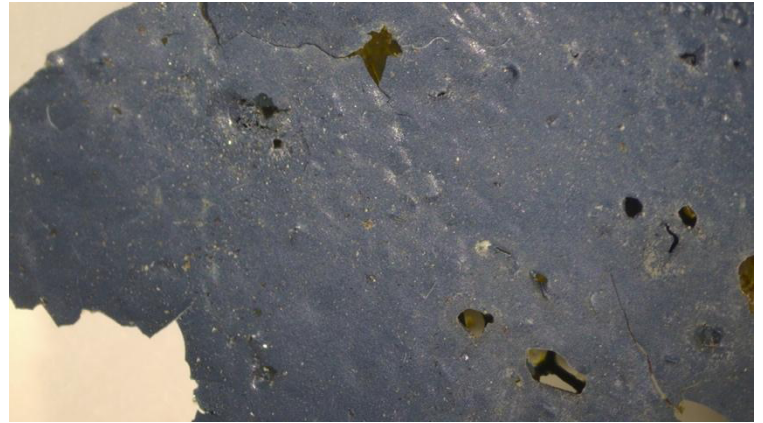
*Figure 24 Paint Sample\_b*

- In the Munsell Book of Color the match is: Hue- 10B, Value- 3, Chroma- 2 (figure 24).

- In Benjamin Moore the match was: Gentleman's Grey 2062-20.

- **Color Analysis:** Further color analysis should be performed. The off-white and blue colors are essential to the original design of the building and should be studied ahead of being reapplied.
