# John L. Miller Mausoleum Research

Student name: Chuyan Zhou  
Professors: Andrew Dolkart & Kate Reggev  
Historic Preservation Program, Fall 2024. Columbia University of New York

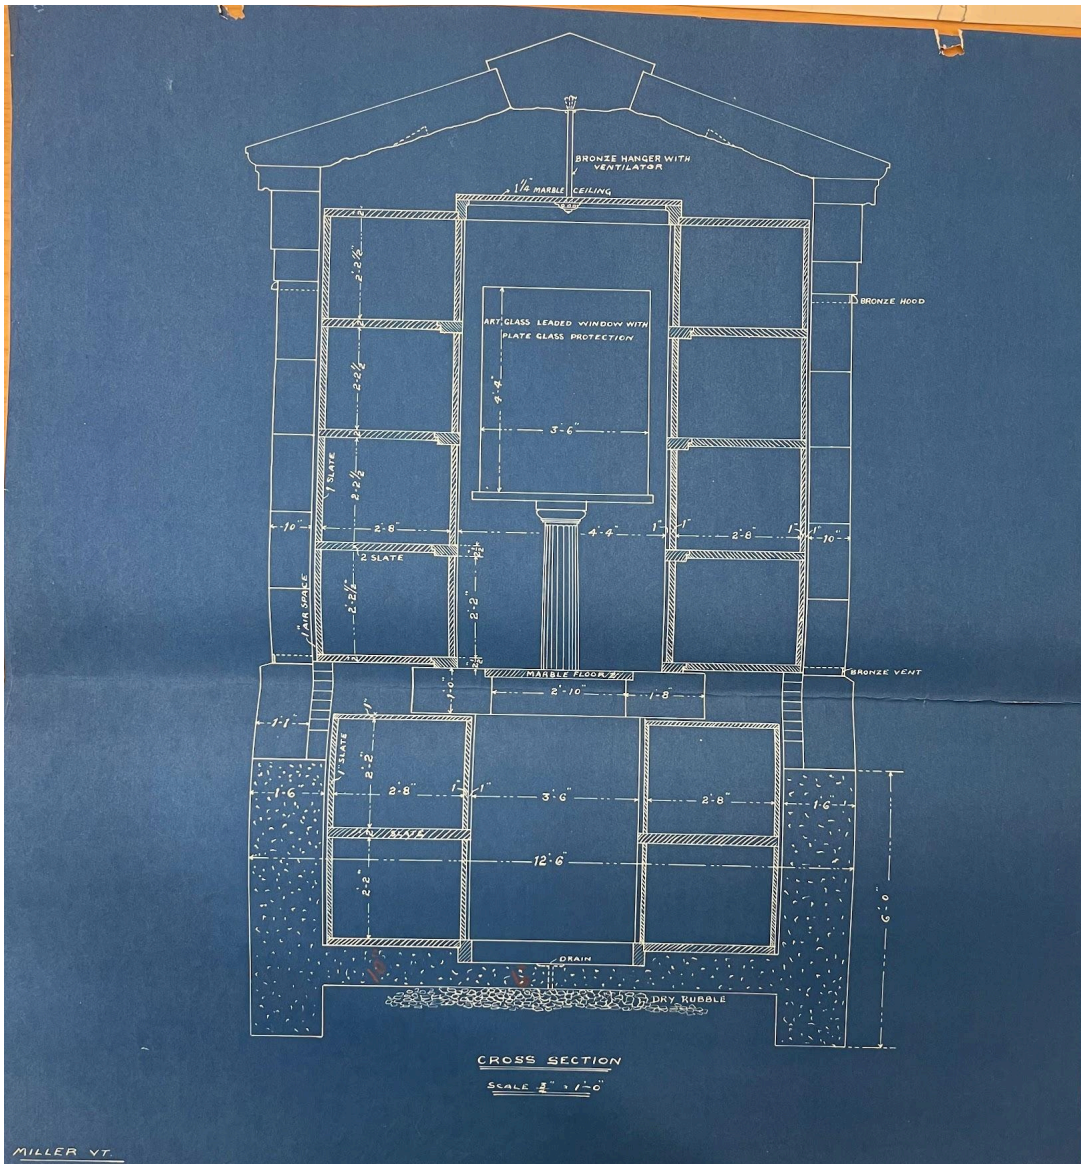
Figure. 1: "CROSS SECTION", Major Monuments Folder, Woodlawn Cemetery Archive, Avery Architecture Library Columbia University, Drawer MM 3.1: Folder 60.

In 1911, John L. Miller commissioned Adler's, a monument and granite works firm, to design and build a mausoleum for his family. The mausoleum was completed in 1912.<sup>6</sup> The mausoleum hosts ten catacombs, four on each side above the ground and two underground.<sup>7</sup> (Figure. 1) The cemetery plot is rectilinear, and the mausoleum is situated at the center, on a gentle sloping terrain. The John L. Miller Mausoleum is adjacent to neighboring mausoleums with no path or divisions in the plans shown at the archive. However, the two adjacent plots have planted trees, with two at the neighboring Coe's plot leaning towards the Miller's mausoleum. (Figure. 2)

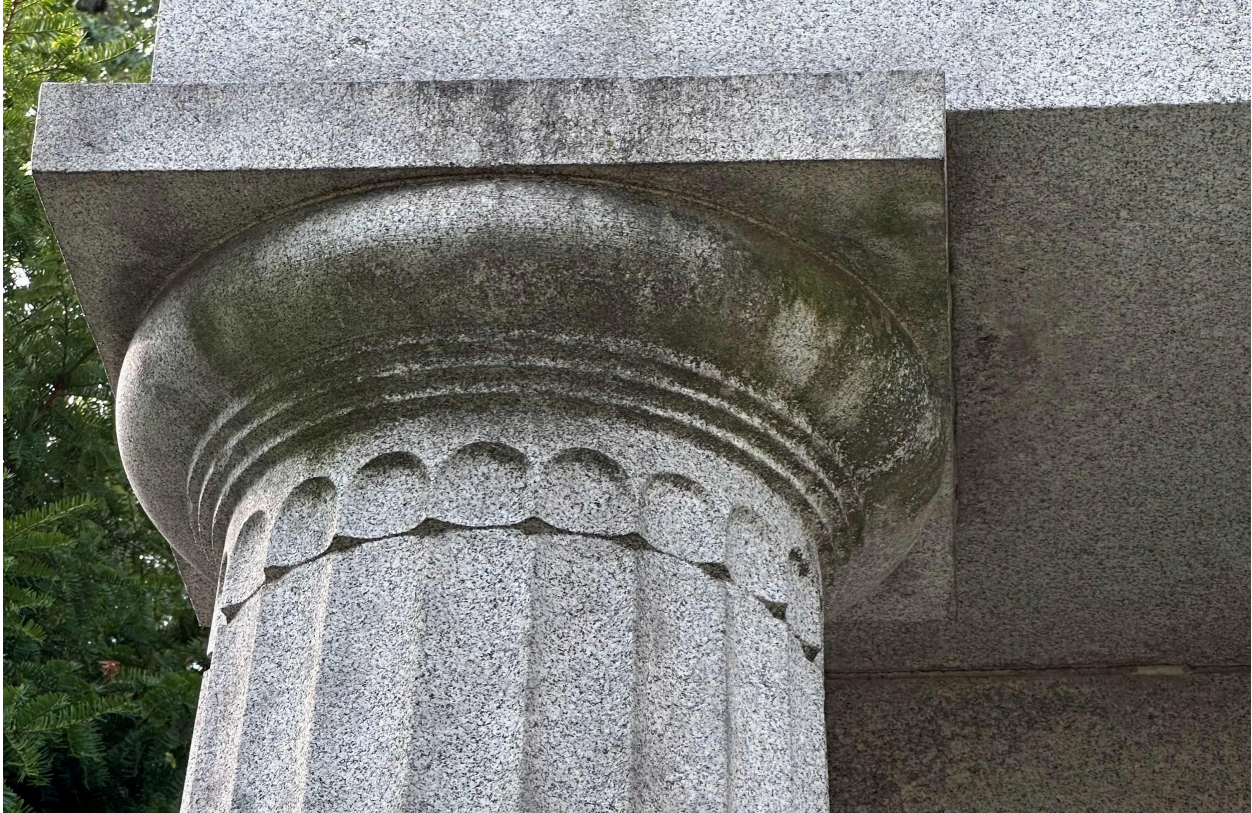
**Figure. 3:** Chuyan Zhou, *Doric Column*, 2024.

(Figure. 3) Above the columns are raised polished, carved granite “John L. Miller”. Atop of the that is a triangular pediment, and a piece of angle granite at the top along the ridge.

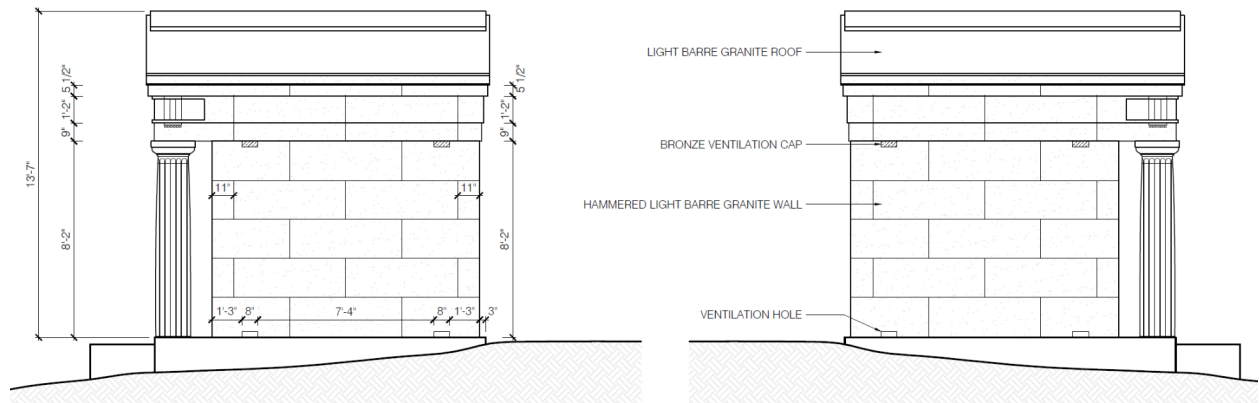
**Figure. 4:** Chuyan Zhou, *Side Elevations*, 2024.

On the side elevations (Figure. 4), the entablature continues to the side, and there is cornice sculpted at the corner of the facade and the side elevation that is adjacent to the front, totally four. There are four rectangular drainage holes at each side, two at the bottom and two under the entablature, each covered with a bronze cap, cut in at the exterior granite ashlar blocks. The exterior wall is finely hammered granite, stacked in order, and the mortar is La Farge cement<sup>9</sup>.

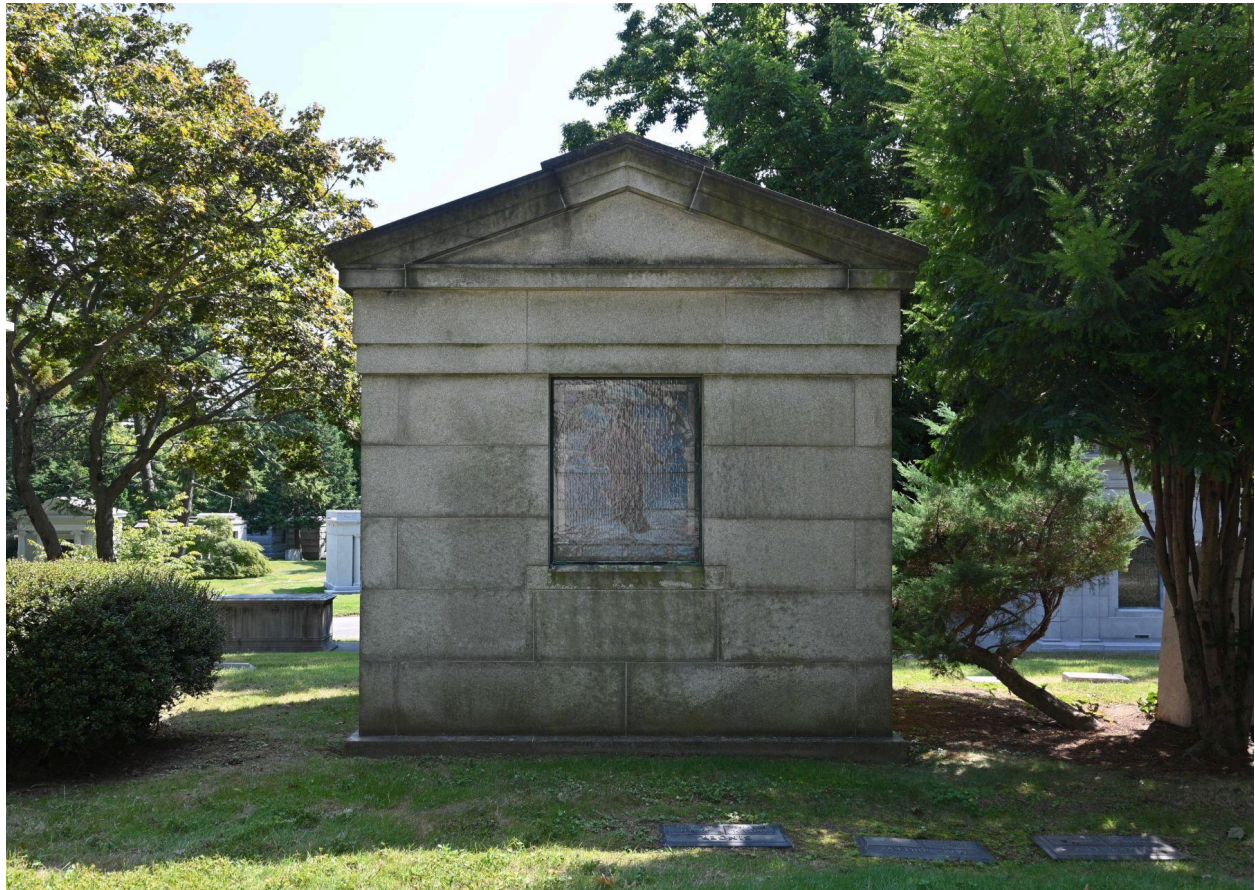
**Figure. 5:** Chuyan Zhou, *Rear Elevation*, 2024.

The rear elevation (Figure. 5) is simple and clean, it has the same triangular pediment, entablature, and cornice as the facade, but with no sculpting. Directly underneath the cornice is the window frame which is made of bronze, and there is a hint of color and shape of pattern can be seen from the exterior because of the treatment of the glass surface. There are holes left in the granite around the window, likely for bronze grills to protect the glass window from damage. However, according to the Rear Elevation and Specification from the archive.<sup>10</sup> there is no evidence showing a plan for this element. The window sill starts from the glass frame straight approximately three inches and then cut diagonally in a forty-five degree angle.

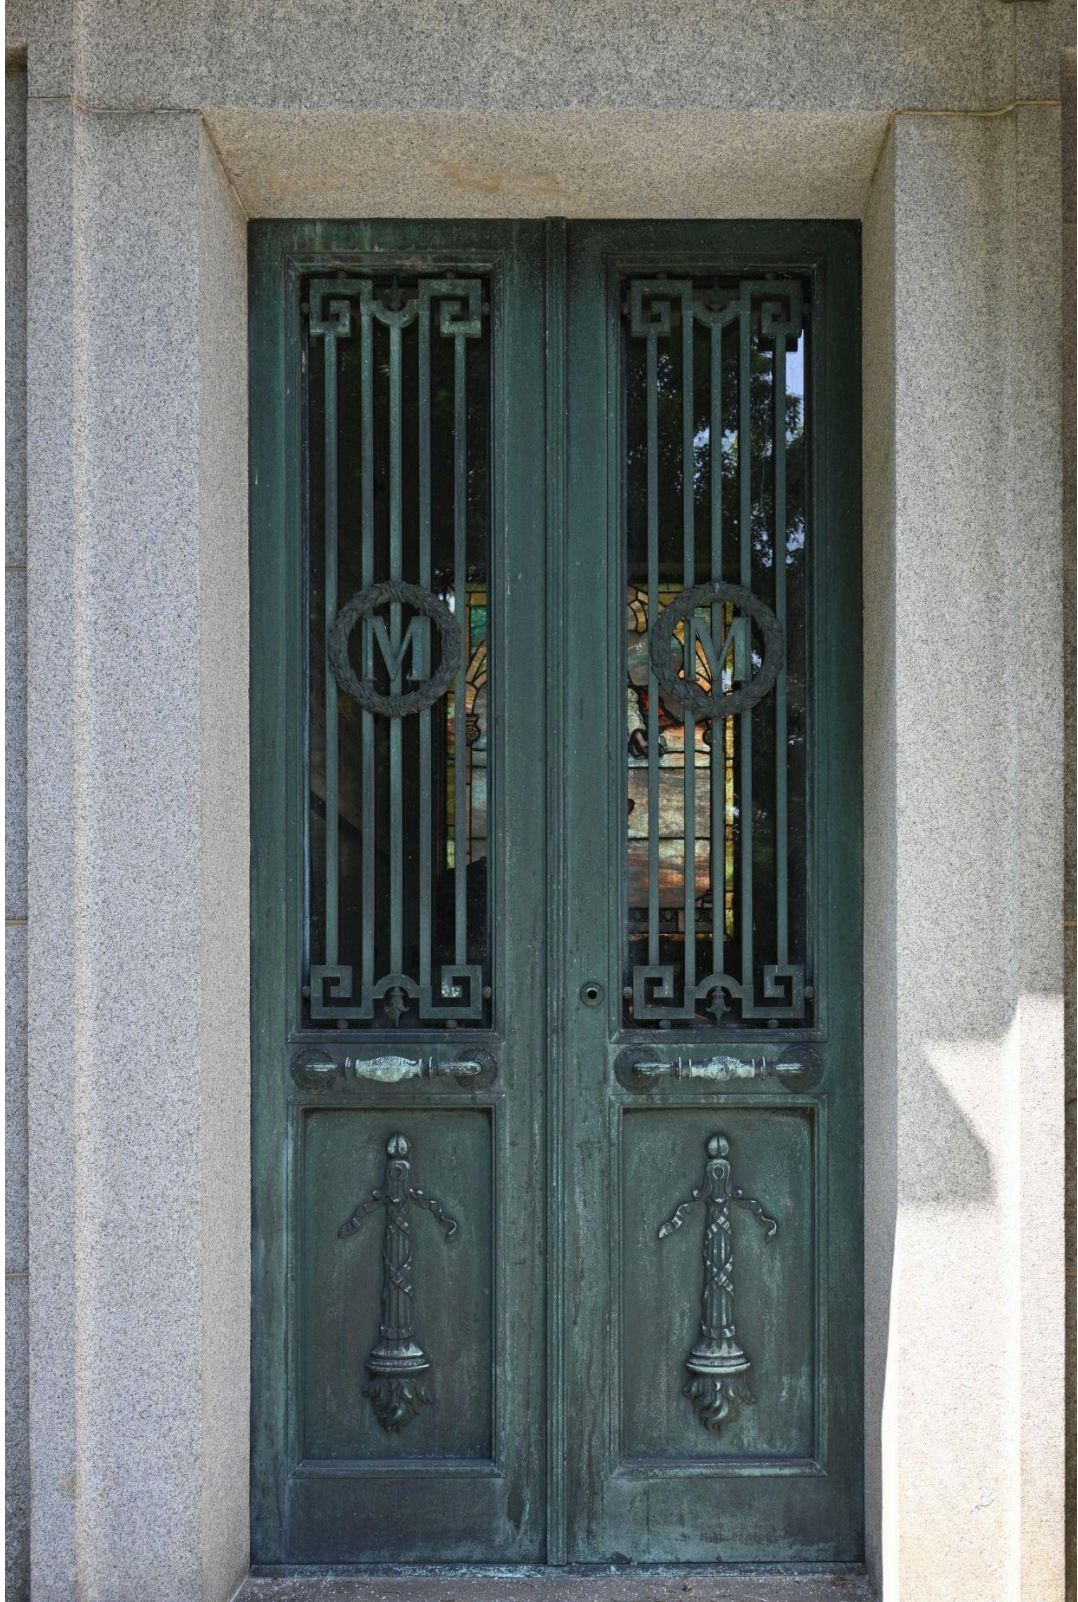
**Figure. 6:** Chuyan Zhou, *Doors*, 2024.

Walking up to the entrance, there are double bronze doors that feature elegant metalwork with rectilinear patterns and the letter "M" in a circular leaf motif attached on the straight metalwork, symbolizing the family. Below that is the door bar horizontally set. The lower part of the door has a sculpted metalwork, it seems to be an up-side down torch with flame.

(Figure. 6) These heavy, double-panel doors lead directly into the mausoleum. When opening the door, the interior of the mausoleum is revealed. The predominant material throughout the
