Marieke van Asselt, Shereen Al Mater
Building Conditions Assessment - ARCH 4830
Prof. Kyle Normandi, TA Blanca Balbuena
March 3, 2024

Harry Belafonte Library (115th Street Branch) Conditions Assessment Report

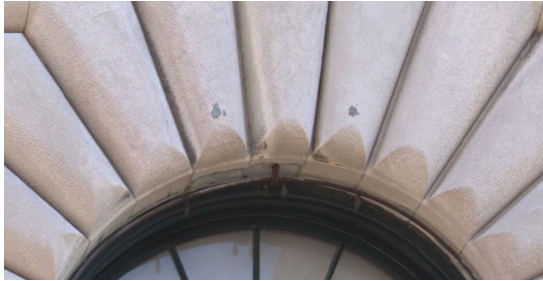
Holes where a conduit was likely attached
A2

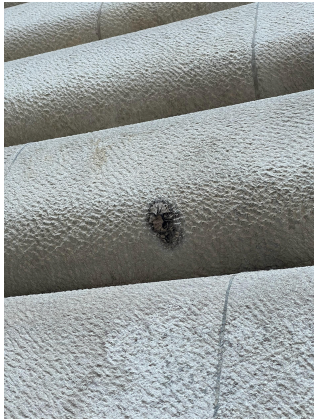
Area of limestone where an insect nest is visible
A3

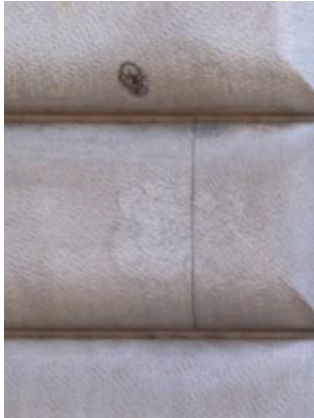
A Dutchman repair that is located below the insect nest
A4

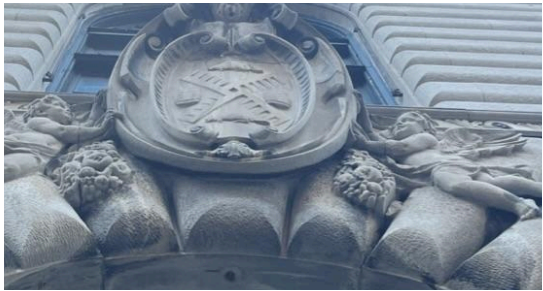
The New York City crest where a piece of the limestone vine on the right is missing

Evidence of a Dutchman repair is also apparent on the first floor at some corner pieces of limestone, the original limestone was most likely damaged by physical impact given its location (A8). Areas where a Dutchman repair is needed include the limestone city crest where a piece of the carved vine had fallen off the facade (A4). Given its location, the damage on the limestone lintel could've been caused by the vine piece colliding in that area when it fell.

As for limestone, recommendations include a Dutchman repair for the missing limestone vine at the crest, filling the holes left by the plaque with mortar that matches the limestone, repairing or replacing the chipped stones at the corner of the facade, conducting a mortar analysis and repointing the mortar where needed including the discolored mortar filled conduit holes and the area of masonry on and surrounding the salt deposits. As for the soiling, paint, and other debris, there are some cleaning and product recommendations. The paint and graffiti can be easily removed with a gentle paint stripper such as SmartStrip where a quantity of it can be applied for a few hours and then removed. It is simple to use and is gentle enough to work on multiple surfaces. As for the copper runoff, a poultice stain remover such as Sure Klean will assist in the removal of the copper stains by the lanterns and on the cornice. For the overall debris and soiling, a soaking cleaning technique will be efficient and gentle enough on the limestone.

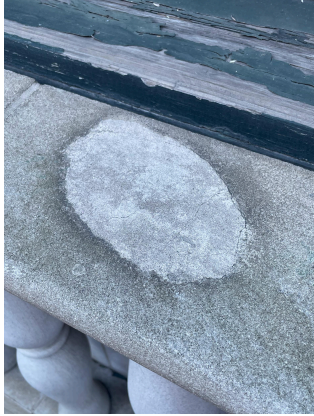
Discolored limestone lintel where the damaged stone was repaired with a concrete fill
A6

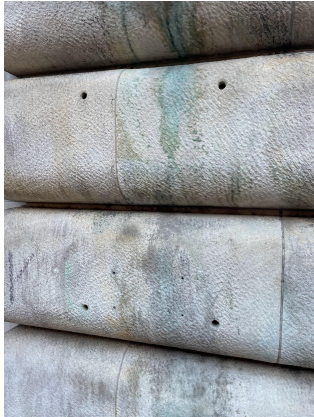
Holes on the limestone to the left of the entrance where a plaque used to exist
A7

The limestone is overall well maintained except for some minor conditions. Those conditions include unrepaired holes on the left of the entrance door where something was attached to the limestone such as a mailbox or a plaque (A6). There's evidence of repair across the facade where small holes have been filled with mortar which is slightly discolored but isn't very noticeable. Those holes were most likely caused by attaching conduits to the facade in the past (A1). Other conditions have been identified as well, all on the first story of the facade, one of which is an insect nest that is located to the left of the center window and coincidentally sits right above a Dutchman repair (A2, A3). On the sill below that same center window, part of the limestone was damaged likely due to impact, and has been repaired with a concrete fill (A5). The area of the limestone surrounding the fill is evidently discolored due to the collection of moisture in the area.

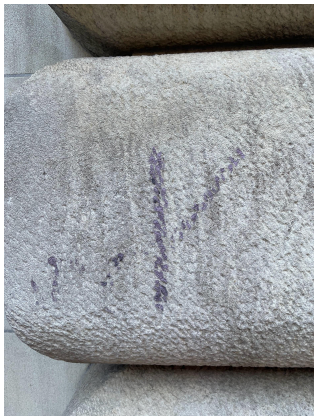
Slight graffiti at the corner of the building

Moreover, there's minor graffiti on the facade and some of it seems to have been done with crayons and paint, they're not very noticeable which could be due to the rain gradually rinsing them off (A7). Similar to the graffiti, some paint splatters are visible by the doors and windows which likely occurred accidentally during paint jobs that took place during the 2002 renovation (D1). The last existing condition on the limestone is some chipping at the corners of the facade, one chip which is on the granite and another on the limestone (A9). Given their location, the chips most likely occurred due to impact.

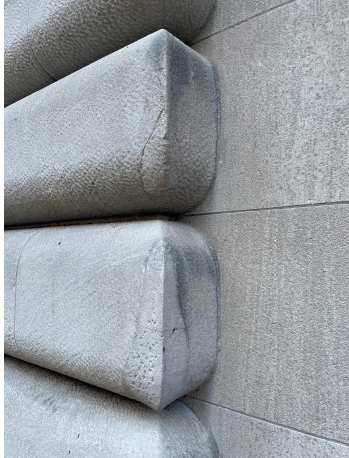
Two Dutchman repairs at the right corners of the building facade
A9

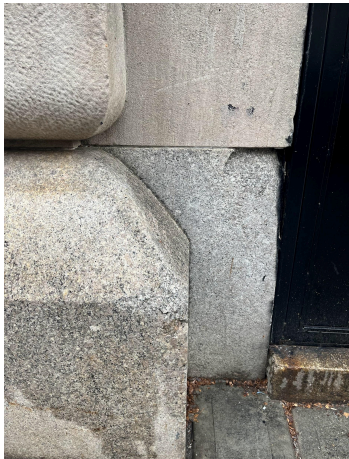
Two chips at the right corner of the building's facade

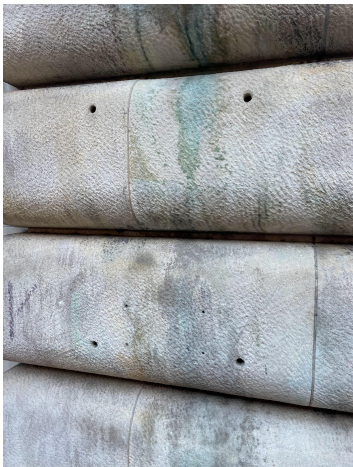
Copper runoff due to copper lantern

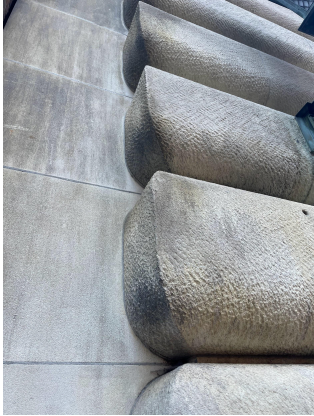
Soiling at the left corners of the building
B3

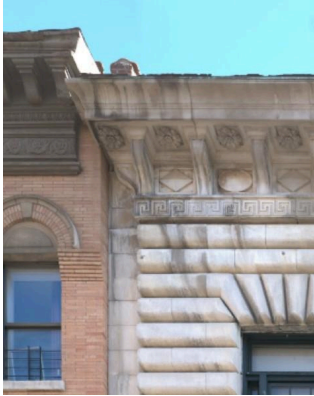
Soiling at the top left corner of the building/cornice

Soling is another minor condition that exists on the facade. Gypsum is present in the crevices of the decorative elements which are the crest, banding, and cornice due to the lack of contact with rain water (B3). The elements are highly detailed with sections where water can't reach which resulted in the buildup of gypsum. There's also evidence of soiling on the facade along the corners of the building and the edges of the limestone blocks, it is quite minimal and should be easy to resolve (B2). Another condition is copper runoff, there's some copper runoff beneath the entrance lanterns and on the cornice where a copper flashing might've been used on the roof (B1). The runoff is minimal and there might've been an attempt at cleaning it before during a past renovation.

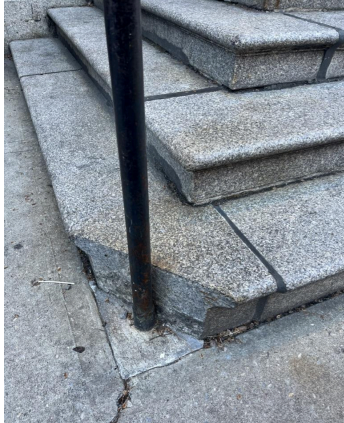
Missing piece of stone at the corner of the staircase
C2

The stairs and ramp are functional but they could be in better condition. Cracking of granite is evident in many conditions where the steel tubes of the railing meet the stairs and ramp (C2, C3, C4). The issue could be caused by corrosion and age as many of the cracks are accompanied by rust runoff. In places where the cracks were detrimental, pieces of granite were entirely displaced, such as the bottom of the ramp and the corner of one of the steps where an entire piece of granite was missing (C1, C5).

The recommendations for the stairs, ramp, and railing are to replace the pieces of granite that are not salvageable, such as the condition that exists at the ramp where the stone is completely cracked and displaced. We also recommend salvaging whatever is deemed possible of the stone and railing and replacing it where needed.

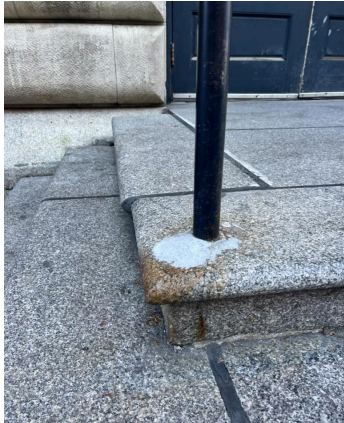
Rusting at the top left corner of the staircase
C3

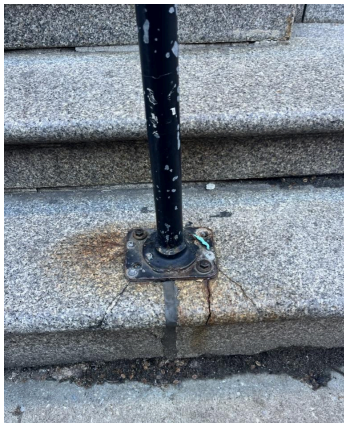
Rusting and cracking at the bottom right corner of the staircase

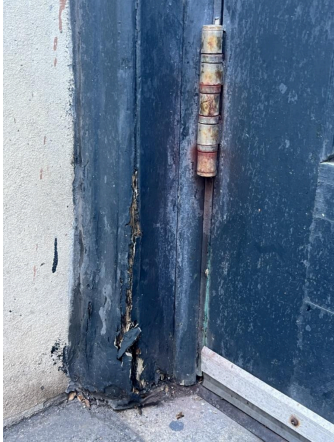
<p>The paint is delaminating due to iron rusting from the hinges as well as water pooling at the entrance.</p>
D2

Recommendations for windows and doors include securing the flagpoles on the third-story window as they pose a threat, restoring the door and window frames to stop further deterioration, and conducting paint sampling to find the correct paint color for repainting.

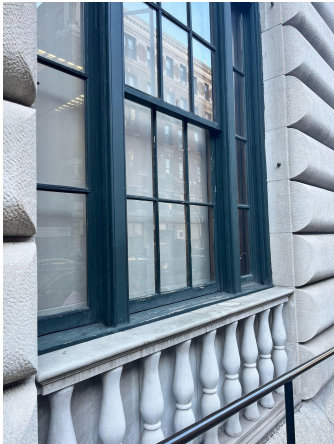
<p>All of the windows display peeling paint.</p>
D3

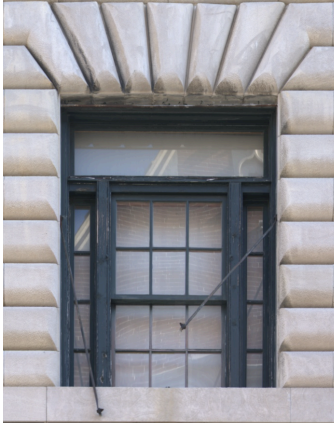
<p>The iron rods which supported the flag post are now unsecured and pose a risk to pedestrians below.</p>

The windows and doors are not in the best condition. The first floor windows and double doors have been repainted during the 2002 renovation but the paint is not faring well. It is already delaminating at some spots like at the base of the door frame and on the window sills, those spots are critical as they get damaged the most by environmental factors (D1). The second and third-floor windows have not been repaired when the 2002 renovations took place and they're currently in need of attention. The paint delamination on them is in a much worse condition than the first-floor windows and the wooden frames are deteriorating (D2). There's also the issue of some old flagpoles that are hanging loose on the center window of the third story (D3). The current flag is above the entrance door and the old ones could pose a hazard if not secured.

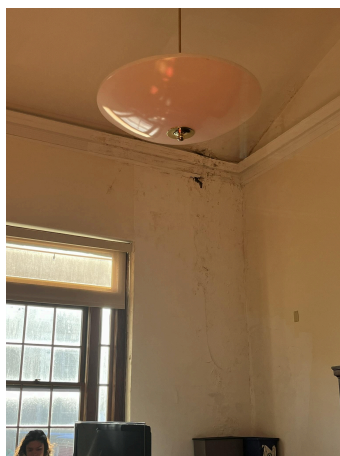
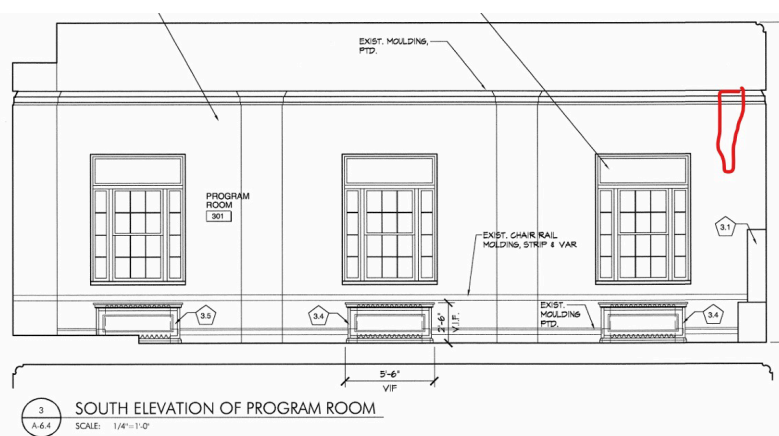
On the third floor of the library, particularly in the program room, a lot of water damage exists on the walls. It is worse on the south wall which is the exterior wall of the main facade, where the damage is very prominent and is due to leakage within the roof system. The damage also exists on the east wall where the exterior wall is brick masonry that is infiltrated with water as well.

As for the water damage on the third-floor interiors, the first step would be to find the source of the leakage and address the issue. Once the roof is repaired and the envelope is tightly sealed then repairs need to take place on the interior walls where the damaged parts of the wall system can be repaired or replaced.

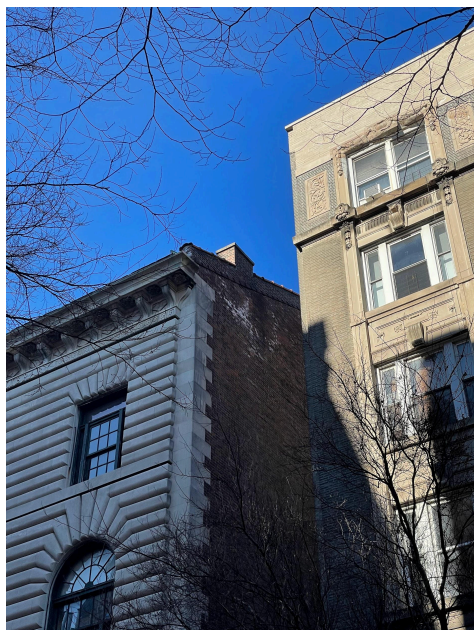
Although the front facade is mainly constructed of limestone, the other facades are constructed out of brick. The rear and west facades are not visible but part of the east facade is visible as the adjacent building is not attached to the library. There's evidence of salt deposit on that facade but it's quite minimal and is limited to the third story.

The cause of trouble on the east elevation, including the salt deposit, has to do with water infiltrating and moving throughout the brick masonry. The recommendation here is to repoint all the mortar within that area with a type N mortar and repair the tiles that are capping the wall as they are the source of the water infiltration.
