Paul Rudloph's Modulightor Building

Building Conditions Assessment

Phase 1: Research and Investigation Results and Preliminary Conservation Proposals

Prepared by Cecelia Halle March 4, 2024

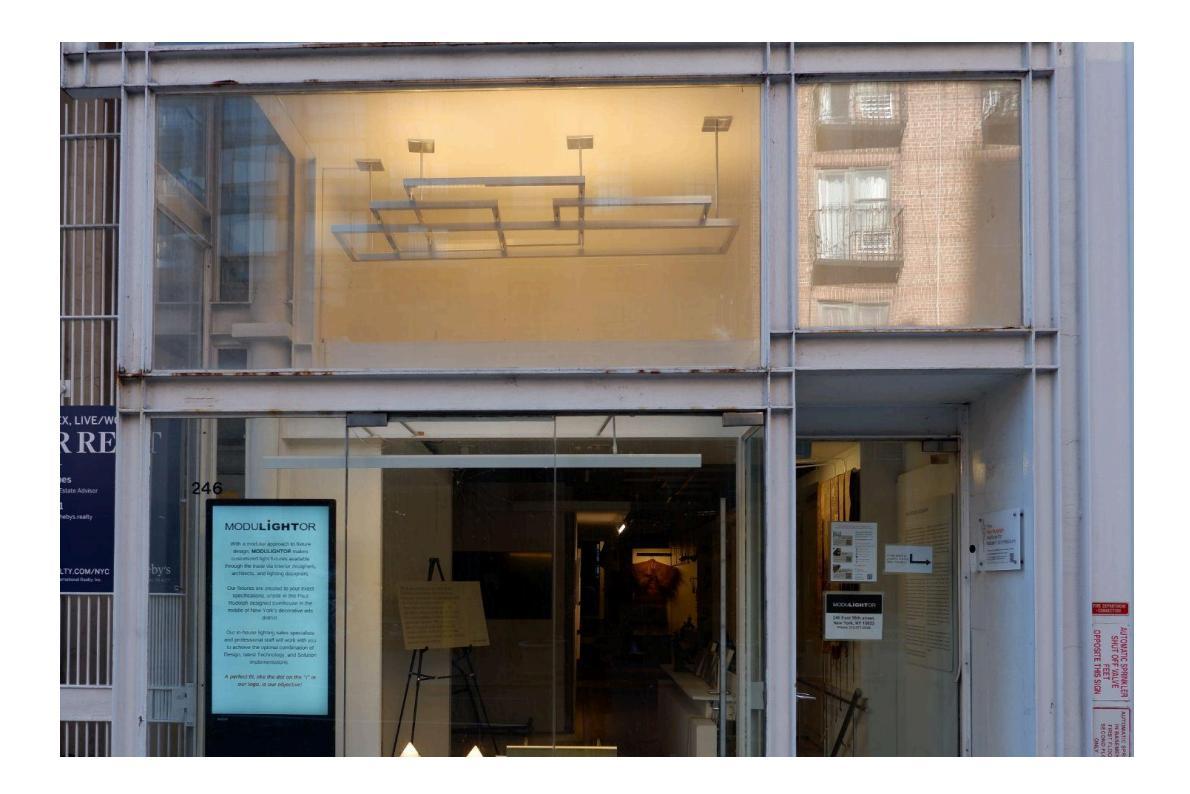
Significant corrosion is also found at grade level, where exterior steel structures come into direct contact with the sidewalk. The lack of a plinth or any sort of barrier at ground level has led to severe corrosion on the north elevation (North Elevation: RJ-1, C-4) and has similarly manifested on the third-floor raised porch on the south elevation (South Elevation: C-1, C5, C-9). Though relatively little corrosion is found throughout the third and fourth stories of the South elevation, there are early iterations of soiling patterns that resemble the North Facade.

Corrosion patterning on the ground floor exterior. Photo by Cecelia Hall
