The Eidt Mausoleum

Historic Preservation Studio 1

Woodlawn Project

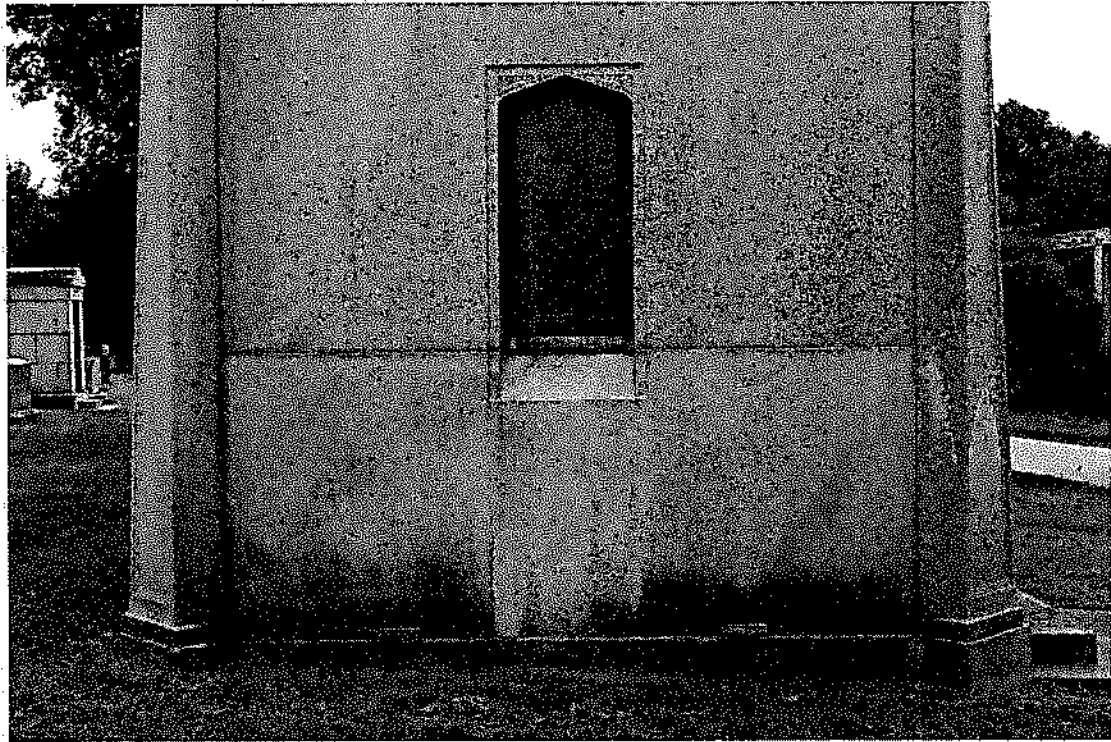
The exterior of the mausoleum is in relatively good condition. Mortar is missing from joints in a few small areas, but the vast majority is still intact. There is significant biological growth on the north side of the structure, but it does not appear to have damaged the stone (see image 6). Three exterior vents also appear to be missing their metal covers.

Image 6: The north elevation. Note the significant biological growth.

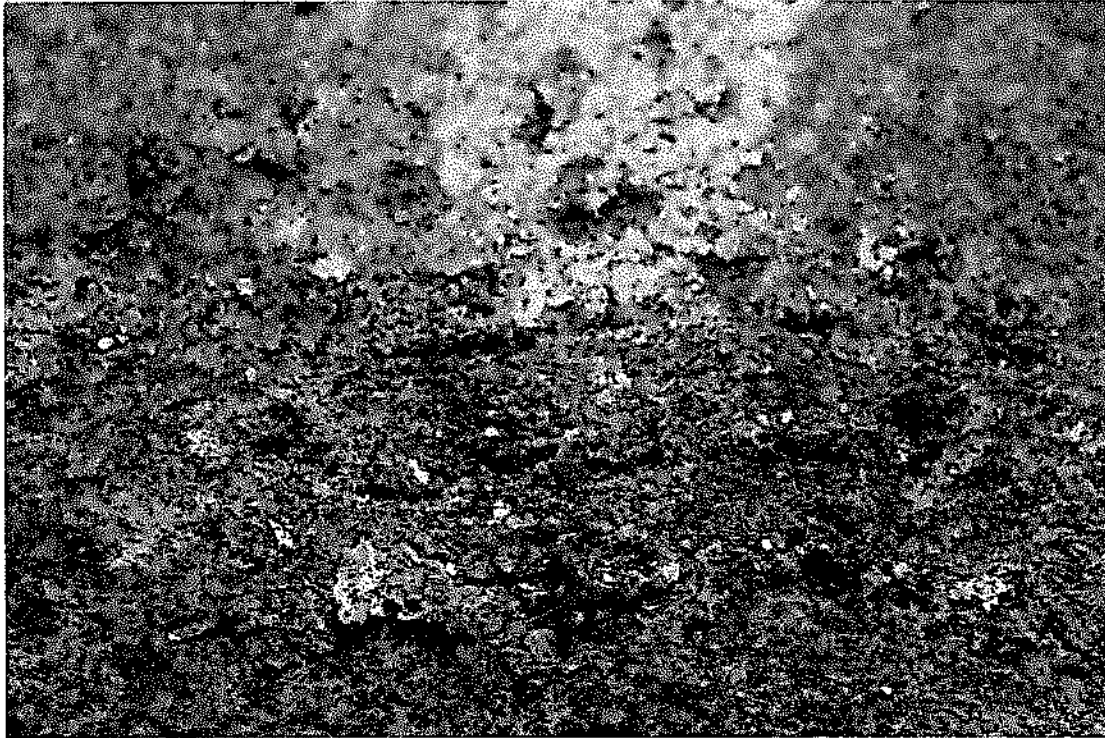
The interior of the mausoleum shows significant signs of decay. Upon opening the door, one is immediately greeted by large brown stains near the door threshold (see image 7). Within a few feet of the door the floor begins to make a crunching sound underfoot. Closer inspection shows that the granite surface has deteriorated to the point where pieces are flaking off of the main stone body (see image 8). In addition, there is significant efflorescence on the stone floor and walls (see images 9 and 10). This is particularly evident directly under the north and east windows, though it is also present higher up.

Image 8: Close up of the granite floor. Note the deterioration and flaking.

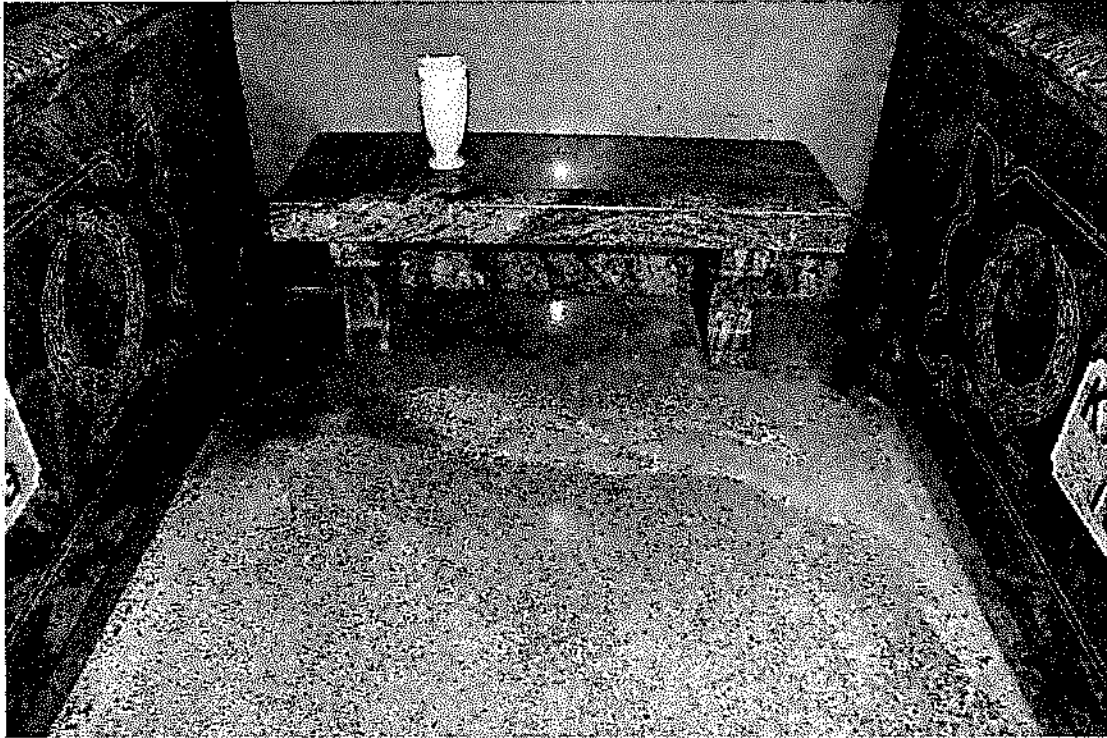
Image 10: Efflorescent staining on the floor.
