Dingyi Zhang

Fall 2022 HP Studio I: Project # 4B Paper

McGrorty Mausoleum

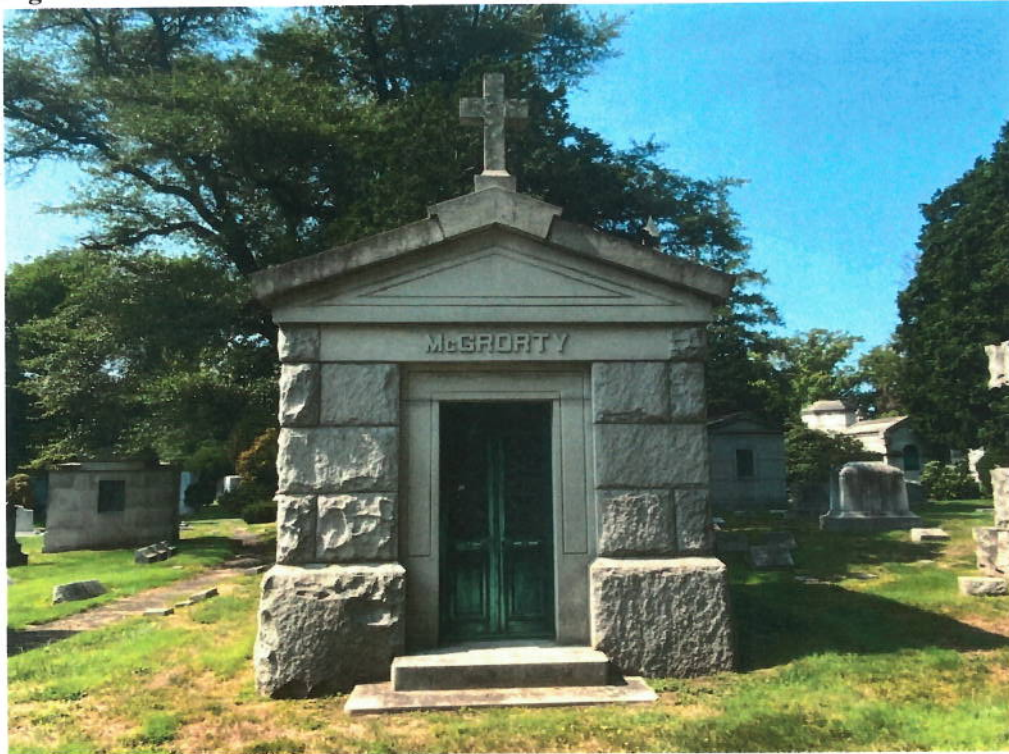
The McGrorty Mausoleum (*Fig. 1*) is located on Lawn Avenue in the Heather Plot of Woodlawn Cemetery. This paper mainly focuses on the biography, design and current condition.

Figure 1. The façade of the McGorty Mausoleum. Imaged by author.

In the elevation, the current condition and material of mausoleum have been marked in detail. For example, through observation, there are obvious blistering phenomena on its pediment, eaves and roof, which is due to the detachment of an outer stone layer.⁹ Other parts, such as the rear elevation facade, have the deterioration of "soiling", which may be due to the deposition of pollution in rain. In addition, there is biological growth, namely lichen.

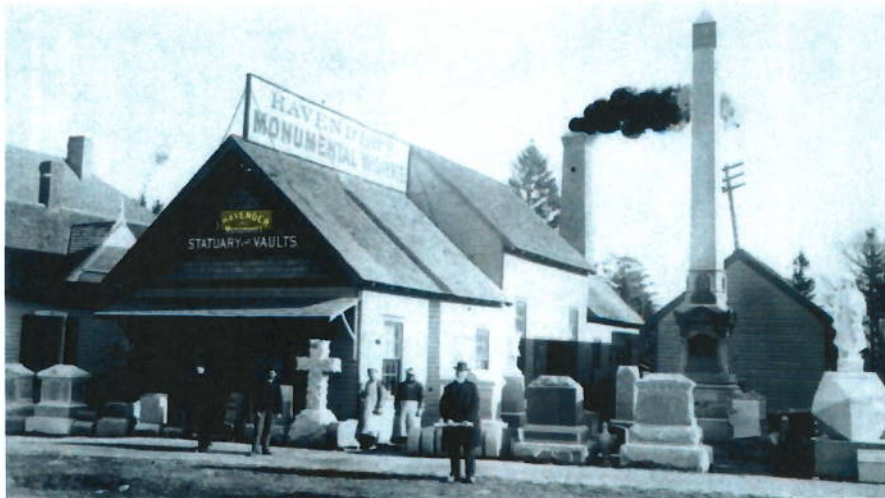
Figure 4. This photograph of Havender's Monumental Works was taken around 1903 at their plant located at 3686 Jerome Avenue across the street from Woodlawn Cemetery. Note the 20-sided stone called an icosahedron at the extreme right, which is considered a masterpiece by stonecutters. Courtesy of the John McNamara collection.

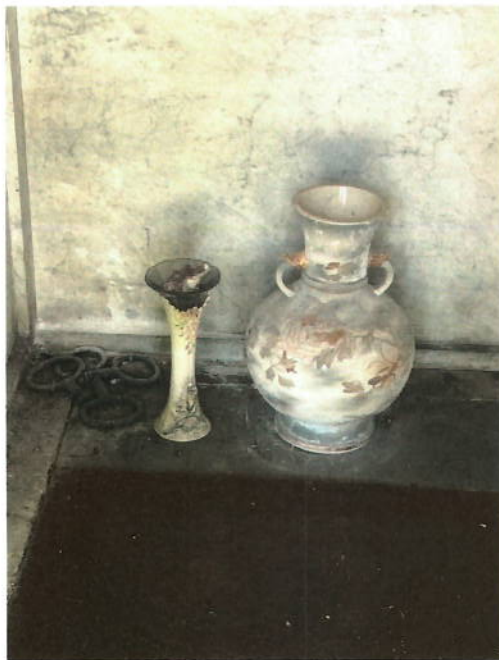
When entering the mausoleum, most of the space is reserved for the placement of catacombs. Therefore, its corridor is very narrow. As soon as entering the door, there will be a rectangular space and two Chinese style vases at the far end (*Fig.6*), painted glass is located above the bronze framed windows inside the room, which is very beautiful. The painting is well preserved, and its frame has no obvious defects, which shows that the production process is excellent. Some marble surfaces have yellow dirt, which may be due to the iron minerals inside the marble. When iron contacts with oxygen, iron oxide will be produced, so rust will be formed, resulting in pale brown.

Figure 6. Vases in McGrorty Mausoleum. Imaged by author.
