# **The Carrington Mausoleum**

Sophia Haynes

HP Studio Fall 2022

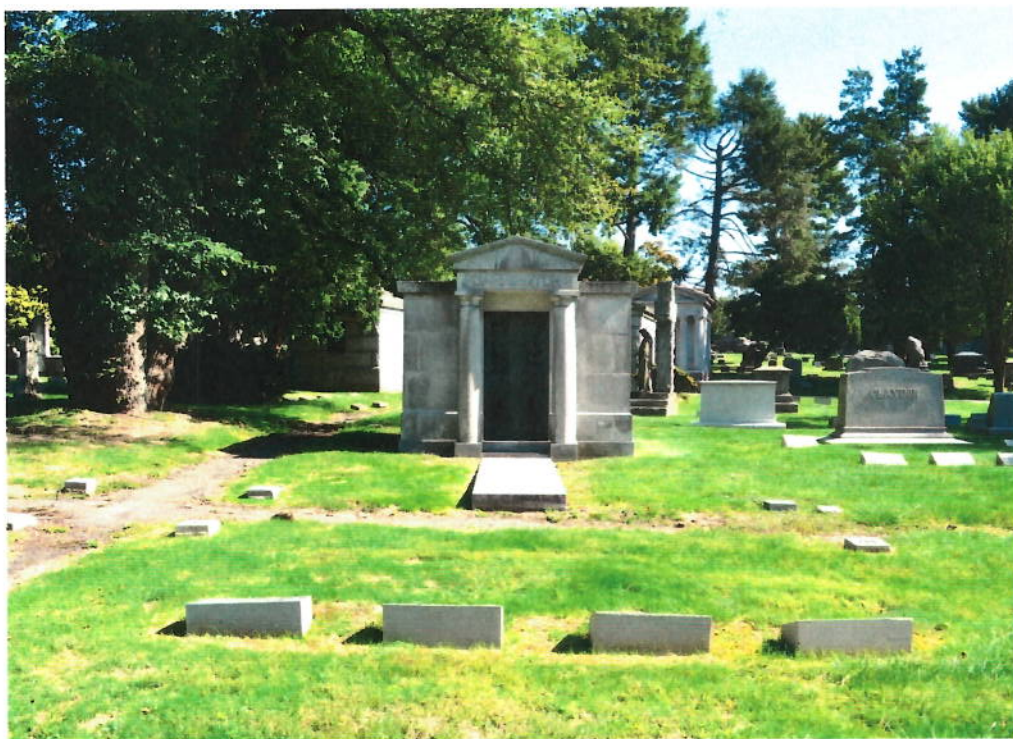
The Carrington mausoleum is located in section 69 in the Heather plot of Woodlawn Cemetery, and built by C.E. Taytnor Granite Co. The plot is rectangular and is in the middle section of the plot. There are four foot wide passageways along the perimeter of the plot. There is a long Granite block that is a path that leads to the mausoleum. On the west side of the plot, but not on the plot site, there is a quadruple trunked tree that hangs its limbs over Carrington. The stone is fine-cut and hammered Hallowell granite, with two roman doric columns made of the same granite. There is a set of bronze doors with plated glass windows with a single feather ornamentation on the lower half of the doors.<sup>1</sup> The mausoleum is austere and more petite in size compared to some. (see *figure 1*).

(Figure 1. Front Elevation Carrington Mausoleum, Woodlawn Cemetery)

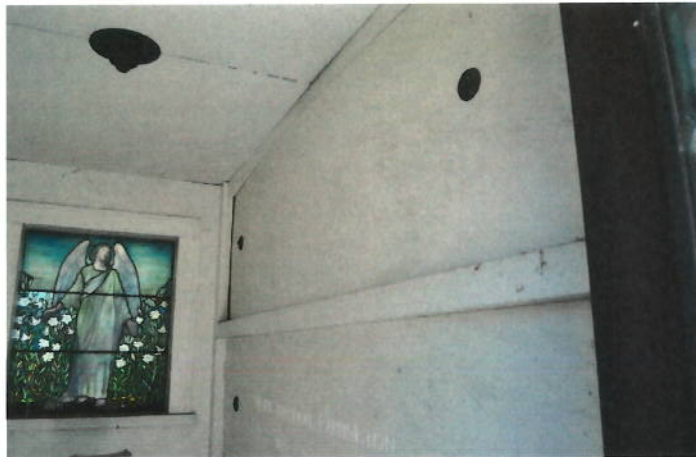
Inside the mausoleum, everything is a polished light veined Italian marble, except for the floor which is honed, as well as the wall cladding.<sup>2</sup> There are a total of six catacombs, three on each side and each catacomb is covered with a thin, one inch thick, seven foot long slab of marble with names engraved (figure 2). There is a large stained glass window with a picture of an angel in a tall white lily patch. The stained glass is not signed, but it is protected by a piece of glass on the outside and held by two saddle bars. Due to the protective glass pane, it is difficult to see it from the outside, but once you enter the mausoleum it is very clear (see figure 3). There is a small marble table placed in the back of the mausoleum, possibly for trinkets or flowers when loved ones visit.

(Figure 2. Bending of Marble Slab inside Carrington Mausoleum, Woodlawn Cemetery)

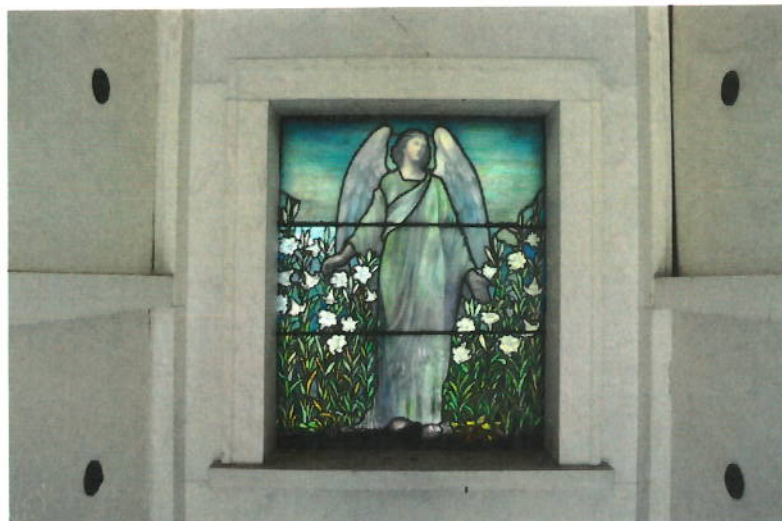
(Figure 3. Stained Glass Inside of Carrington Mausoleum, Woodlawn Cemetery, 2022)

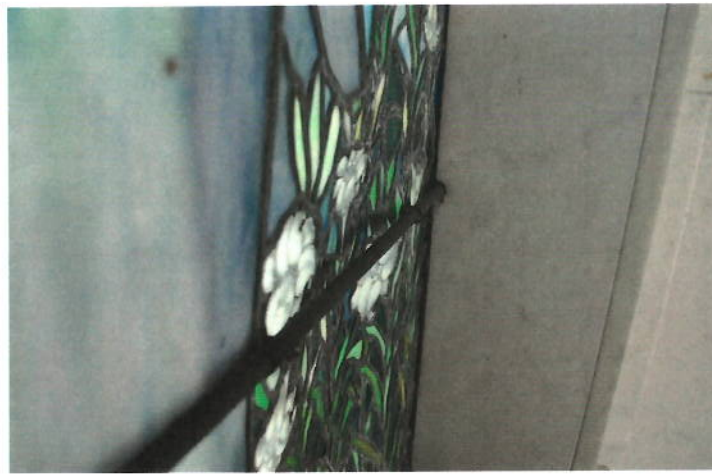
The mausoleum has held up well for being over one hundred years old. It seems as if it hasn't been visited in a while due to dust and such. There were broken vases on the table, and a coin near the stained glass. The angel stained glass seemed to have warped possibly because of the protective glass on the outside and poor ventilation inside the mausoleum. The lead came seemed to have been misshapen causing curves through the bottom of the glass (fig 5). Another sign of poor ventilation is the bending of the thin marble catacomb slab covers in the mausoleum (fig. 6). They seem to have been too thin and they are marble, so the process of thermal hysteresis might have occurred. Thermal hysteresis is when a thin piece of marble is exposed to

various temperatures, its crystals bend and contract possibly due to water, eventually bowing outward permanently.<sup>15</sup> The humidity in the summer could contribute to the warping of both the marble and the stained glass. Lastly, there are some differences between the West and East facade conditions. The West side has a large tree that hangs over it while the East side is empty. The West facade has lots of biological growth, possibly algae, and lichen, etc (fig 7). The last side does not have a large amount of biological growth, possibly due to the lack of sunlight, and it shows a contrast between the aging of both sides due to their locations.

(Figure 5. Stained Glass Lead Warping Conditions, Carrington Mausoleum, Woodlawn Cemetery)

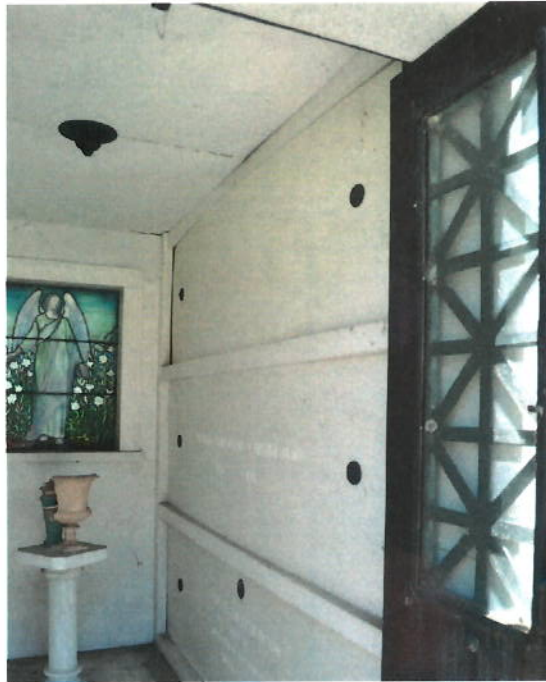
(Figure 6. Bending of Top Marble Slab Catacomb Cover, Carrington Mausoleum, Woodlawn Cemetery, 2022)

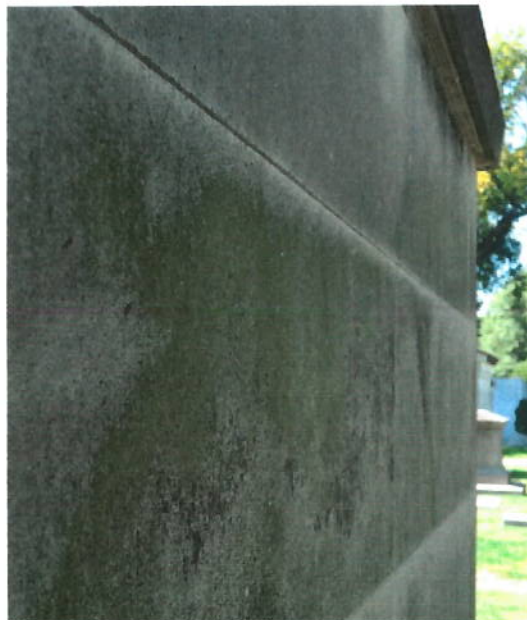
(Figure 7. West Facade, Biological Growth, Carrington Mausoleum, Woodlawn Cemetery)
