Michelle Leach
Studio 1 Historic Preservation
Professors Andrew Dolkart, Kate Reggev, and Claudia Kavenagh
October 12, 2021

De Witt Mausoleum

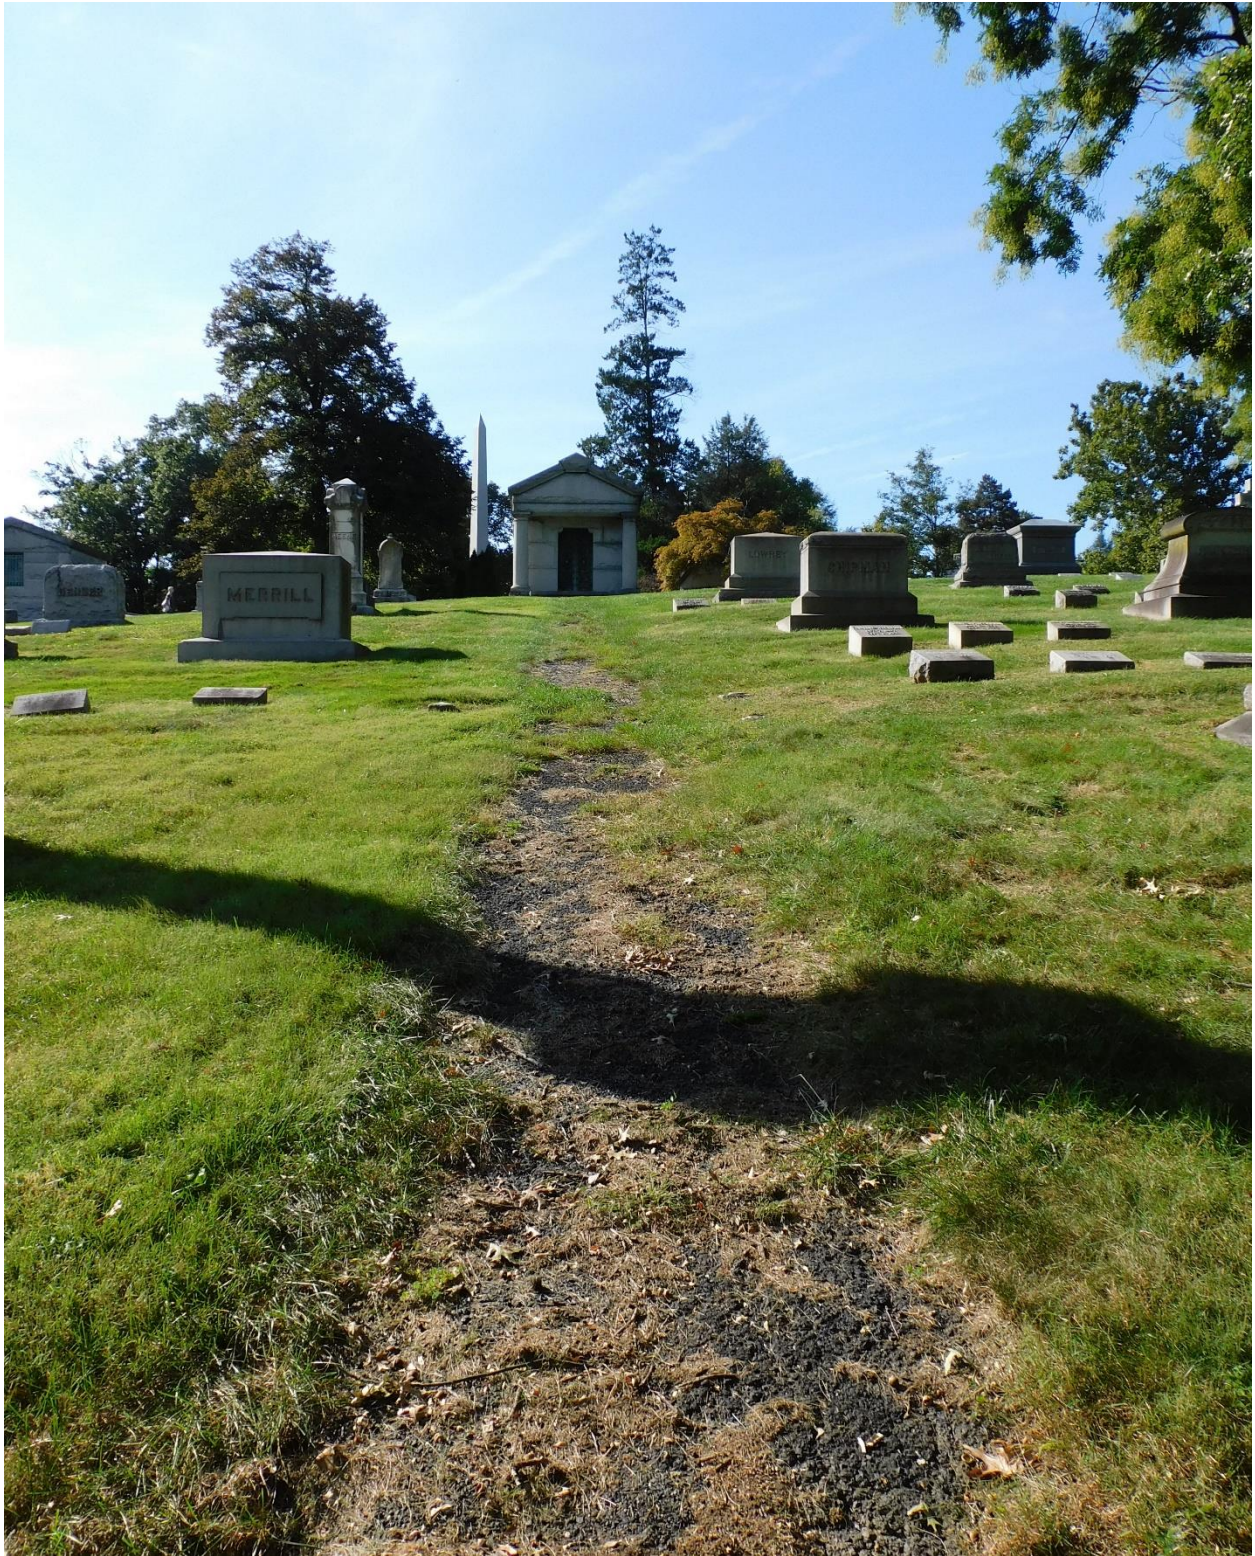
Figure 1: Mausoleum Site photo 1

With no surrounding trees, any visitor is met with an open view of the mausoleum from the road and a raised view of the cemetery from the mausoleum itself (figure 1). This view was preserved by the family as Charles requested to have trees removed that had been planted on the lots adjacent to the De Witt's on either side of the path to their mausoleum.⁴ The mausoleum itself is made of large blocks of Barre Vermont granite⁵ that is heavily rusticated with smooth Doric columns. The most striking elements of the building are the beautiful bronze doors and matching window grille over the stained-glass on the rear façade. The design for this building was inspired by another mausoleum at Woodlawn Cemetery. The Edwards mausoleum was built in 1904 by the Harrison Granite Co. and was specifically mentioned in the design drawings and specifications for the De Witt's building.⁶ It too has heavily rusticated granite blocks, and the bronze door and window were replicated for the De Witt mausoleum. The main difference between the two buildings is the columns. Where the Edwards family chose to have short, rusticated, rectangular columns, the De Witt family picked taller, Doric columns. This gives a slightly more refined look to the De Witt mausoleum. While the De Witt mausoleum is not vastly impressive in size or style, there is sophistication to the details. The bronze door and window are intricate, the interior of the building has white veined Italian marble, and the stained-glass window depicts a beautiful landscape that catches the afternoon light.

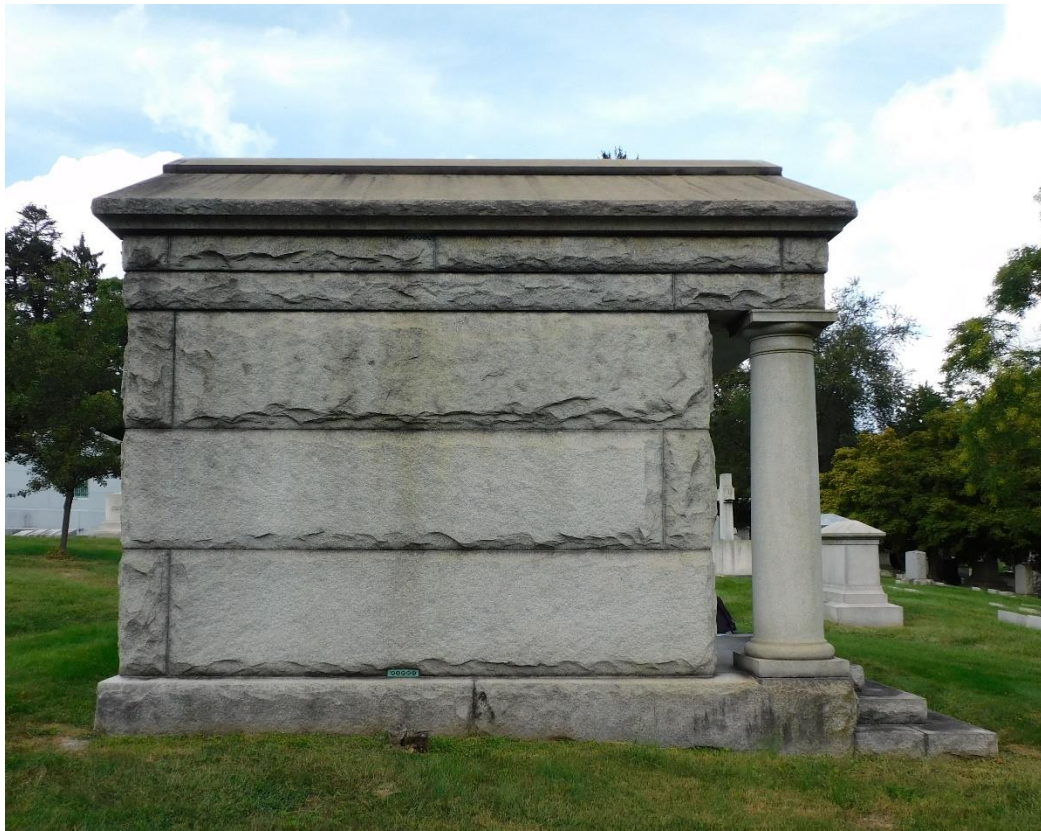
Figure 4: North Elevation

a similar pattern of biological growth on its north facade. This indicates that the problem could be related to both the direction and design of the mausoleum. The drawings for both mausoleums found in the archives indicate that the catacombs are placed against the side and back walls with only a small gap between the catacomb and the walls. This could contribute to the extra moisture in this area of the north walls for both mausoleums. The problem could also be worsened by the number of vents in the mausoleums. There are only two on each long side of the building, one placed near the base of the building, and one placed under the roof line. Many of the mausoleums at Woodlawn Cemetery have double this amount, so this lack of ventilation could lead to increased moisture and increased biological growth.

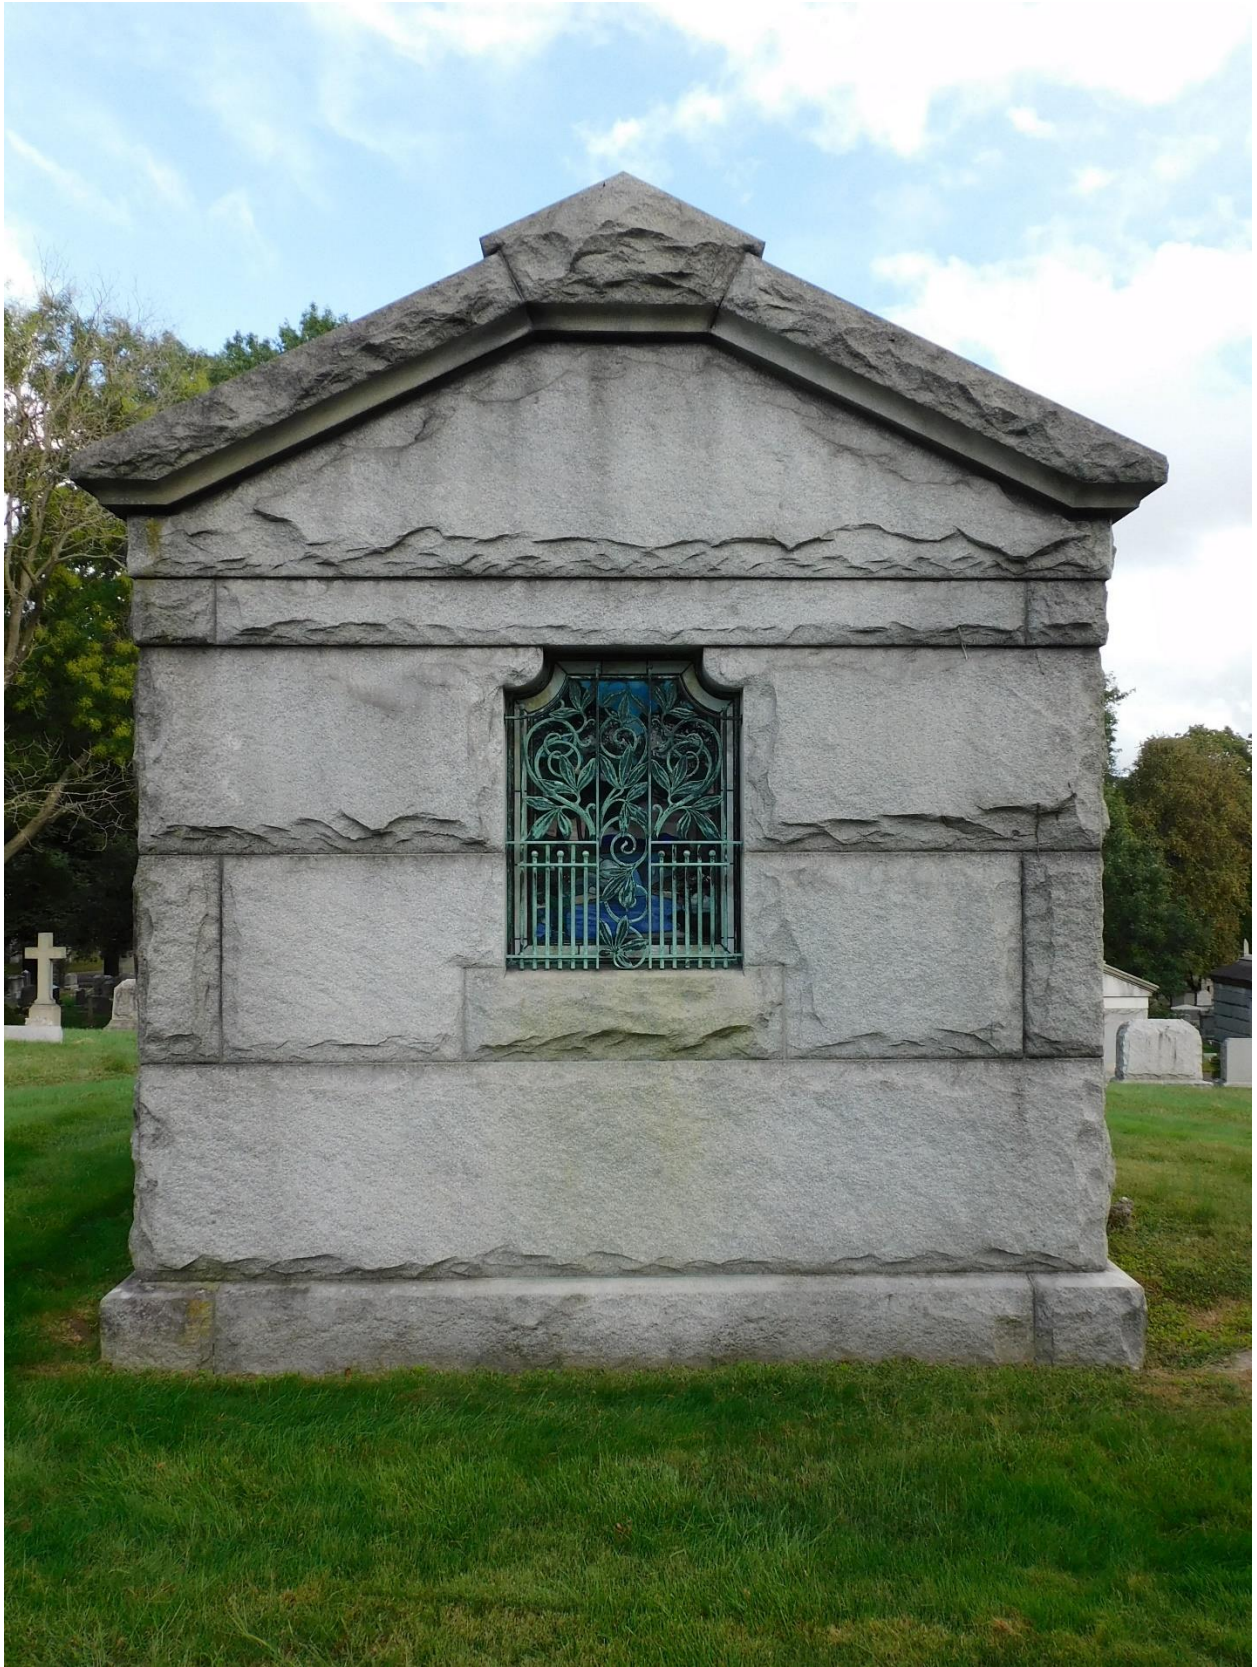
Figure 5: South Elevation

In its current state, the mausoleum now has signs of its age and some concerning features that need to be addressed. The exterior has problems with various types of biological growth. On the south, east, and west facades, the biological growth is mostly contained to areas near the roofline or close to the ground. On the North façade (figure 4), this is a much more prevalent issue. A large portion of the north façade is covered with black biological growth. It is in an interesting pattern, being more prevalent towards the back of the mausoleum. The north side of the building remains cool and damp because it does not get very much sun. This could contribute to this problem. The Edwards mausoleum, which has a both a similar design and orientation has

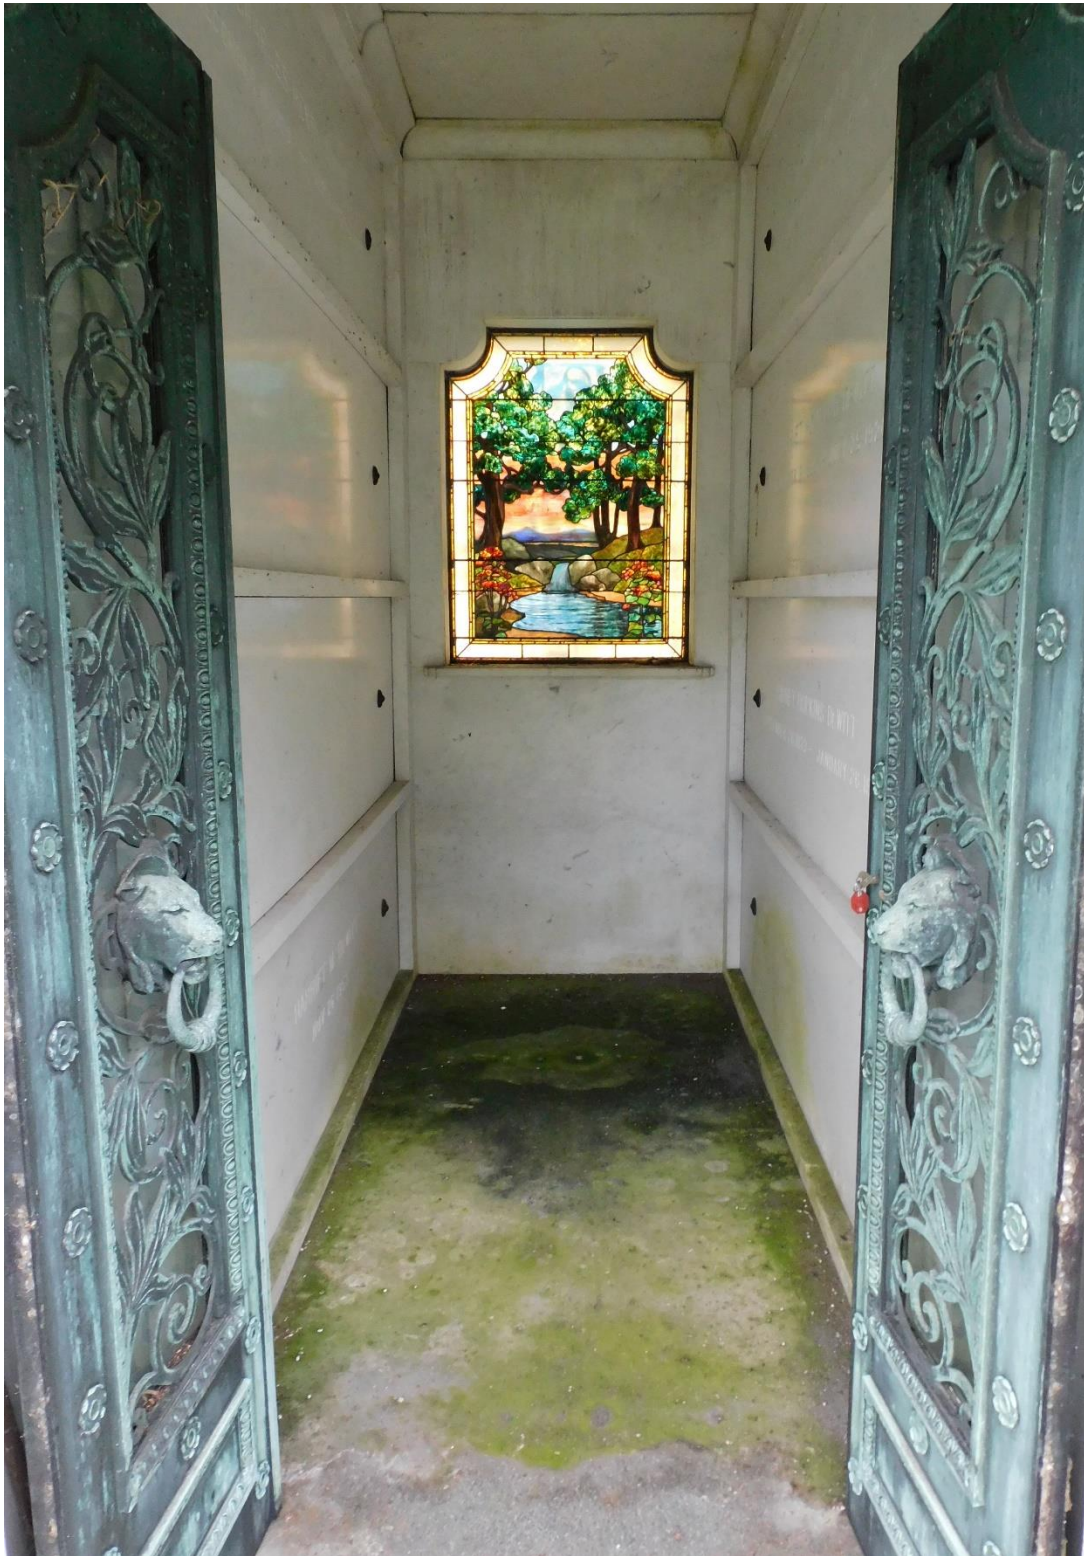
While the biological growth on the exterior is visually problematic for the mausoleum, the much more concerning problem is moisture. The entire floor of the mausoleum is covered in biological growth and the pattern indicates that water drips off the ceiling (figure 7), contributing to the problem. This has left the granite floor of the mausoleum bright green with biological growth as well as affecting the marble of the lowest visible catacombs. The marble above the stained-glass window also has streaks and stains where water has been present. This problem could be due to condensation occurring in an attic space that is indicated in the archival drawings, which needs to be investigated and addressed by Woodlawn. The extra moisture in the building has also led to the hysteresis affecting the marble near the ceiling of the mausoleum. Hysteresis often occurs in slabs of thin marble when the temperature or humidity is not the same on all sides of the slab. This causes the marble to bow, leaving gaps or edges that do not meet in the way they were intended. In the De Witt mausoleum, hysteresis is minor but could have large effects. The facing panels of the catacombs are affected very minimally but the curved pieces of marble along the ceiling are the most noticeable because the hysteresis has caused gaps at the

Figure 7: Conditions Detail 1, interior biological growth

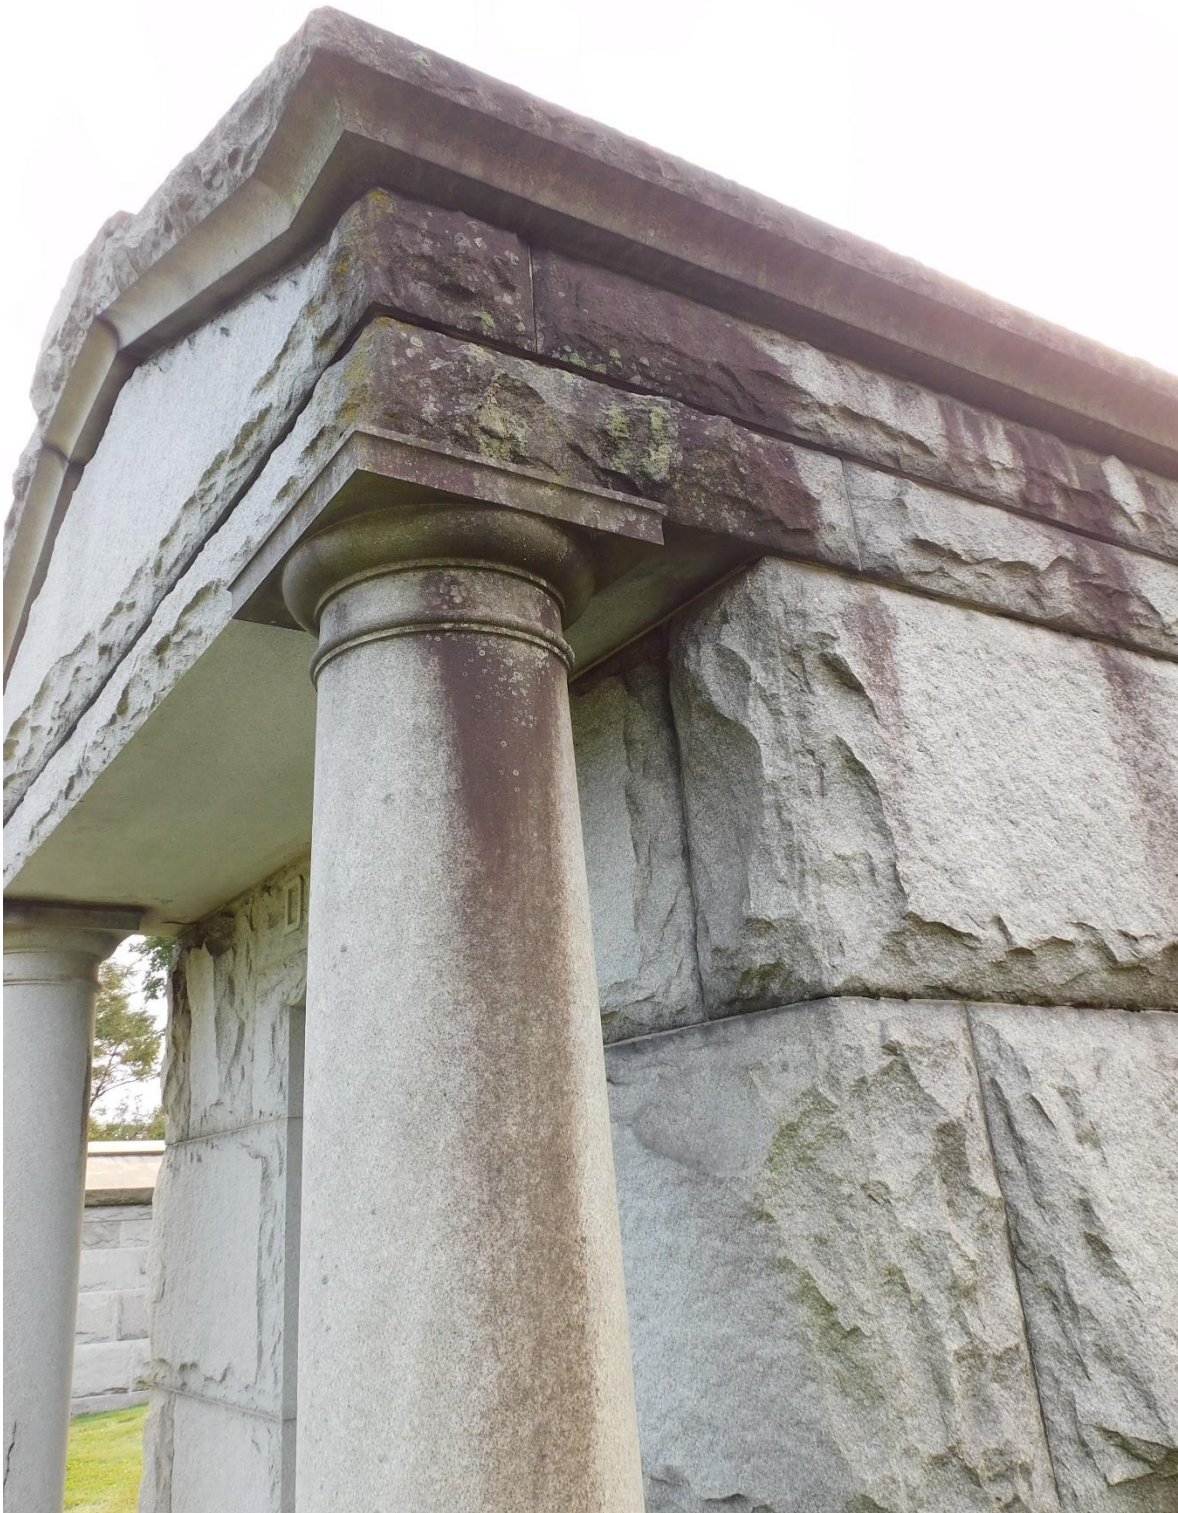
Figure 8: Conditions Detail 2, exterior biological growth

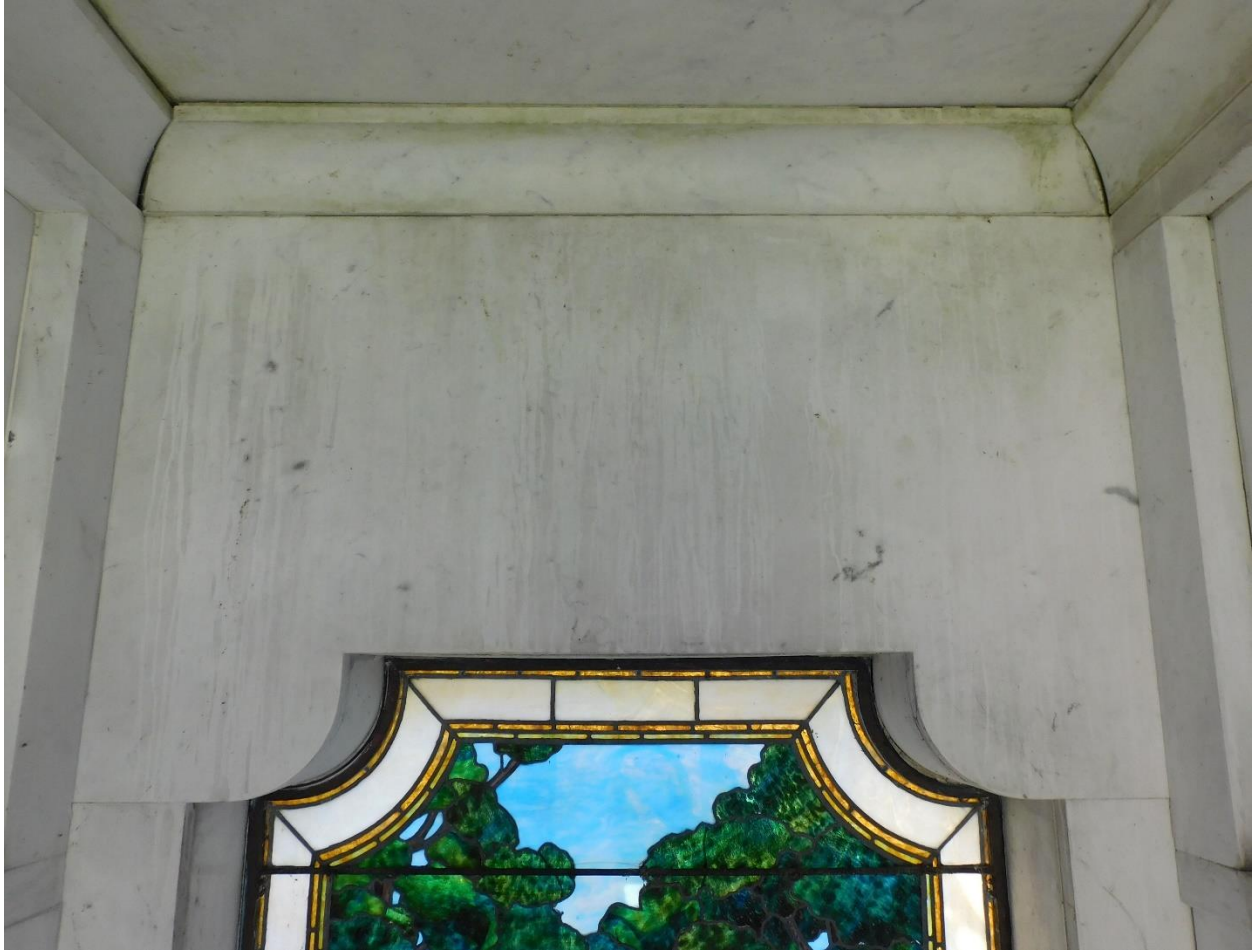
corners of the ceiling (figure 9). The staining due to water and biological growth on the west wall could be related to these small marble pieces fitting incorrectly and increased moisture and should be addressed. The correspondence materials for both the De Witt and Edwards families mention various issues with the roofs of these buildings.¹⁰ Reports of leaks or necessary repointing of the roofs were brought up in multiple letters about these mausoleum's conditions. Without upkeep since Howland's death in 1993, if not since the death of Harriet the younger in 1953, it would be unsurprising to have an issue with the roof of the building. For this reason, Woodlawn should also inspect the roof for any leaks that could also be contributing to the moisture inside the mausoleum.

Figure 9: Conditions Detail 3, water staining and hysteresis
