A Checklist for the Restoration of Architectural Cast Iron in the U.S.

Author(s): RICHARD PIEPER

Source: *APT Bulletin*, Vol. 44, No. 4, SPECIAL ISSUE ON CAST AND WROUGHT IRON (2013), pp. 7-11

This article covers nine issues to consider when embarking on a cast-iron restoration.

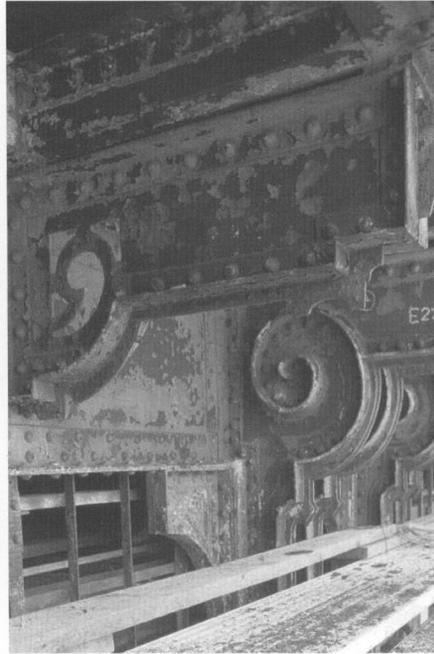
Fig. 7. Cornice brackets. The bracket in the foreground is fabricated of riveted-steel plate and angle. The similar bracket behind it is one large casting.

The format for construction documents should communicate adequate information without intimidating or overwhelming the bidders (Fig. 6). The format used for a set of documents for the restoration of an 800-piece facade is not likely to be appropriate for a large ferry terminal with nearly 9,000 pieces. The documents prepared for the restoration of the Battery Maritime Building were so overwhelming to bidders that the project was ultimately divided into two different bid packages (Fig. 7).
