Blasted building

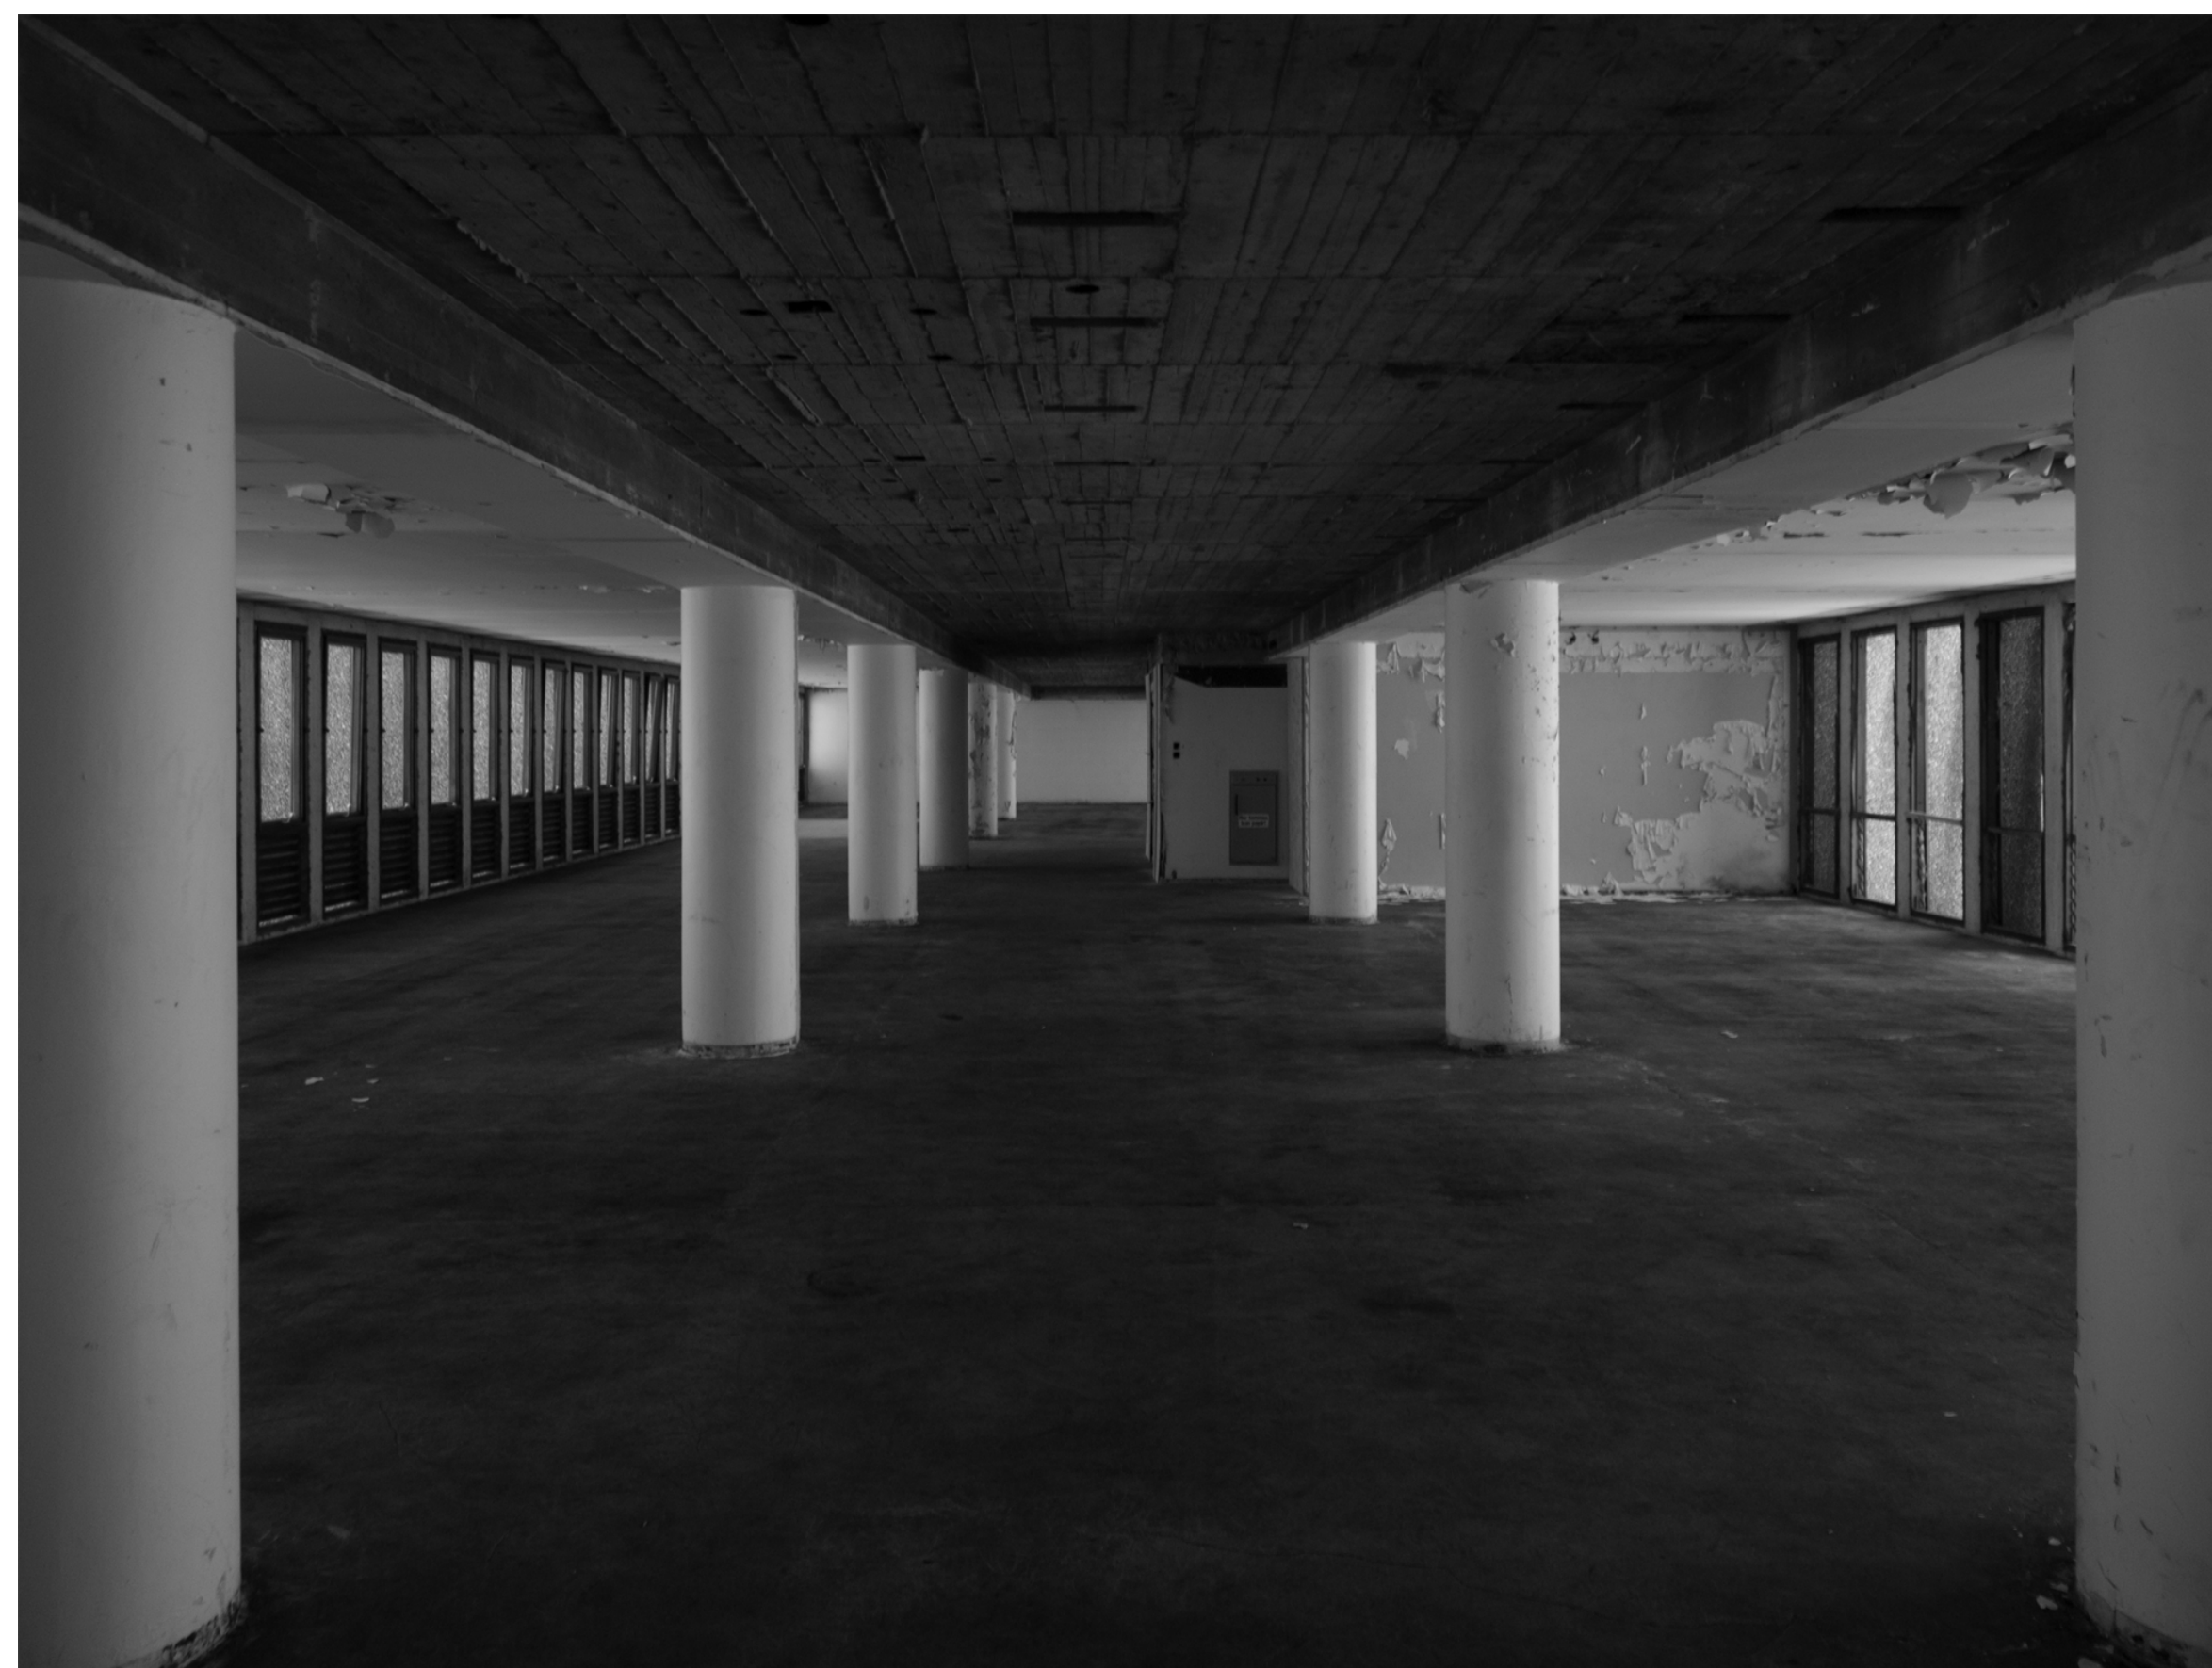
All flooring, including the original linoleum from 1958 as well as the new surfaces from 1990, has been removed, exposing the raw concrete slab stained with glue and spills of uncertain origin. A condition of symmetry thus prevails between the concrete floor and the concrete ceiling. Taking into account the straight, non-articulated columns and the floor-to-ceiling window-openings, the space can be imagined flipped upside-down still maintaining its original appearance.

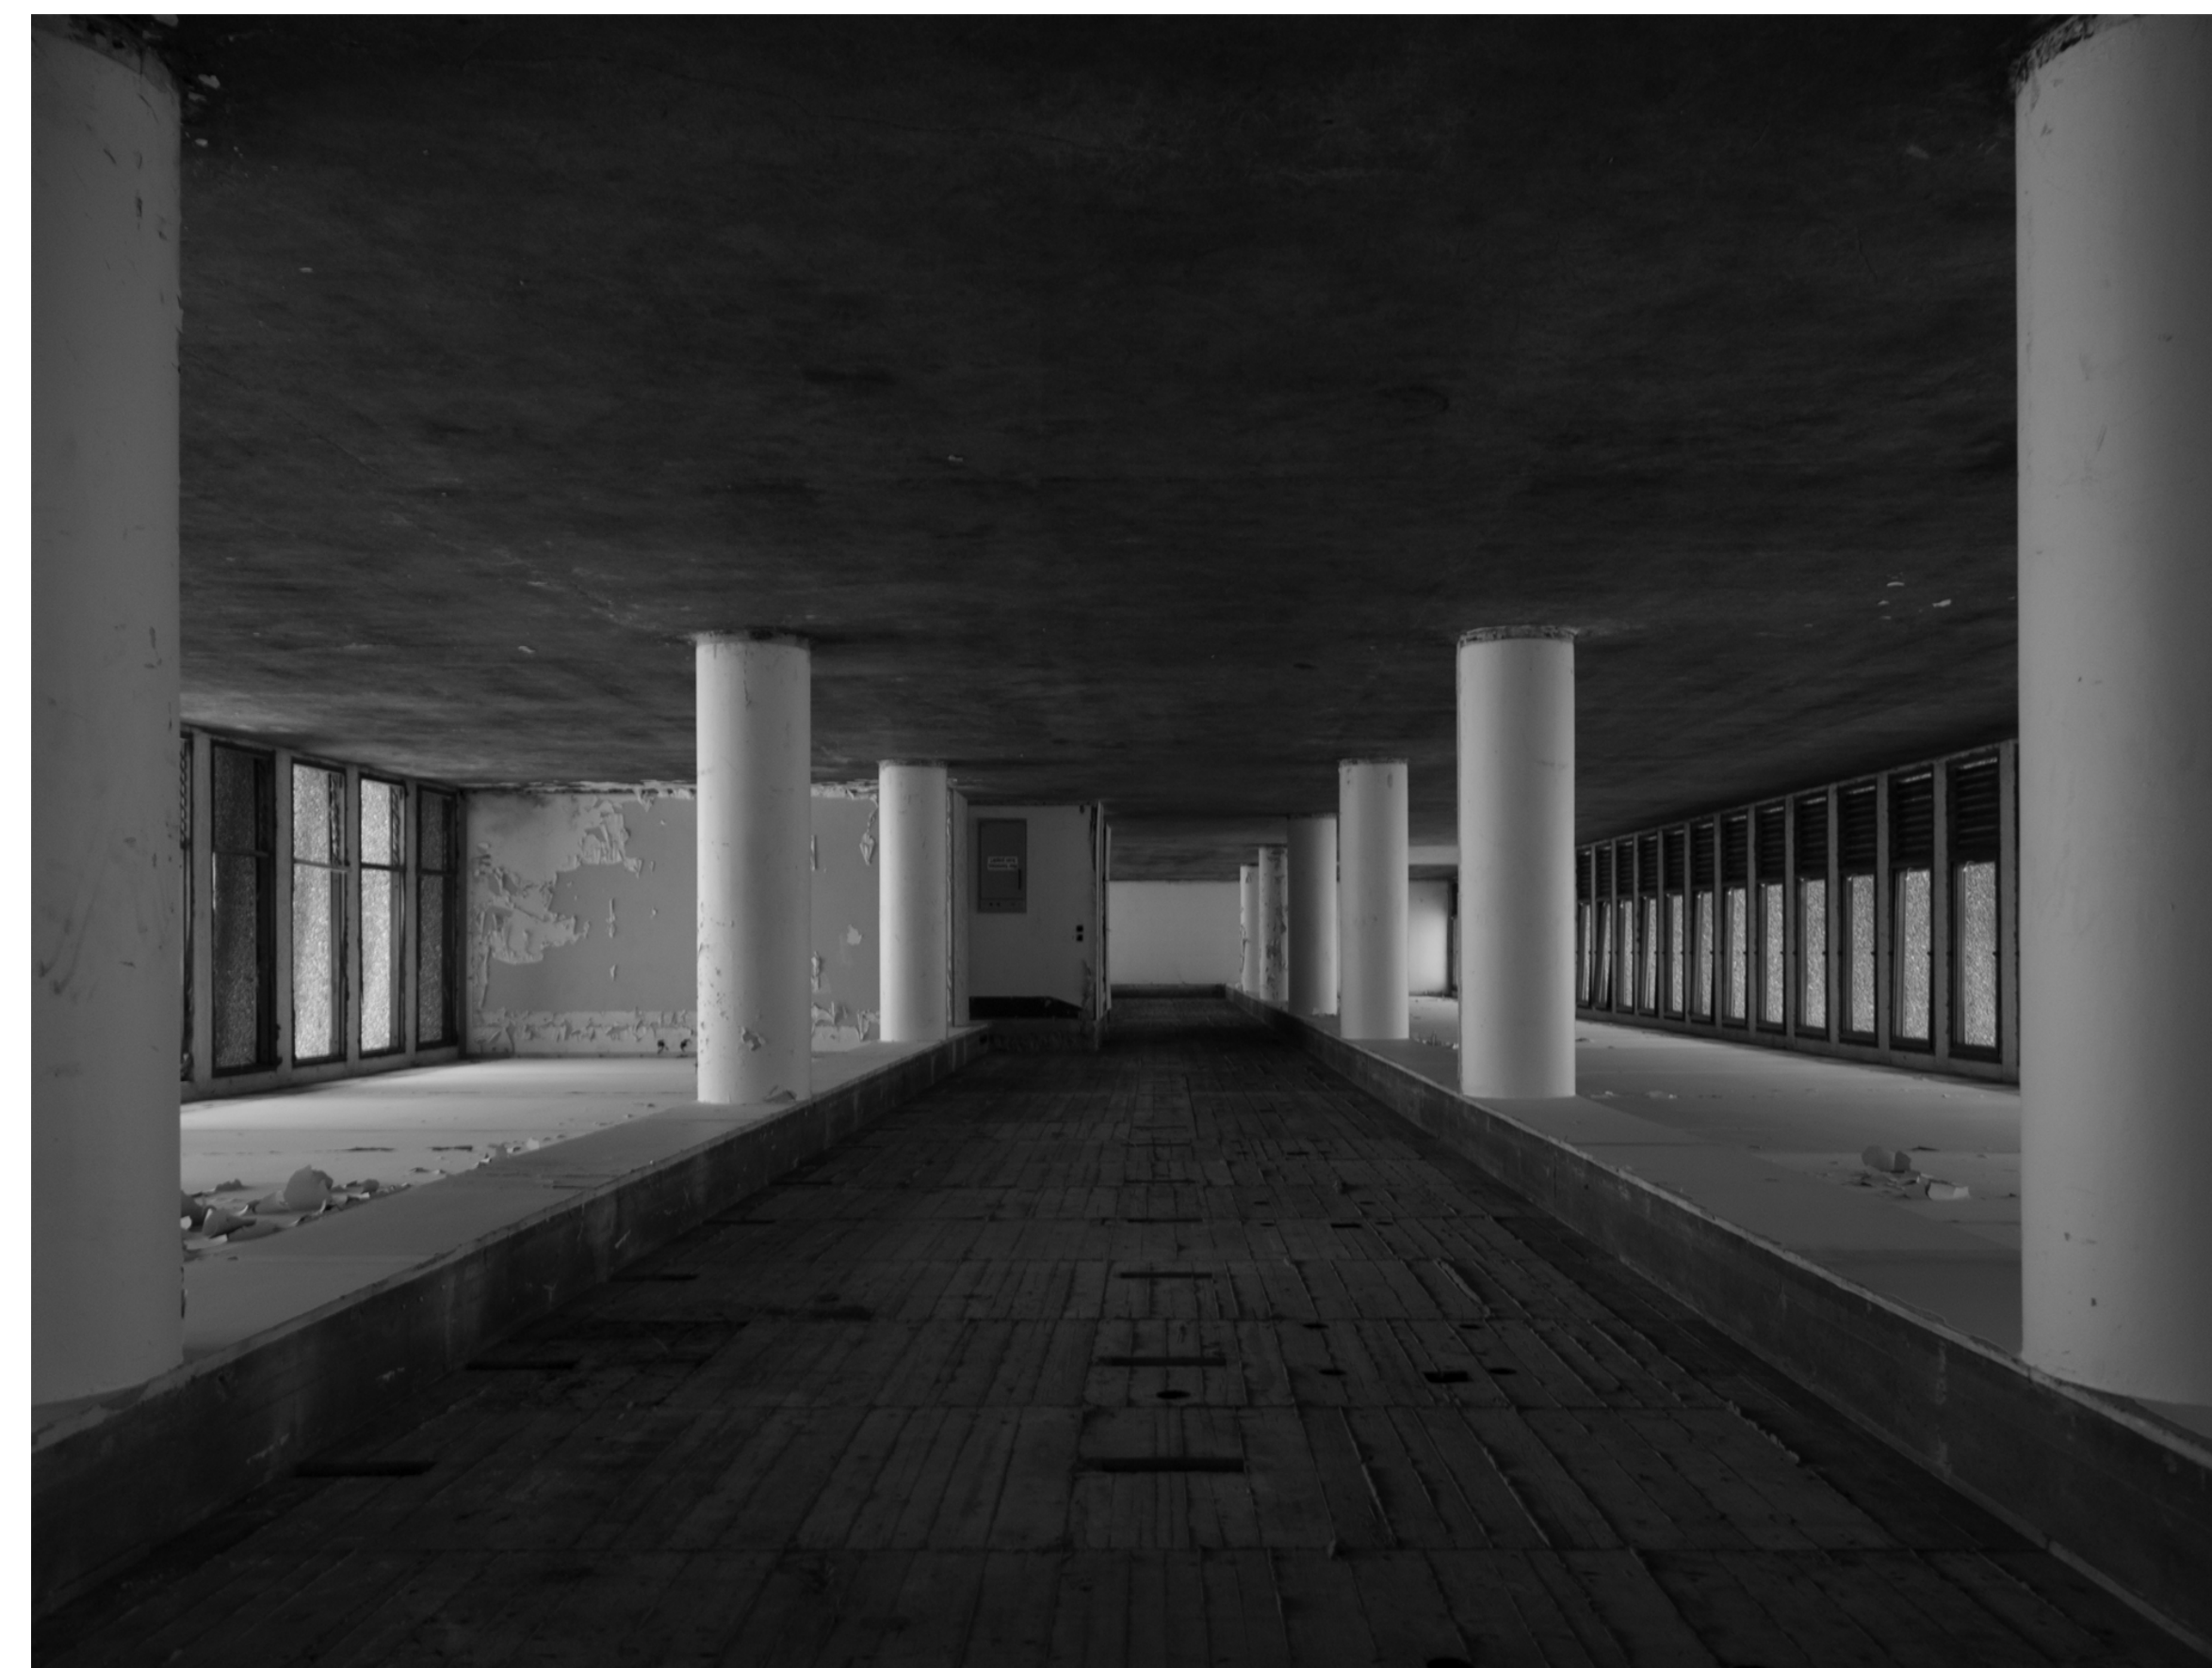
The peeling paint reveals the board-form pattern of the cast-in-place concrete slabs and beams, never meant to be exposed. Also revealed is the fact that the only interior walls left standing on the office floors are made of concrete, a fact Viksjø explicitly wanted to conceal behind white paint. In his project text published in the journal *Byggekunst* in 1959 he states; “it is not enough that a building is correctly constructed. It is equally important that it appears correct, and it might be necessary in architectural terms to “erase” some constructive parts that confuses the building’s static appearance.” What we encounter is an architect interested in the aesthetics of structure rather than the dogma of structural honesty. The destructive forces of the bomb has exposed the “tricks” of the architect, but more importantly, it has disclosed an attitude of ambiguity which seems to be present throughout the building.
