THE APSE OF SAN MARTÍN DE FUENTIDUEÑA

BUILDING CONDITION ASSESSMENT

BLANCA BALBUENA LORENZO
M.S HISTORIC PRESERVATION
SPRING 2024

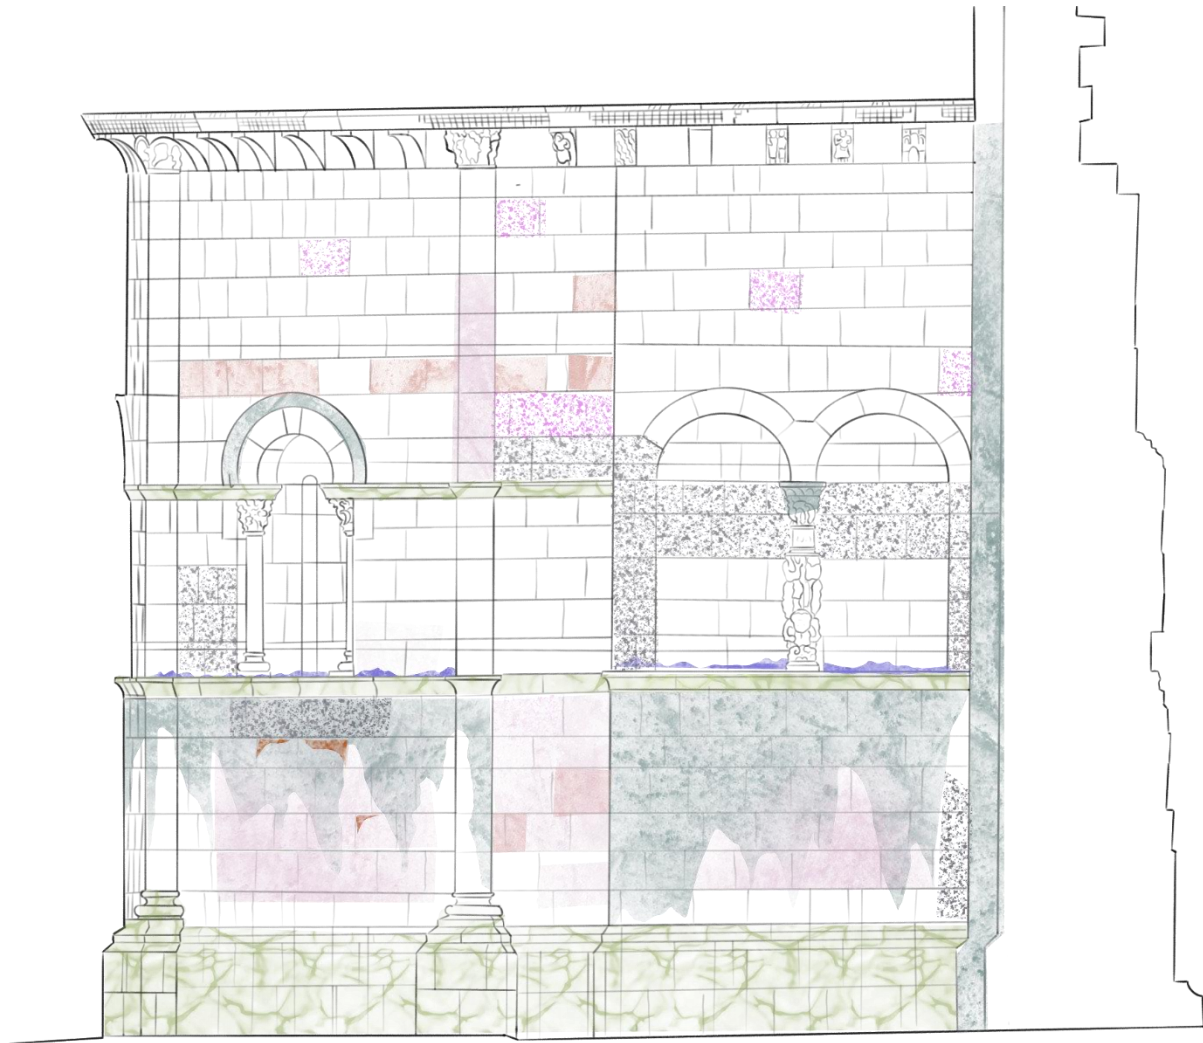
NORTH ELEVATION

To better understand the state of conservation, the causes and indicators of deterioration have been divided into intrinsic factors, in this case, due to the characteristics of the limestone, and extrinsic factors. This latter block explores the damage caused by temperature, water, pollution, biodeterioration, and human action. These damages can be seen in detail in the [deterioration map](#) in the appendix.

-   BIODETERIORATION
-   POLLUTION
-   SALT EFFLORESCENCE
-   FISSURES
-   EROSION/SUGARING
-   LOSS OF MATERIAL
-   DISCOLORATION
-   SPALLING/FLAKING

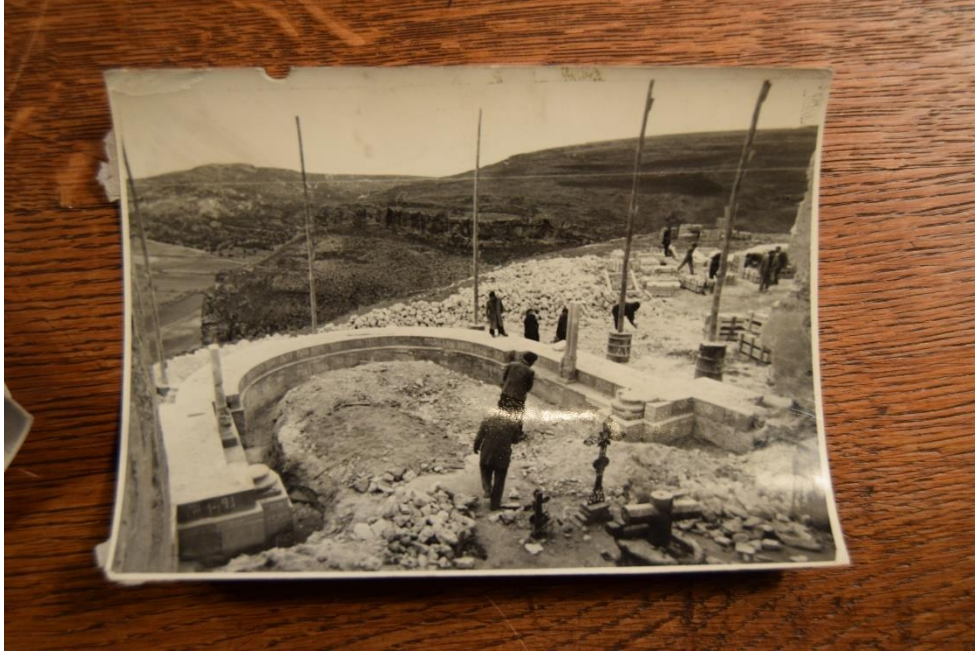
Fig.9 Apse Reconstruction. The MET Archive

Upon clearing the space for the work to commence, architects from the firm of Brown, Lawford & Forbes initiated the preparation. Throughout the reassembly (Fig.9), the team encountered challenges

such as the unevenness of the base compared to the original Fuentidueña site, the partial collapse of one side, and material losses in some pieces. Despite these issues, the team efficiently resolved the challenges, replacing many pieces with similar limestone extracted from a quarry located 20 km from Fuentidueña.

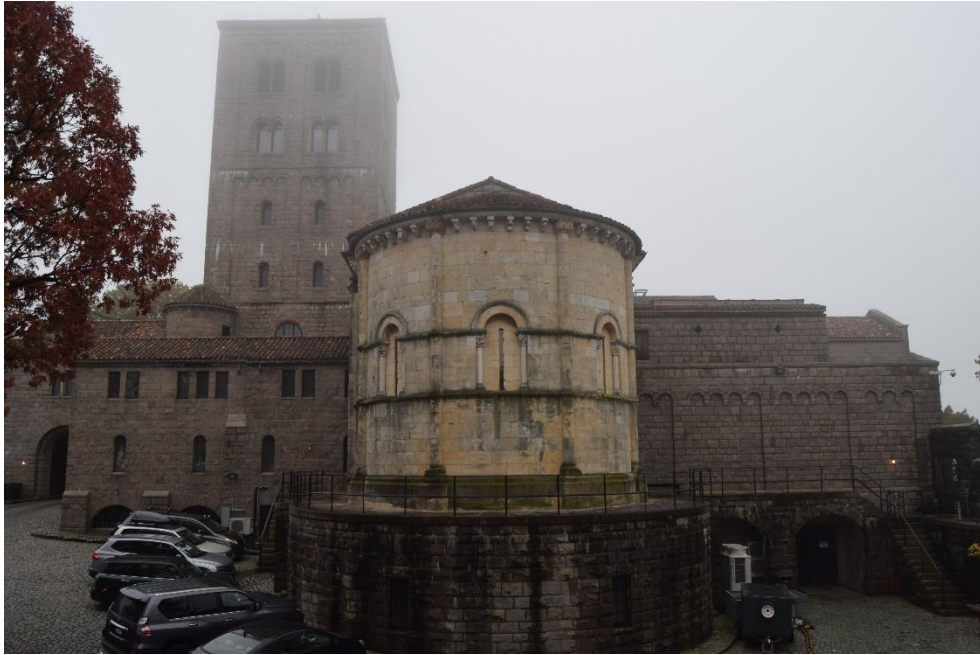
Fig.11 The Apse of San Martín at the MET Cloisters. Own Resource

Moving to the apse, often referred to as the presbytery or sanctuary, it delineates the most sacred space of the temple. This area housed the altar and, by default, the sacristy. The structure of the apse can be described in three main sections (Fig.11).

Starting with the lower body, it consists of a base that slightly protrudes from the rest of the apse. This base is finished with an exterior bevel and an interior beading molding. In the middle body, three flared windows open to the exterior. Each window features a pair of columns connected by a semicircular arch. The sculptures decorating this section exhibit typical Lombard Romanesque motifs¹⁴. The upper part of the apse is covered by a semi-dome, extending into a prolonged half-barrel in the straight section, reaching up to the transverse arch, which served as the Triumphal Arch during the early Christian stage.

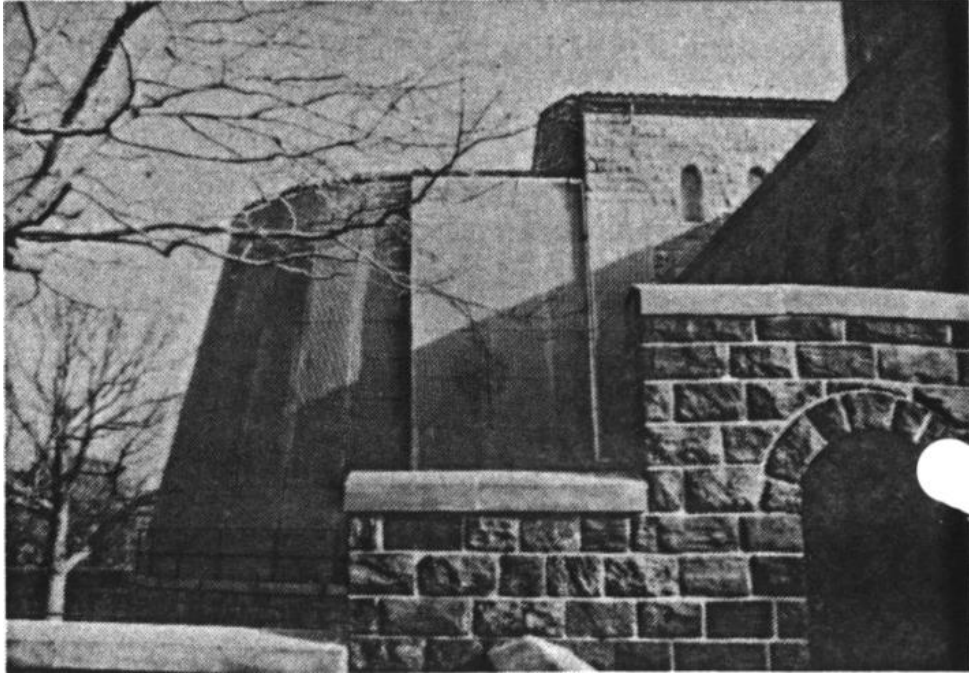
Fig.14 Apse Enclosure in the 1070's. The Met Archive

Such was the concern for the imminent deterioration of the dolomitic stone that in 1971, a temporary enclosure (Fig. 14) made of "wood and plastic"²³ (fiberglass panels and wooden beams) was installed to shield it from inclement weather and extreme climatic changes in the area. According to Merino de Cáceres²⁴, from that point onward, the apse was "hidden from the public and inaccessible to the thousands of visitors who come daily to The Cloisters, which was one of the reasons cited for the monument's transfer to United States." Due to the scarcity of documents regarding this protective enclosure—its design, construction, effectiveness, or removal—it has not been possible to confirm whether this measure prevented visitors from viewing the apse from both outside and inside. However, anecdotal evidence suggests that prior to the construction of the enclosure, it was possible to see the apse from the outside, whereas currently, the space is closed to the public and functions as a parking lot and a recreational area for museum employees. It's possible that this situation has changed since the installation of the enclosure.

This protection cover was removed more than 15 years later, following advocacy from numerous experts for its elimination, such as the authors of the 1986 article²⁵. Notably, Merino de Cáceres visited on November 16, 1984, representing the Spanish Ministry of Culture, to inspect the preservation status and the protective enclosure. During discussions with key figures from the MET and The Cloisters²⁶, the architect voiced concerns about the cover, advocating for its removal due to the risks it posed to the interior of the apse—increased temperature and humidity resulting in serious

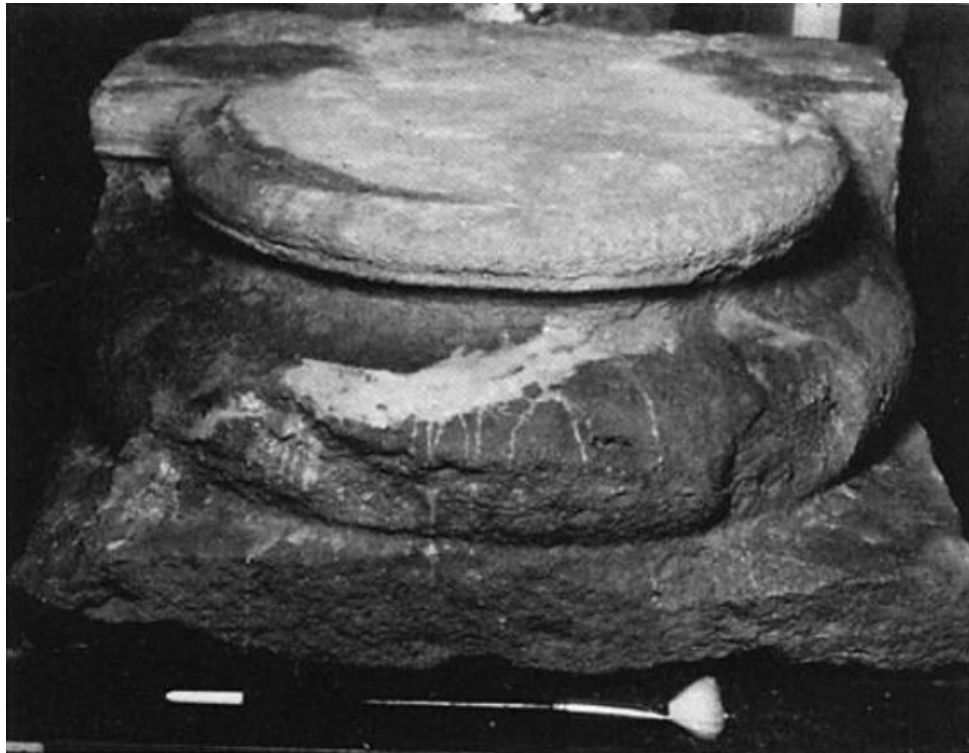
Fig.15 Column before treatment. The Met Archive

In 1999, the museum carried out conservation work on the base of a column (Fig.15) stored in its warehouse, necessitating transportation due to renovation work of that storage. Upon arrival at the museum, many pieces were found to be in poor condition and were exchanged for replicas made of dolomitic stone extracted from a quarry approximately 20 km from Fuentidueña. This may have been the case with this particular piece.

The article evaluated the use of consolidants such as ethyl silicates or acrylics in various solvents, but these were discarded after testing on samples. Finally, a treatment based on cyclododecane, melted and applied with a brush to areas with cracks, fissures, and small fragments at risk of loss, was performed. The result was an opaque surface that became practically unnoticeable when dry, achieved by using an air gun to allow the product to penetrate. Subsequently, the rest of the surface was treated with a solution of cyclododecane in a ratio of 3 parts Shellsol OMS to 1-part xylenes by volume, applied with a spray. This product was chosen for its low toxicity, with xylenes added to increase the concentration in the saturated solution.

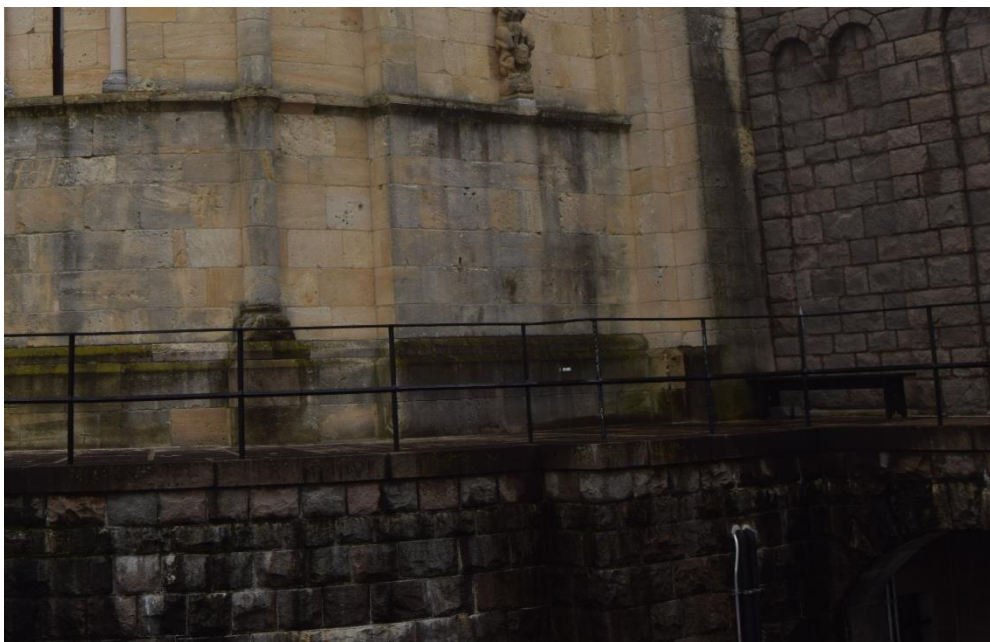
Fig.17 Water deterioration under the beading molding. Own Resource

The action of water alone can cause stains and aesthetic alterations, such as those under the beading molding (Fig.17). Water, along with the effect of temperatures, causes moisture and drying cycles that increase the concentration of dissolved salts, leading to precipitation if the stone becomes saturated. This deterioration is visible in some areas, such as the upper part of the molding. As a result of this process, the material becomes fragile and can disintegrate the stone superficially or internally. The holes in some stones may be due to the effect of salts. The effect of salts also caused many sculptures to deteriorate. As a preventive measure, four sculptures were brought indoors, and replicas were placed outside.

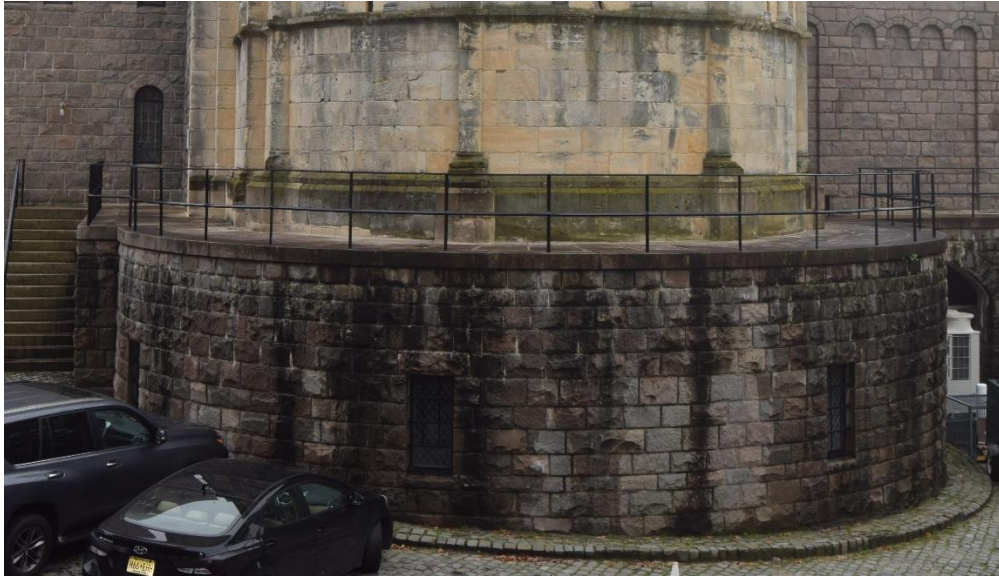
Fig.18 Pollution in the base and under the windows. Own Resource

Pollution can reach the apse in the form of gas, which are usually oxides, ozone, chlorides, or sulfates, among others; or in solid form, such as dust accumulation or material from surrounding vegetation. The deposition of these contaminants causes black crusts, as observed in various areas of the façade (Fig.18), or even, by the action of the wind, creates fissures in the surface. To identify the origin of pollutants, it is necessary to carry out analyses of air quality and the depositions.

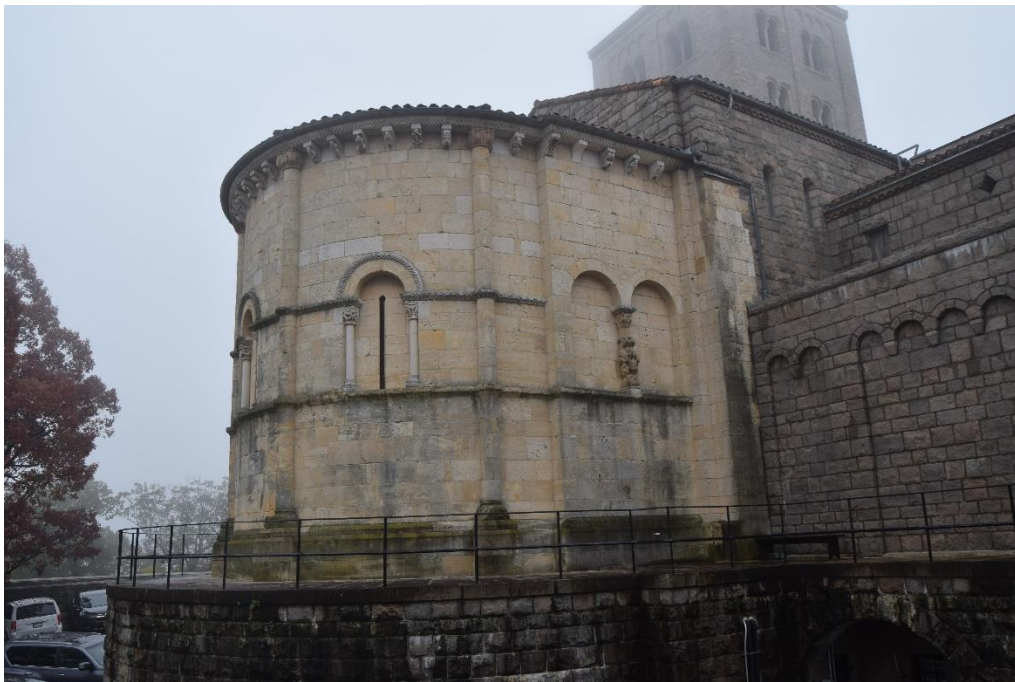
Fig.19 Biodeterioration in the upper level and under the windows. Own Resource

One of the problems that most affects the preservation status of the apse is biodeterioration. Among the biotic factors, small animals can be identified, such as birds, which deposit droppings in areas such as windows or the cornice (Fig.19), which can be difficult to remove, although no bird droppings

have been identified visually. The most pressing biodeterioration comes from lichens and small plants, like moss, which are due to the pH type of the rock, salinity, porosity, high relative humidity, and light. The presence of these organisms can cause anything from different coloration to the original, or water damage
