The Eidlitz Mausoleum

Historic Preservation Studio I- Fall 2019

Project 2: Woodlawn Cemetery: Graphics and Research

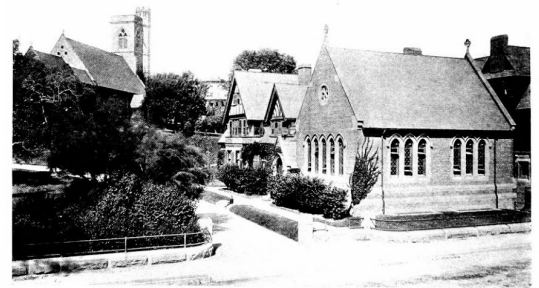
ST. THOMAS' CHURCH AND PARISH BUILDINGS, MAMARONECK, N. Y.

Fig. 2: St. Thomas Church and Parish in Mamaroneck, NY, an example of Gothic-style architecture built by Eidlitz

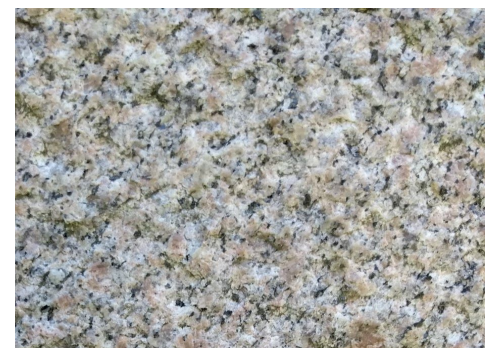
Fig. 6: Red Westerly Rhode Island Granite, Eidlitz Mausoleum

the design process, Mr. Eidlitz chose a red Westerly Rhode Island granite for the external stone, and the Presbrey-Leland granite from West Dummerston, Vermont for the floor of the mausoleum.¹⁵ Eidlitz specifically requested Westerly Rhode Island granite be used as the exterior stone in his contract, as

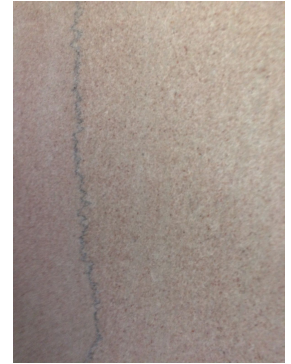
Fig. 7 Detail of Tennessee Pink Marble walls of Eidlitz mausoleum

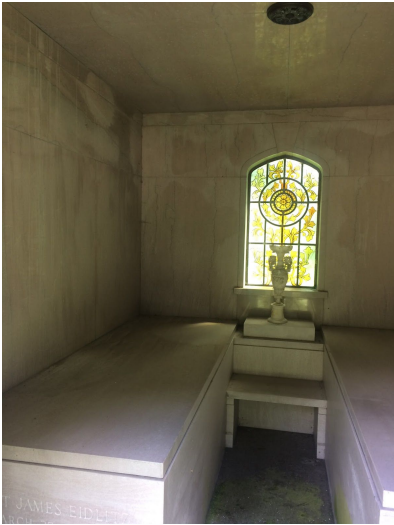
Fig. 8 Interior of Eidlitz Mausoleum, Tennessee Pink "Marble" walls

the Presbrey-Leland granite was actually originally typed into the contract for the chosen exterior stone, then crossed out and replaced with Westerly Rhode Island granite, which on-site visual analysis of the stone confirms is in place. Inside the mausoleum, both the interiors walls and sarcophagi are made of "Tennessee Marble", which is in actuality a pink-colored limestone with distinctive veins.

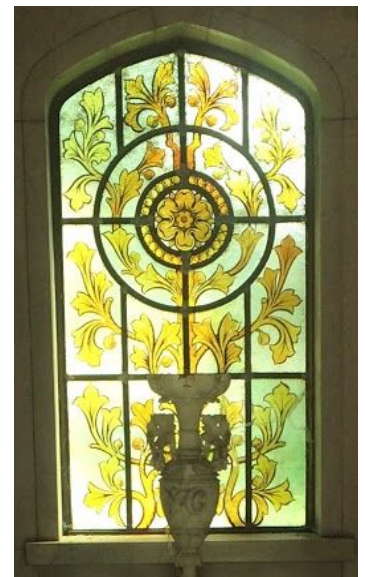
While the interior is quite simple in its design of just the sarcophagus and a small bench, mirroring the exterior aesthetic, it does include an amber-colored stained glass window featuring symmetrical designs

Fig. 9 Detail of stained glass window and vase, Eidlitz Mausoleum

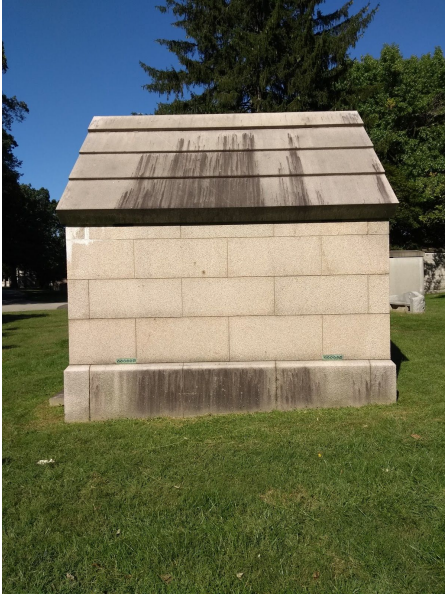
Fig. 10 Side elevation of mausoleum, with conditions visible (biological, lime mortar deposits)

Considering that the mausoleum is over eighty years old, the materials have held up somewhat well, as the foundation walls are structurally sound. Overall, considering the Eidlitzes provided a \$3,000 perpetual care fund in 1935, which has most likely run out by this point, the building's structure has remained solid on the exterior side walls. However, problems become apparent once one starts to examine the roof, as well as the other point in which water can enter. It should be noted that the roof eaves have largely been able to protect the exterior walls from the biological growth seen on the base

but much of the roof's functions have been compromised. The roof and base

have developed dark streaks over the years, that on-site visual inspection points to being

biological growth, with specific type to be determined. From a visual identification, the growth

could be a cyanobacteria or microalgae growth, and if either is the case the growth may actually

be leading to damage to the roofing materials, thanks to water retention by the growths.¹⁶ The

recommended solution to biogrowths such as these is the use of a biocide on the growth and then

removal by a cleaning agent, with periodic follow ups.¹⁷ These growths are known to be more

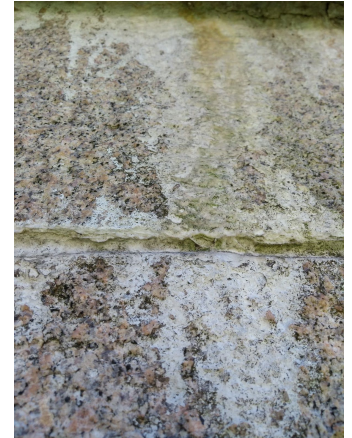
On each of the corners of the building, just under the eaves of the roof, appear what would seem to be lime mortar deposits, although no testing was conducted to confirm such, just the on-site visual observation of calcite deposits. These deposits point to a much larger issue at play, that water has somehow gotten into the joints and has allowed for these minerals to become displaced. While this itself is concerning, when one examines the roof to try and pinpoint a possible cause for this water issue, what may be the most likely cause of the water damage appears even more concerning on closer inspection. The roof ridge, which is a separate piece of masonry from the side roofstones, has large cracks along the joints on both sides. While in the original plans for the mausoleum it was specified that the ridge stone would have lips to cover the joints, it seems as if this may have actually backfired, and instead concentrated the elements into the weaker spaces near the joints. Thus, these cracks may be the beginning of a chain of water damage in the mausoleum, however, this can not be concluded

Fig. 11 Detail shot of calcite deposits, Eidlitz Mausoleum

until further analysis is performed. The repair of the joints may end up being the start of the solution, but will require more in depth study to conclude this definitively.

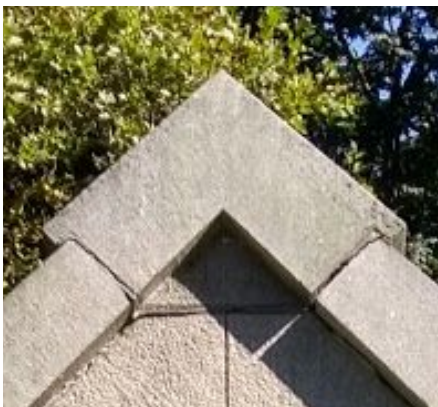
Fig. 12 The crack on the roof ridge can be seen here, extending from the sides to center

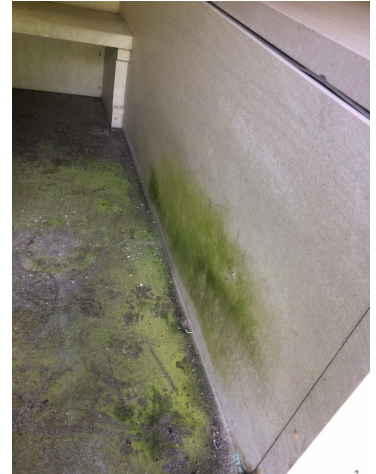
Inside, there are quite a few issues, some of which may be related to this structural issues of the mausoleum previously mentioned, although it cannot be confirmed. The interior floor is covered in

biological growth, specifically what appears to be a form of green algae. The algae is mainly concentrated in the middle and front sections of the interior, and does in fact line up with the cracked joint on the roof ridge, and thus may

point to this failure in the roof. The algae has gotten to the point that it has started to grow on the side of Mrs. Eidlitz's sarcophagus, and may eventually spread to Mr. Eidlitz's as well. While there are no puddles on the floor, the algae is very much alive and moist, indicating that there is an ongoing moisture issue within the space. The back walls and ceiling also show signs of water damage, pointing to the roof once again as a potential cause. The interior room also has a musty smell, one of the signs that the National Parks Service lists as a sign of moisture damage in areas of high humidity or poorly ventilated space.¹⁸ Thus, the vents of the mausoleum should be thoroughly examined for any sort of blockage or damage to the system, as this could also contribute to the growth of algae within the space. As the original plans do include a small attic space above, it is crucial to examine the roof and attic thoroughly, as they may well lead to the discovery of the cause of this water damage. Until the definite cause is found through a thorough examination, cleaning of biogrowth will not be of use, as the conditions will persist and it will return. However, if the cause for the moisture issues are found through examination of the vents and roof/attic, there is a good chance that repair of the issue and maintenance of the structure will benefit its future greatly.

Fig. 13 Biological growth on floor & side of Mrs. Eidlitz's sarcophagus
