Mausoleum Owner: Clarence Winants Hillyer

The Hillyer mausoleum is located on Plot #12810, Section 128, Filbert, Woodlawn Cemetery. It is at the corner of Fern Avenue and Park Ave, facing east. Viewed from the Fern Avenue, the mausoleum is sheltered in the shade of several trees (Figure 1-3). Clarence Winants Hillyer is the owner of the mausoleum. The mausoleum was built in 1911, after Clarence's first wife Fannie died.

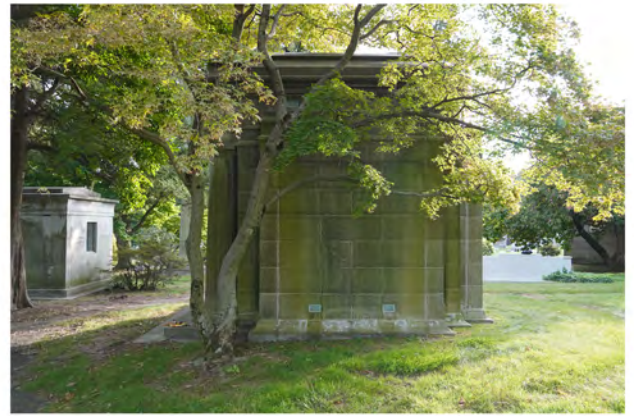
- Some organisms are growing on the exterior walls. A tree is just one foot away from the north wall of the mausoleum, and three trees are about ten feet from the front, while the other two

However, the north side is covered with lichens and other organisms.

7. North Elevation

quite severe due to condensation and poor air flow. To better preserve the mausoleum, the staff should prune the trees beside it frequently to help more light and air get to the mausoleum, and examine how the ventilation system could be improved to resolve the interior water problem. Besides, since evidence of moisture on the interior is obvious, they should also take a closer look at the roof to see if there are any places that rain and snow can enter.

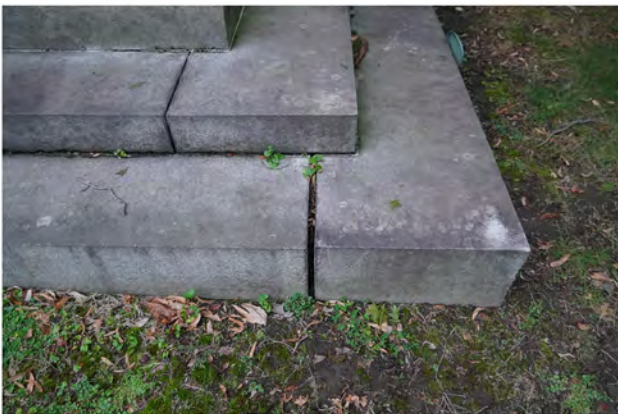
- The vents on the north side are not working as well as they should because there is biological growth beneath them. The vents are made of bronze, and bronze can kill the organism. If the vents work pretty well, the moisture in the air that flows out could carry out some bronze. Therefore, there should not be organisms under the vents. By contrast, the vents on the south side are working.
- There are gaps between step stones, so water could flow down to the foundation and cause damage to the foundation, or movement of the earth that would result in damage to the foundation (Figure 8).

8. Gaps between step stones

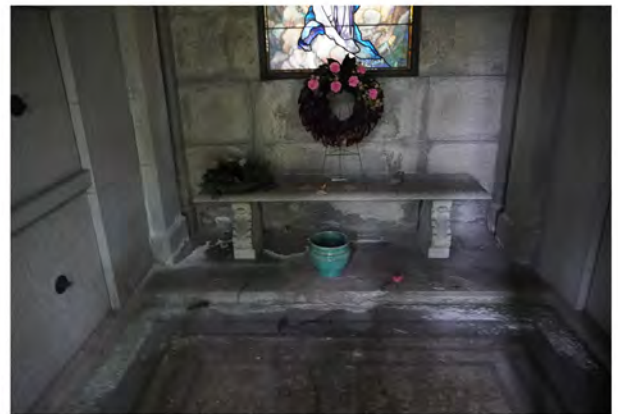
Thirdly, the salts dissolved in the water have damage to the surface of the stone, and the damage goes deeper than the surface, causing the stone to flake off and blister. Some parts of the stone on the ground besides the mosaic have broken down into powder (Figure 9). The salts are carried by water because of condensation and poor ventilation.

9. Interior stone salt damage1

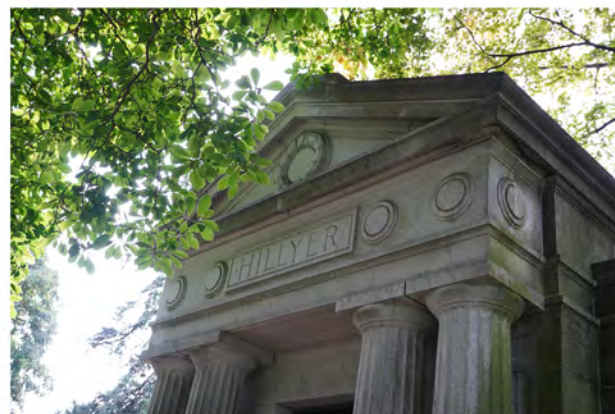
From the above information, it is clear that the Hillyers were a wealthy family, so the mausoleum is quite impressive. In general, the mausoleum represents a Greek Neoclassical style, with four Doric columns on the front. There is a circular floral pattern on the pediment. Beneath the pediment is the sign of “Hillyer”, with two rings on each side of it (Figure 13). The walls are almost blank, showing the taste of simplicity and grace (Figure 4-7). Its contractor, Harrison Granite Company, established in 1845, is a New York based company famous for building monuments in classic forms. All the stones come from Barre, Vermont. The Harrison company had built lots of memorials, crosses, grave stones, steles, carvings, and mausoleums before 1911.³ The Hillyer mausoleum is a middle-sized one among them.

13. The pediment
