WOODLAWN CEMETERY: BIBLIOGRAPHICAL RESEARCH
EXERCISE 4B

Student: Blanca del Pilar Balbuena Lorenzo

Fall, 2022

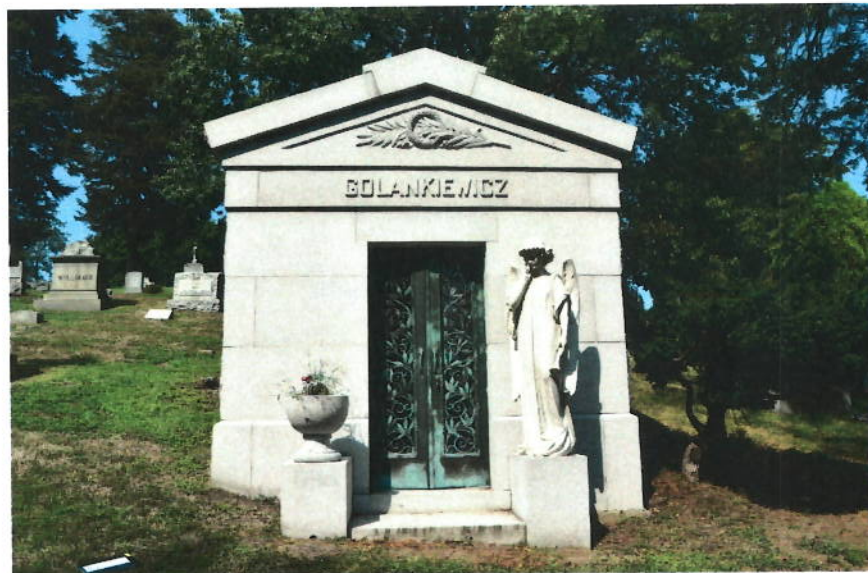
Img. 4 Majewski's Mausoleum.

The Majewski Mausoleum (Img. 4) is located in the Highlands plot if we take a panoramic view, the mausoleum is located at the edge of the area, near the road, between Ravine and Whitewood Streets, on the sides and at the back of the mausoleum are numerous single-person tombs.

In general the structure is quite simple and small in size. It is mainly made of granite (probably blue granite), white marble, as well as copper. The granite is found in the exterior wall, being the thickest of all; the marble in the interior, with a thinner thickness than the granite; and the copper is found in the main door and in details in the tombs, in the ceiling and in the windows.

- The mausoleum. In general the building is in very good condition. The interior is really clean, concluding that they keep it in good condition, preventing it from deteriorating. One of the few existing problems is the roof of the mausoleum. A slight bowing is observed in the joints of the pieces that compose the roof. It does not seem to be a serious stability problem.
One of the most curious things is the difference in some details between the Polchinski company's plans (Img. 6 & 7) and the current structure. It is not possible to determine with certainty but probably the door was a last minute decision, as it is not similar to the one in the plans. Also, the angel sculpture (Img.8) does not appear on the plans, so it may have been a later addition by a family member other than Sophie.

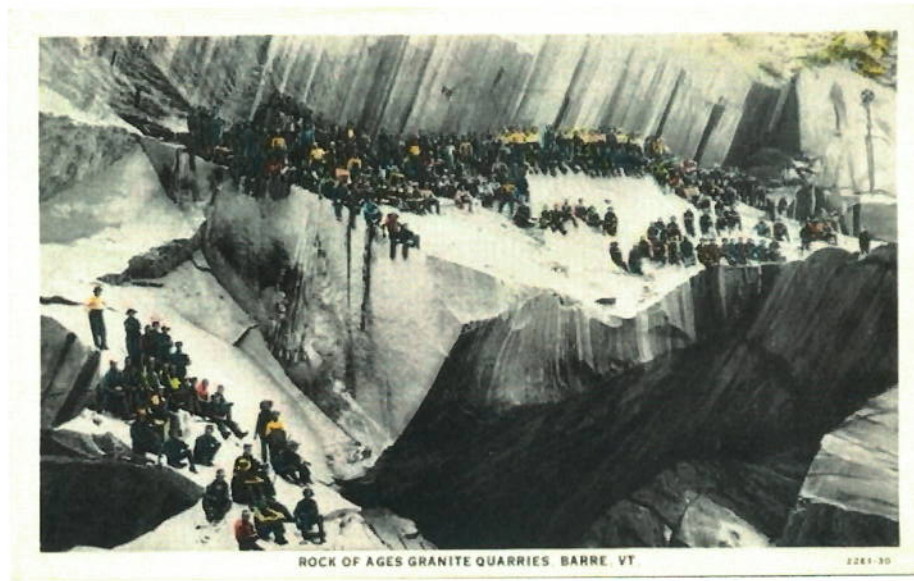
Img. 5 Rock of Ages Quarries, Barre, VT. <https://bit.ly/3T8Tp5X>

Based on documents found in the Avery Library archives, the work to build the mausoleum was approved in February 1926. Sophia Majewski, as previously reported. The company that undertook the construction was Joseph Polchinski Co. Inc. and, although the company's catalog has not been found, it is known to still exist and they continue their work of designing mausoleums, single-person tombs and statuary. Nowadays, the Polchinski Memorials continue to have that characteristic style of simplicity, making small buildings with little decoration. The blue granite, the most abundant material in the mausoleum, has the following characteristics:

- Great ability to withstand extreme temperatures, fluctuations, hydrocarbons and acid rain from atmospheric pollution. Withstands the passage of time well.
- Many colors are available.
- A fairly affordable material when compared to marble.
- Can be carved in different ways.

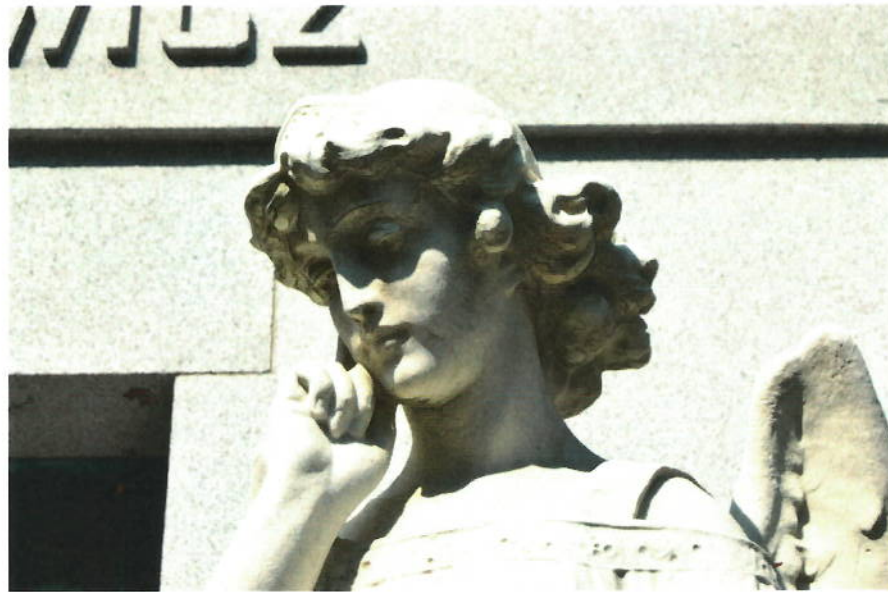
Img. 8 Angel Sculpture

- Sculpture. Although it is not known with certainty the type of stone that was used to make the sculpture, it is possible to intuit that it could be some type of slightly porous limestone or marble. The state of conservation is quite good, intuiting that it is a later addition to the construction of the mausoleum. Due to the environment (Instituto del Patrimonio Histórico Español, 2002), with a climate of strong variations of temperature and humidity, some cracks and fractures of little importance are observed. Environmental pollution is the deteriorating factor responsible for the darkening of some areas of the face and yellowing by acidification in the wings and some folds of the tunic.
