# The Robinson Mausoleum

Yekaterina Nestser  
Historic Preservation Studio I  
Professors Andrew Dolkart and Kate Reggev  
December 12, 2024

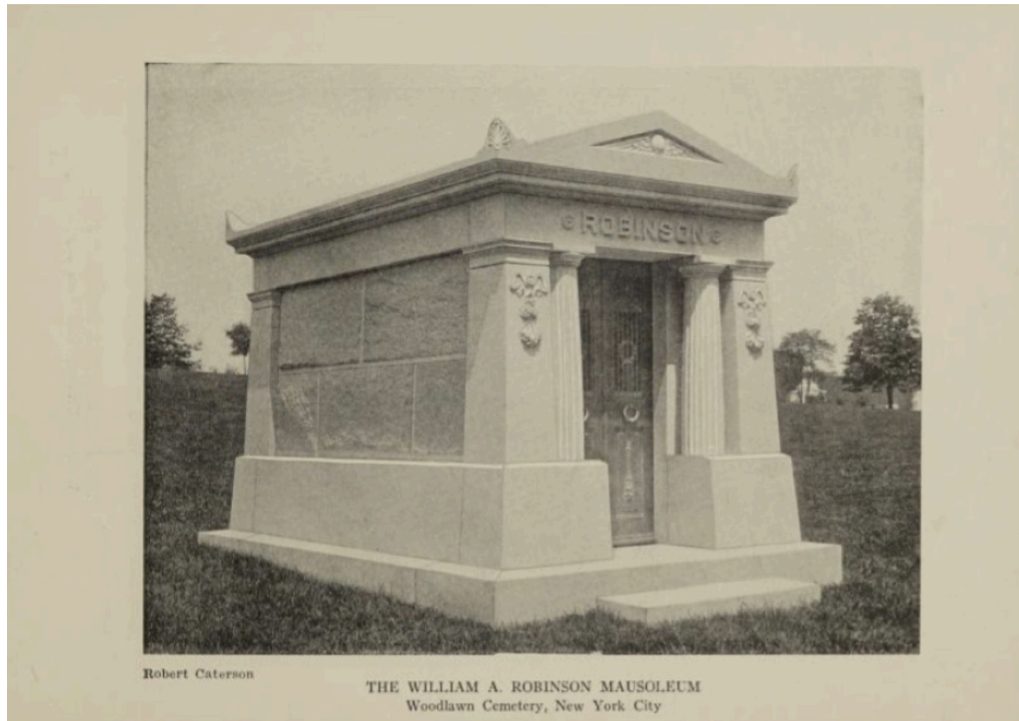
**Figure 1:** *The Monumental Works of Robert Caterson (1900)*

The Robinson mausoleum, featured in the prestigious *Monumental Work of Robert Caterson* (1900) catalog, stood ready over two decades before its eventual occupants—William A. Robinson (1842–1922) and Sarah J. Robinson (née Hobson, 1842–1923)—were laid to rest<sup>1</sup> (Figure 1). While it might be assumed that the decision to commission the monument was a joint one, it remains unclear which of the two initiated the project; in fact, both parties seemed rather indifferent to the upkeep of such a considerable investment. Correspondence from Woodlawn dating to 1910, requesting a 50% increase to the originally projected \$1,000 upkeep budget, reveals that William and Sarah had to be well aware of the mausoleum's maintenance needs. Despite having the funds to do so earlier, the couple delayed providing the suggested payment, obliging only in 1922, when the estate of the now-widowed Sarah issued a one-time check<sup>2</sup>.

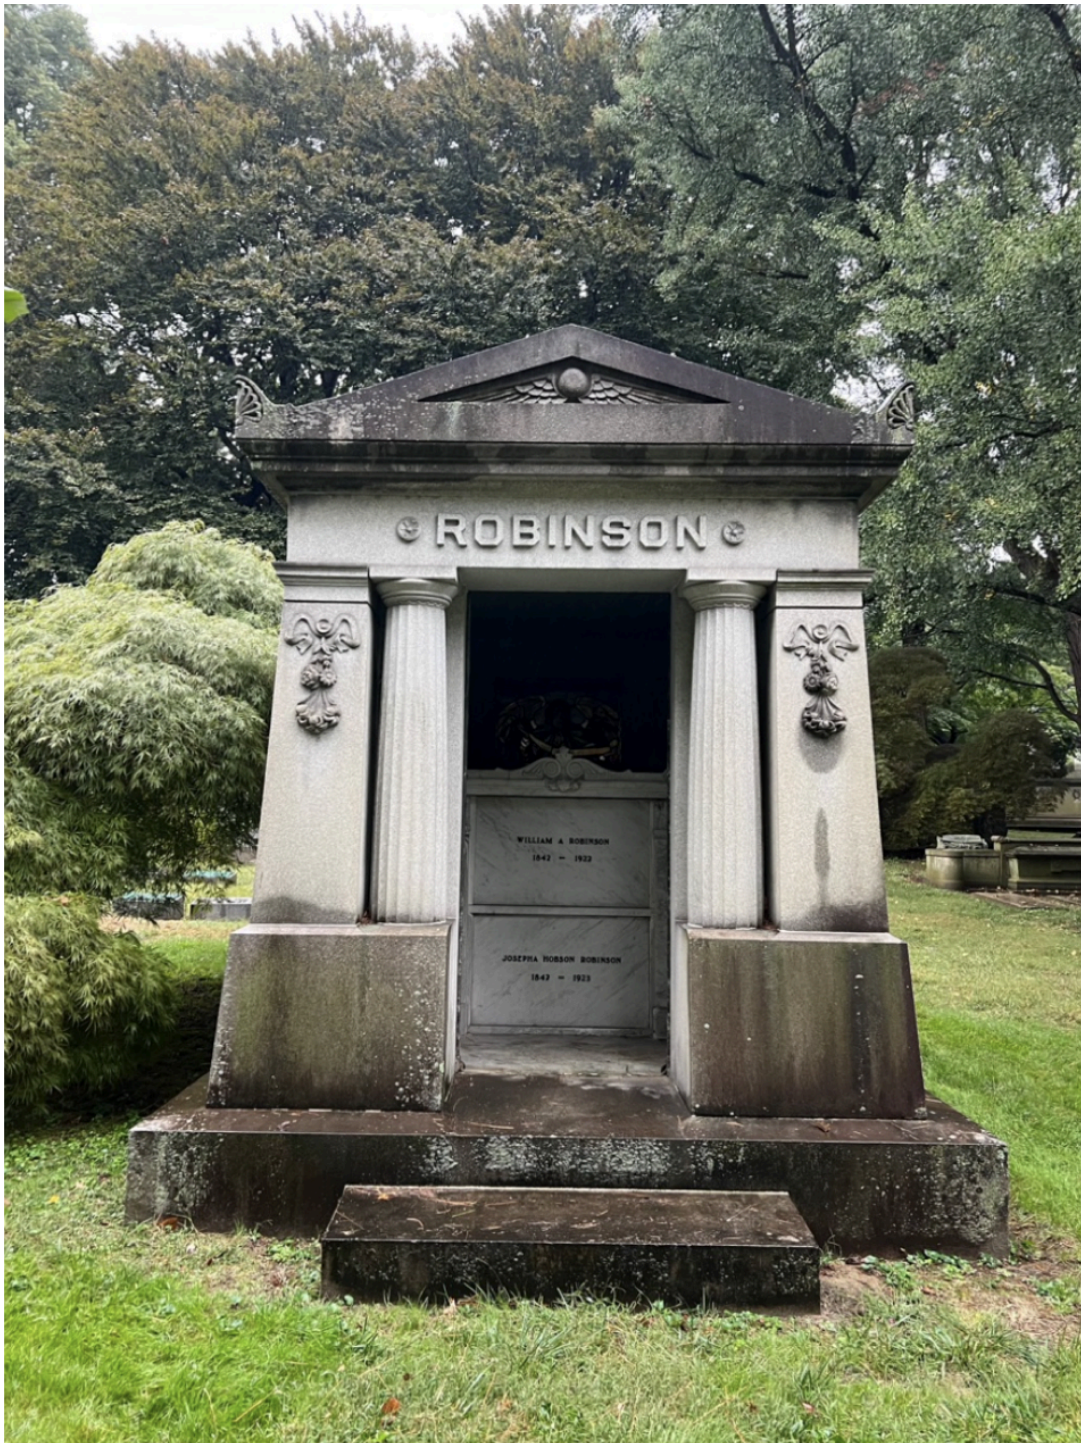
**Figure 3:** Nestser, Yekaterina. *Mausoleum with Open Entrance*. September 2024

This anonymous legacy is mirrored in the mausoleum's interior design, which seems almost reluctant to accommodate visitors. The marble-clad sarcophagi of Mr. and Mrs. Robinson dominate the limited space, arranged in a distinct 'bunk' orientation with William resting above and Sarah below (Figure 3). The narrow confines allow for, at most, two visitors before the space begins to feel uncomfortable. Marble also sheaths the walls, though signs of neglect are evident. A damp spot in the southwest corner of the granite ceiling hints at humidity concerns, contributing to damage on the coffins and its fine details, such as the crumbling palm leaves, which continue from the exterior theme (Figure 4). An entire panel has even detached from above the entrance portal. Though it seems as if the space was not expecting visitors, the bronze lettering on Sarah's grave is proof of otherwise: the unnaturally flicked-up 2 on her birth date is a unique example of deterioration created by force (even if accidentally spawned) rather than brought on by time. (Figure 5)

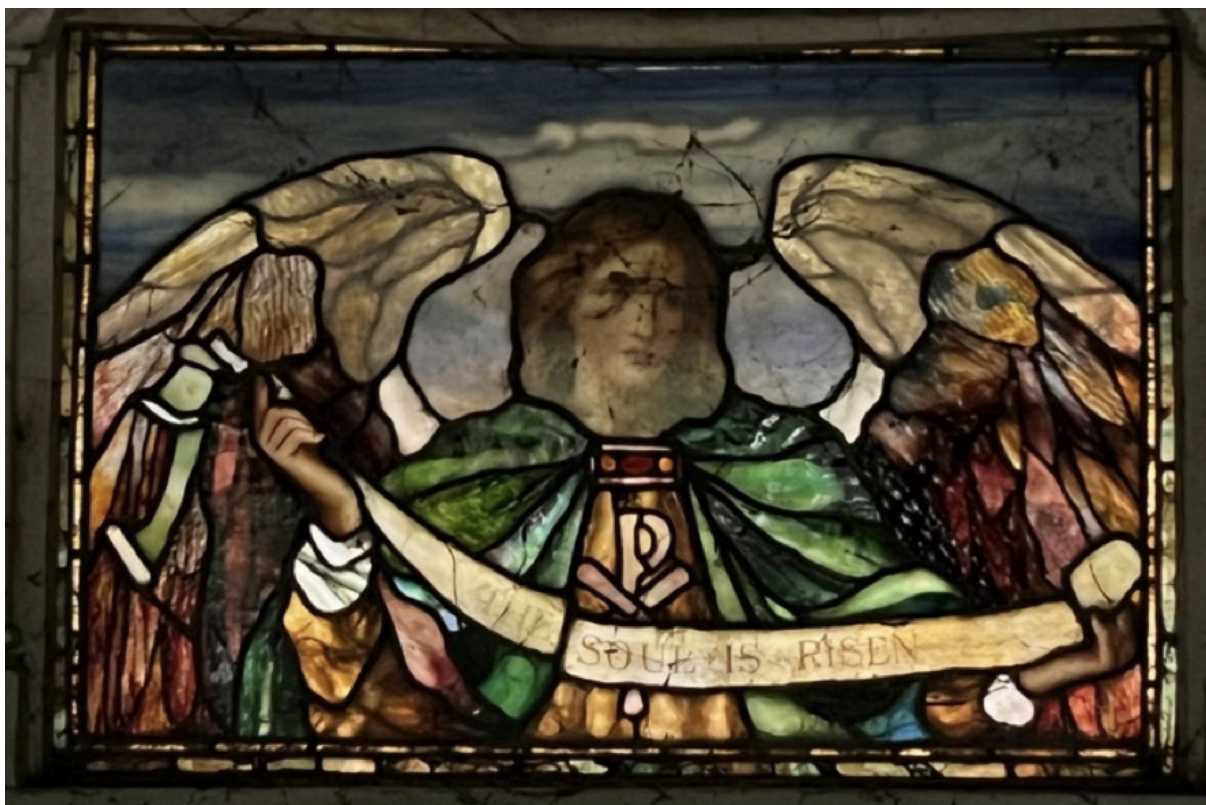
**Figure 6:** Nestser, Yekaterina. *Stained-Glass Window.* September 2024

A stained-glass window occupies the upper half of the northern wall, possibly a commission from Tiffany Studios. The window depicts an angel holding a scroll inscribed with the faintly legible quote: **THE SOUL IS RISEN** (Figure 6). The challenging design employs a variety of signature motifs such as opalescent glass and favrile glass jewels. While the northwestern placement must offer striking illumination in the massive space that is created above the couple's sarcophagi, its distance from the ground and location in the cramped space

make efficient cleaning and maintenance challenging. Additionally, the artwork is in dire need of maintenance, as the weight of the roof is risking the integrity of the glass panels<sup>16</sup>.

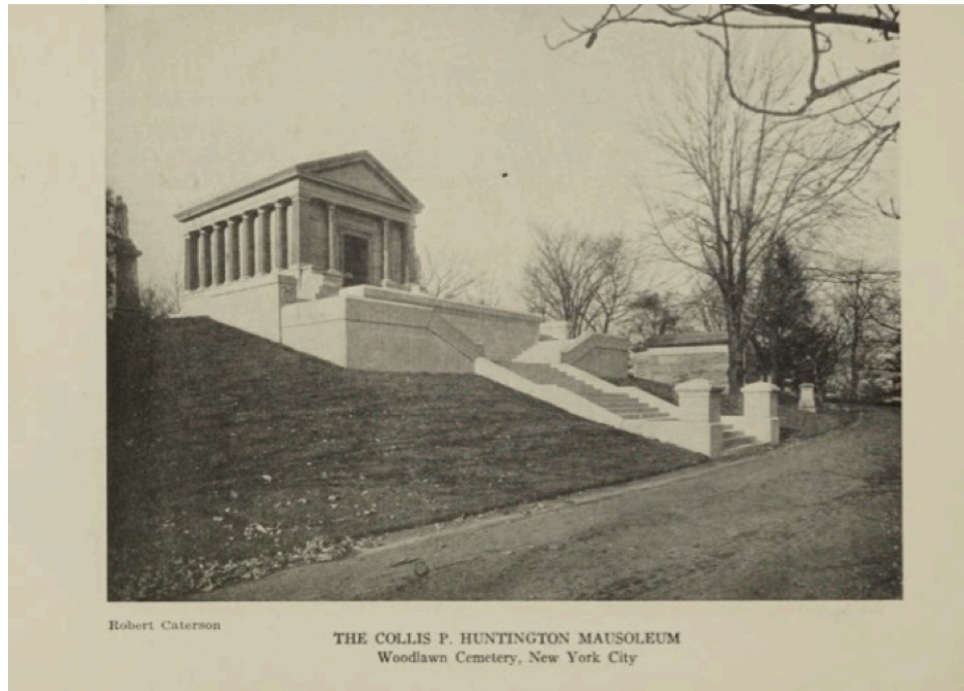
**Figure 7:** Image 1 from *The Monumental Works of Robert Caterson* (1900)

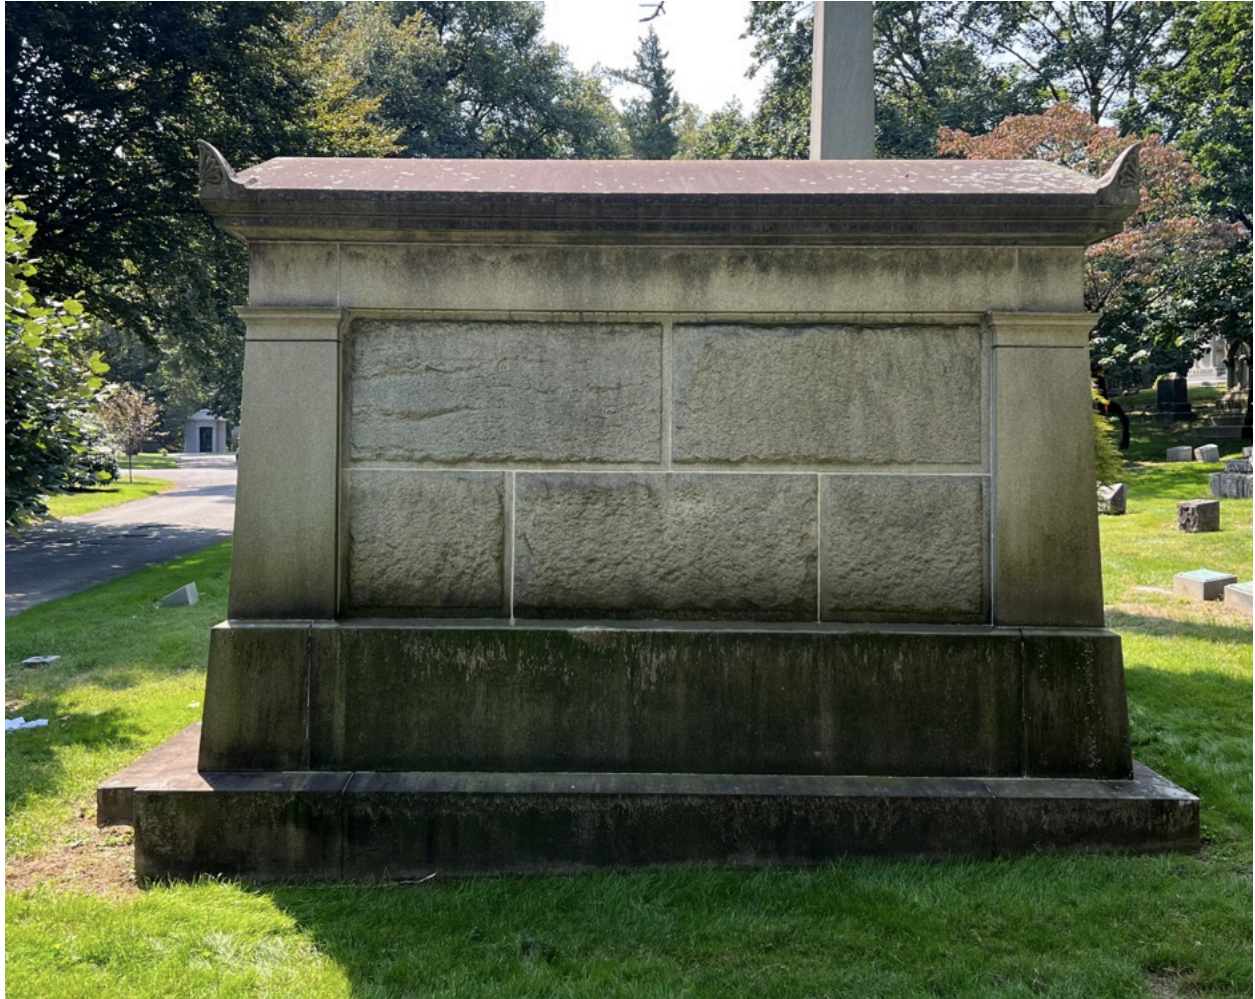
**Figure 8:** Nestser, Yekaterina. *East Elevation*. September 2024

The east and west walls are symmetrical. The main body acts as a granite frame, encasing two rows of five rusticated stones (Figure 8). On the northern wall, the same type of stone similarly occupies the space but only on the lower half of the elevation, while the top half

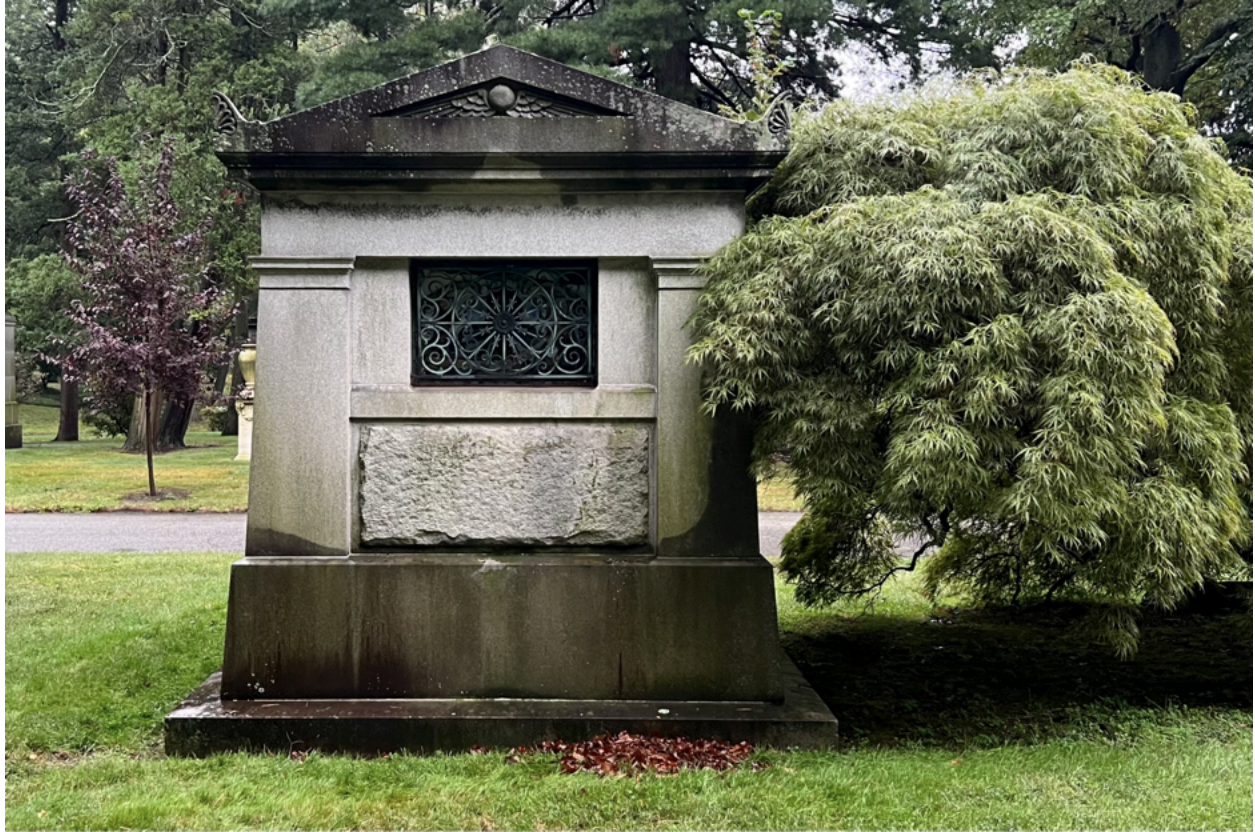
**Figure 12:** Nestser, Yekaterina. *Northern Elevation on Rainy Day, Featuring Japanese Maple Tree.* September 2024

Despite the decades of inflicted neglect, the structure remains in relatively good visual condition. Aside from some manageable material deterioration, most of the maintenance appears more easily reversible. The pattern of organic growth corresponds to the natural disposition of rainfall. This is why one of the most damaged external parts is the roof being provoked by landscaping. Although the Robinson plot is barren of any additional natural elements besides grass, a visit to the cemetery on a rainy day depicts how their neighbor's Japanese Maple tree, accidentally extending to the northwestern corner of their plot, is causing humidity to concentrate at the spot (Figure 12).
