## EX 4B Biographical Report - Kluge Mausoleum

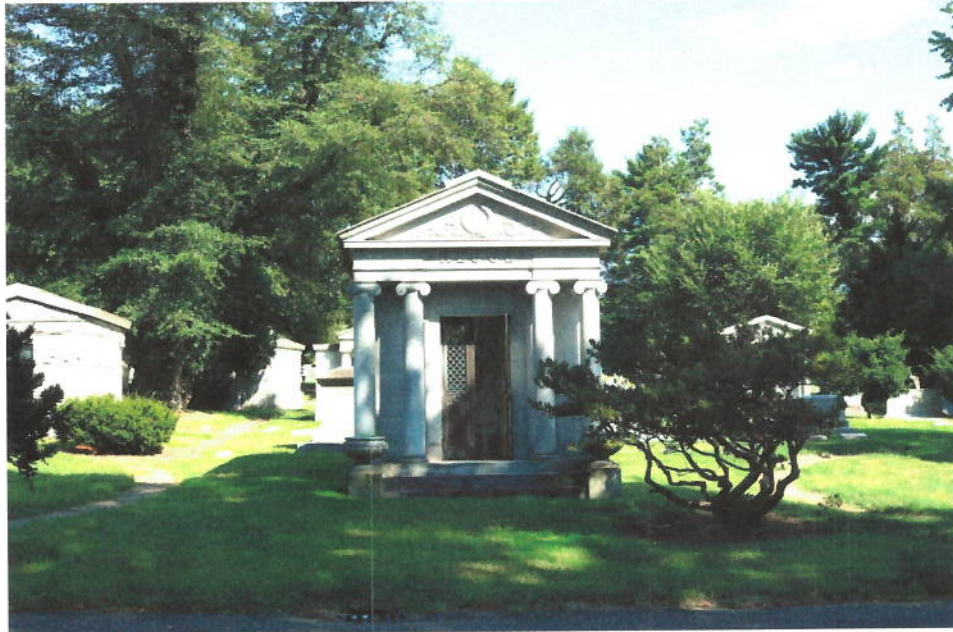
Figure 2. Front view of the Kluge Mausoleum

There is minimal landscaping on the plot except for the coniferous shrub positioned to the right of the mausoleum, and is likely too small to be original. The shrub ingeniously blocks the view of the building for visitors arriving from its left, offering the resting place some privacy. The land it sits on is slightly sloped with the front facade on a lower plane than the back facade.

The Kluge family mausoleum is modest in size, with room for eight catacombs in total – four on each side. The building sits on a base consisting of three different parts – the steps, the portico platform, and buttresses (term used for the backwalls in the blueprints), all having granite as the material choice. The portico platform extends the full width of the building, where four ionic columns support a frieze and pediment. The inscribed family name KLUGE is raised on the frieze. Light Barre Vermont Granite is used for the exterior walls, all of consistent ten inches thick blocks. The high quality granite is free from

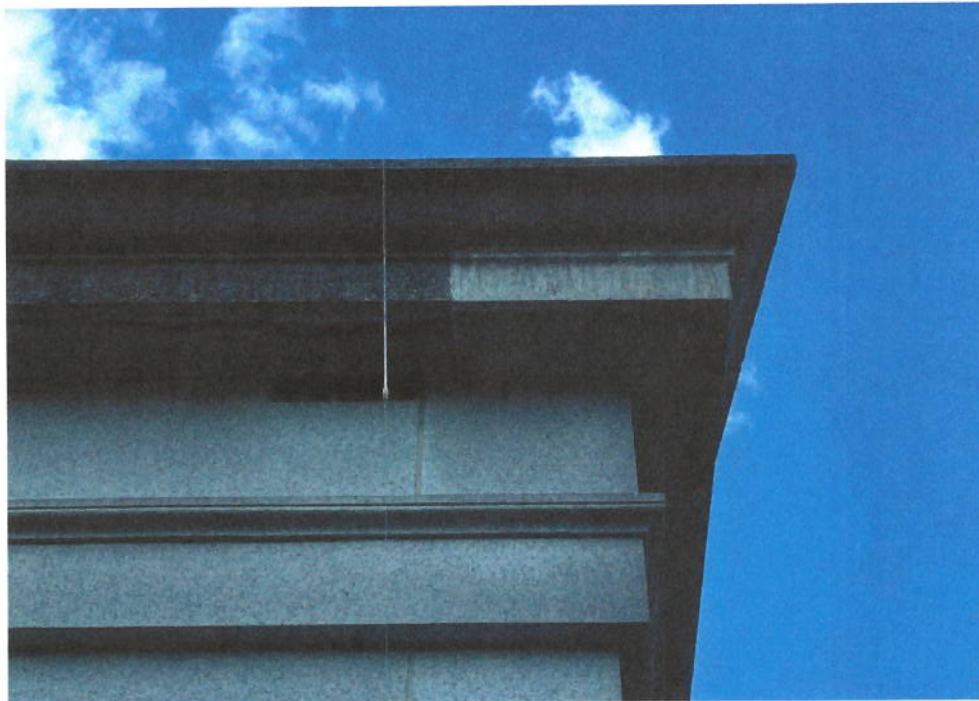
Figure 4. A clearcut starting at the jointline between the pediment and roof slab – oddly clean v.s. heavily polluted.

The mausoleum is fairly well-kept. There is no record of replacements or major defects. The largest visible deteriorating conditions of the mausoleum are soiling and biological growth. Soiling can be most severely seen on the roof of the building, more prominently shown in the right elevation than the left. There is a clear cut visible on the side facade located on the joint line between the pediment and roof slab – where the corner of the horizontal cornice of the pediment is clean and the cornice along the

rest of the roof is dark with pollution. The plausible inference is that the pediment may have been replaced, but at the same time it is also unlikely because the roof slabs and cap would have to have been taken out in the process as well – it also means the carved ornament in the front pediment would have had to be replicated. It is more likely this part of the structure was cleaned when it was being repointed.

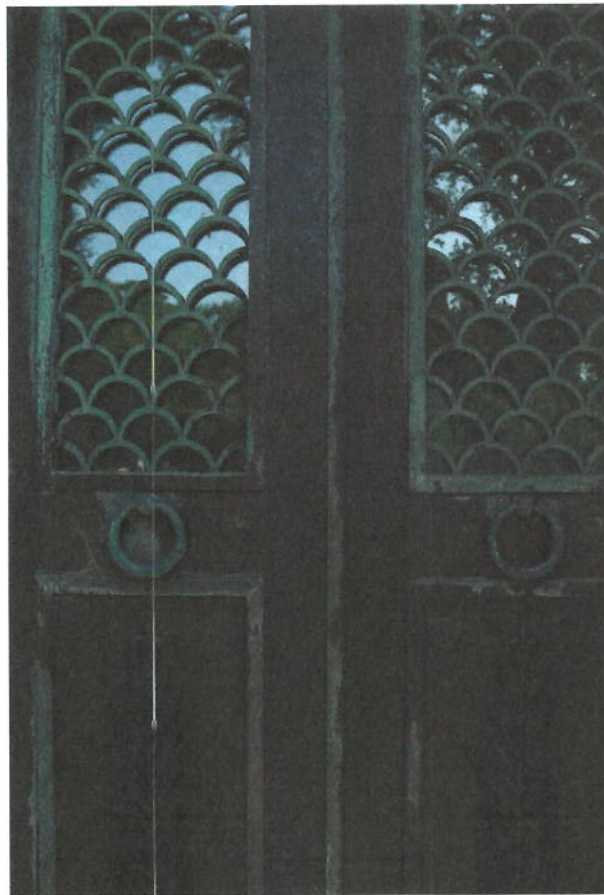
Figure 5. The green patina starting to form around the edges of the bronze door

The entrance door shows tints of green patina around its border edge. The irregular pattern of where the green patina is occurring is unique – usually the entire surface would be green. There are two plausible inferences: 1) it is possibly painted over with brown paint to imitate bronze instead of an actual replacement, and now it is peeling away where it is scratched against the granite architrave around the door when opened, or 2) the door was cleaned and corrosion is occurring from the edge again. The leaf decoration on the bottom half of the door is in almost excellent shape and clarity (free of corrosion).
