# WOODLAWN CEMETERY: PROBLEM 3 - Sherry Mausoleum

BRANDI HAYES

STUDIO 1: READING BUILDINGS FACULTY: FRANCOISE BOLLACK, WARD DENNIS, ANDREW DOLKART

FALL 2009

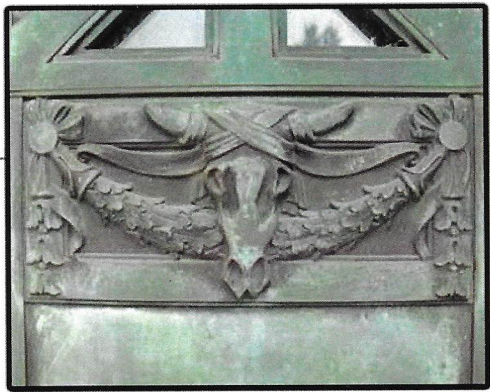
The door is made of bronze, as are the air vents for the mausoleum, and the frame for the stained glass window found on the east side of the building. The bronze has a patina which is protecting the bronze, keeping it in fine condition and lending a pleasant aesthetic value to the design.

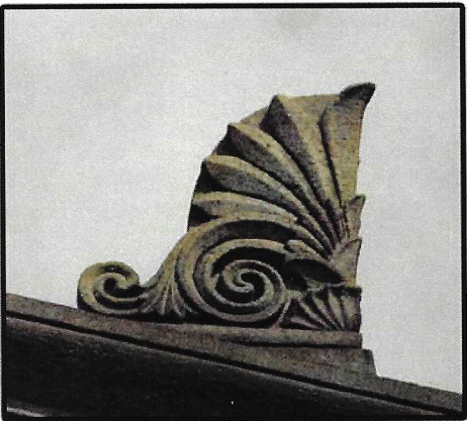
The acroterion is a typical example of the ornamentation found in other buildings designed by McKim, Meade, & White. These few ornaments show that Sherry, though wealthy enough to afford the services of the firm, was not ostentatious. Instead, the design for his resting place is tactful and elegant.

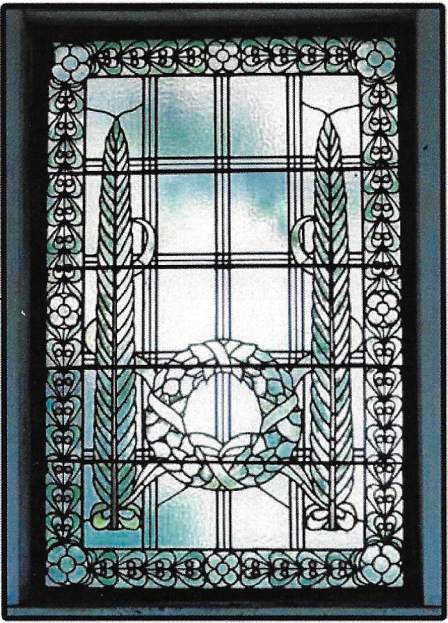
The window in the mausoleum is reported to be a Tiffany window. It is set in a bronze sash, and has four saddlebars to hold it in place. It is not in great condition as the window shows much bowing and sagging, especially at the lower end of the window, where the wreath is located. The small pieces of glass and repetitive pattern are to blame for the bowing. While the saddlebars hold the pieces in place at this time, a restoration including temporary removal of the window may be necessary in the future, as the glass moves slightly in the lead comes when pushed with a finger.

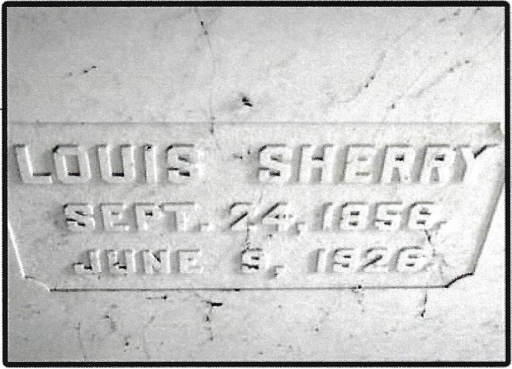
The interior of the mausoleum is faced with C.F. Italian marble, the walls, floor, and molding all highly polished. On the tomb, the marble is etched with the name of the deceased. The marble is in great condition due to its location on the interior. Superficial cleaning should be done to remove dust and cobwebs, which are plentiful inside the tomb.

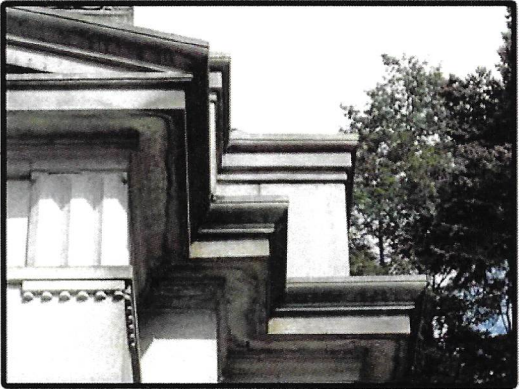
The moulding and base of the mausoleum extend approximately five inches from the building on three sides; the north, south, and east. The west side features a portico and steps where the moulding and base piece would be. The moulding and base are of Fine White Hallowell granite and are in good condition, with some signs of weathering under the overhangs.

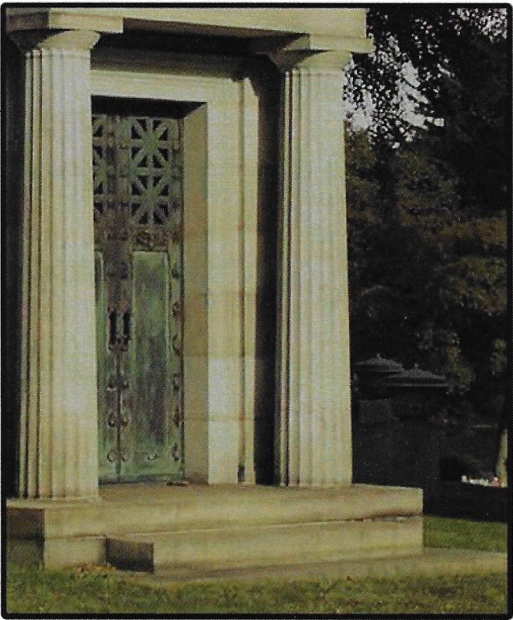
The portico of the mausoleum has two Doric columns, fifty-five inches in circumference at the base and eight feet four inches tall. The columns and front steps are both made of Fine White Hallowell granite. There are three front steps, the bottom almost completely covered by the slope of the site. Because of the proximity to the ground, the steps have the most signs of weathering and biological growth, as evidenced by the greenish stains.
