Illy Auerbach & Liza Hegedus  
Professor Normandin  
Building Conditions Assessment  
4 March 2024

## Lescaze House and Studio- The first modern residence in New York City<sup>1</sup>

### Investigation and Assessment

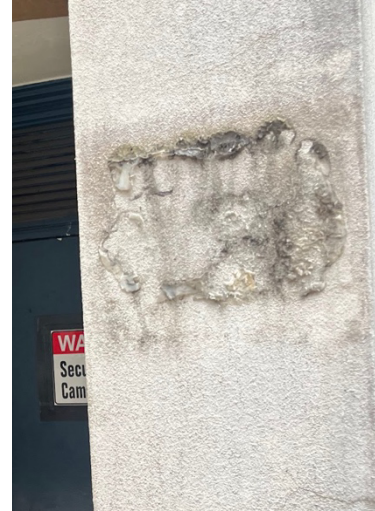
Figure 16 Fixtures\_b

- Some gray cement patches on the walls and ceiling of the English basement level.
- Exposed security camera on the English basement (figure 17).
- Exposed electrical wiring coming out of the ceiling next to the security camera and by the main door (figure 17).
- Peeled building number signage at the east end of the building (figure 16).
- Missing hardware: door knob from the gate, lighting fixtures from above the office door, and above the main house door (figure 15).

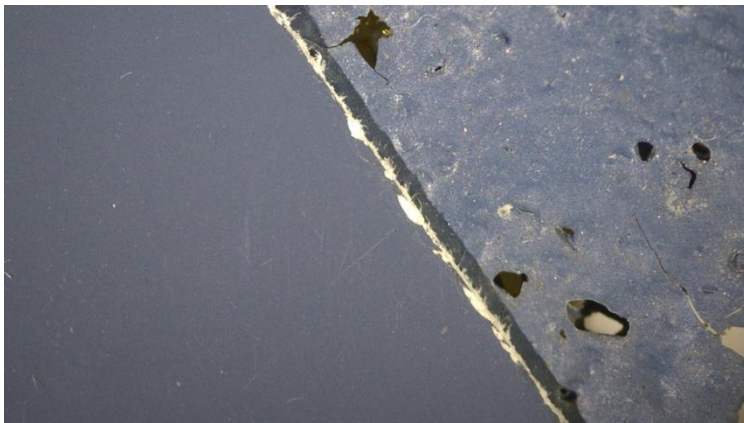
*Figure 25 Paint Sample\_a*

The state of rust is severe in all exposed steel elements. This condition likely occurs due to a lack of maintenance, which would include priming the steel and repainting it.

Additionally, in some spots like the ends of columns or the joints of the gate, it seems like the primer and paint were not applied to the problematic parts that are harder to reach, leading to severe corrosion. Due to this condition, we could easily pick a small sample of the peeling paint and conduct a further study on it (figure 14). On February 22, 2024, we examined the sample in the Historic Preservation Lab and were able to find its match in the Munsell Book of Color and in the Benjamin Moore catalog.
