Marieke van Asselt, Shereen Al Mater
Building Conditions Assessment - ARCH 4830
Prof. Kyle Normandi, TA Blanca Balbuena
March 3, 2024

Harry Belafonte Library (115th Street Branch) Conditions Assessment Report

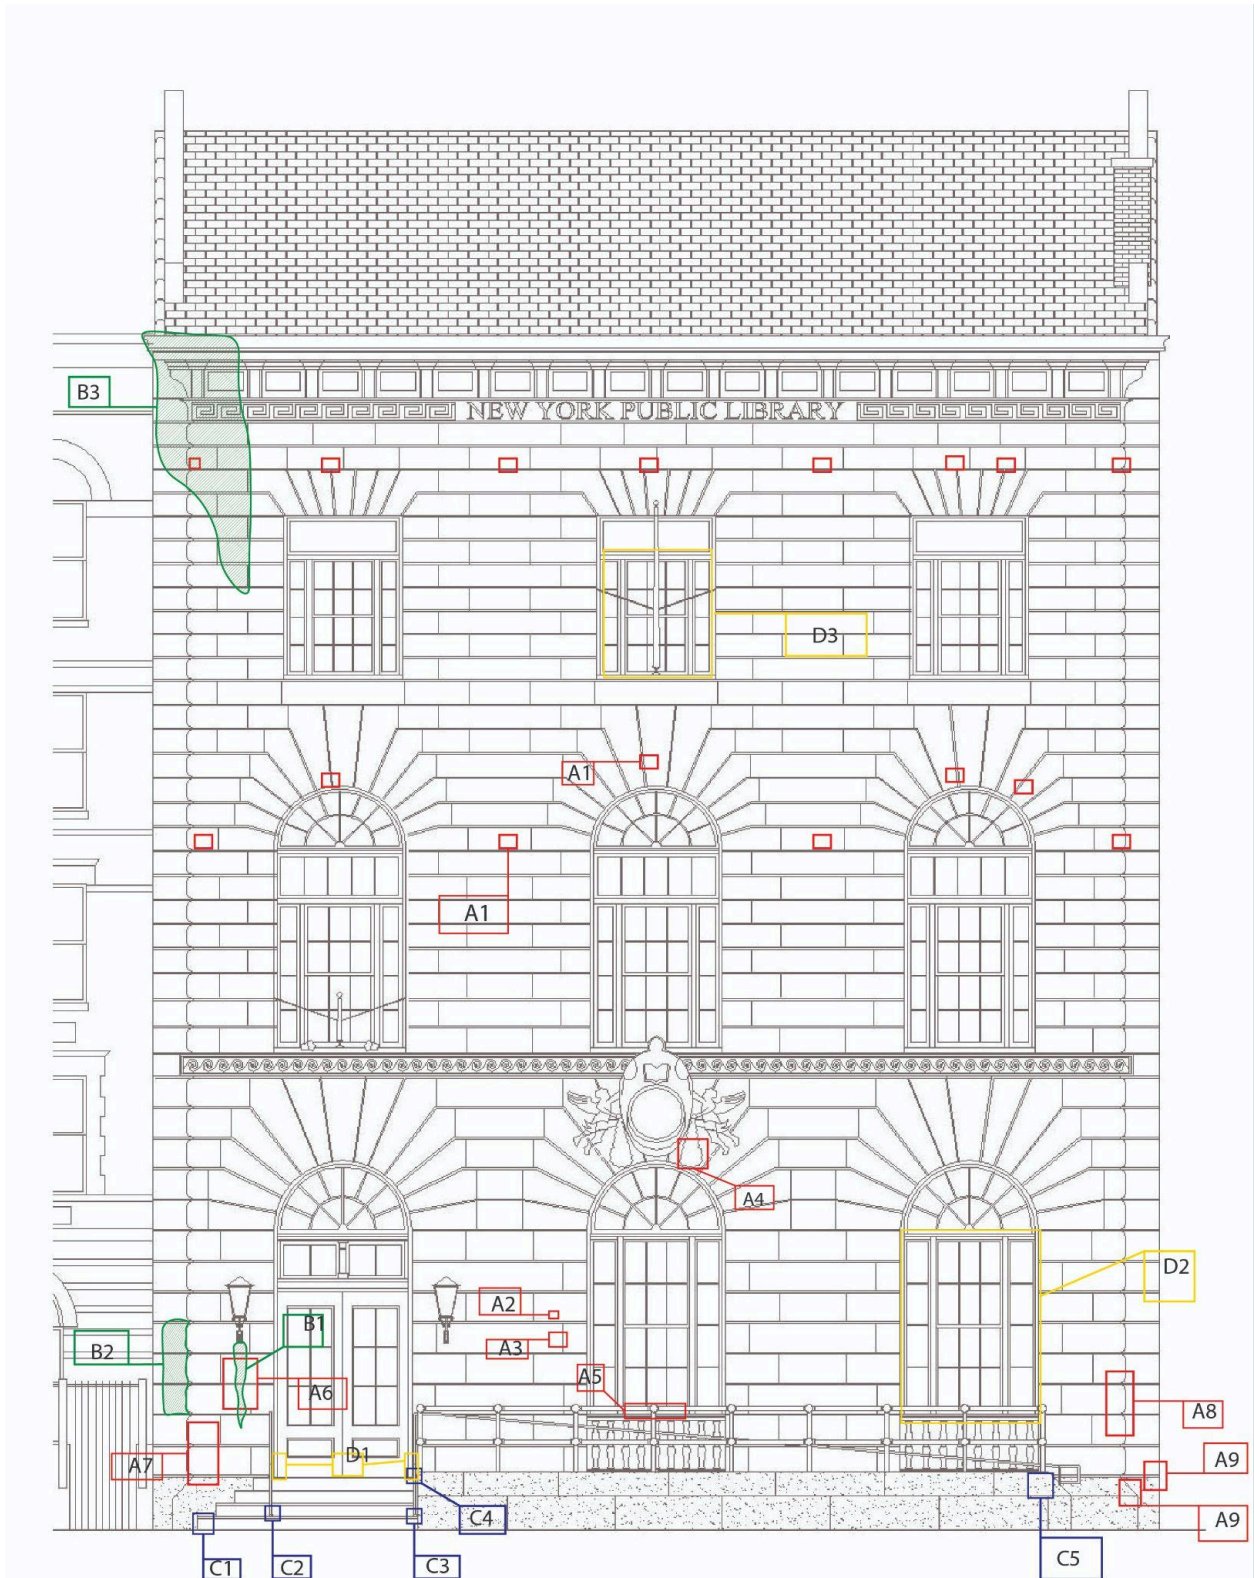
Key	Image	Description
A1

The limestone is overall well maintained except for some minor conditions. Those conditions include unrepaired holes on the left of the entrance door where something was attached to the limestone such as a mailbox or a plaque (A6). There's evidence of repair across the facade where small holes have been filled with mortar which is slightly discolored but isn't very noticeable. Those holes were most likely caused by attaching conduits to the facade in the past (A1). Other conditions have been identified as well, all on the first story of the facade, one of which is an insect nest that is located to the left of the center window and coincidentally sits right above a Dutchman repair (A2, A3). On the sill below that same center window, part of the limestone was damaged likely due to impact, and has been repaired with a concrete fill (A5). The area of the limestone surrounding the fill is evidently discolored due to the collection of moisture in the area.

Evidence of a Dutchman repair is also apparent on the first floor at some corner pieces of limestone, the original limestone was most likely damaged by physical impact given its location (A8). Areas where a Dutchman repair is needed include the limestone city crest where a piece of the carved vine had fallen off the facade (A4). Given its location, the damage on the limestone lintel could've been caused by the vine piece colliding in that area when it fell.

Moreover, there's minor graffiti on the facade and some of it seems to have been done with crayons and paint, they're not very noticeable which could be due to the rain gradually rinsing them off (A7). Similar to the graffiti, some paint splatters are visible by the doors and windows which likely occurred accidentally during paint jobs that took place during the 2002 renovation (D1). The last existing condition on the limestone is some chipping at the corners of the facade, one chip which is on the granite and another on the limestone (A9). Given their location, the chips most likely occurred due to impact.
